PSY2 RETAIN TIPS
(as of 05/23/98 at 00:56:36 EDT)

RETAIN Technical Data

May 23, 1998

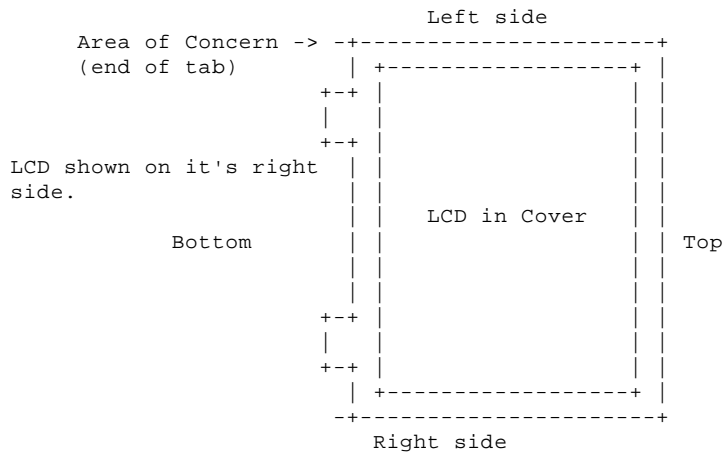
Check for cracking or breakage on the top cover FRU P/N04H8326 or FRU P/N42H1423 as shown in the following diagram:

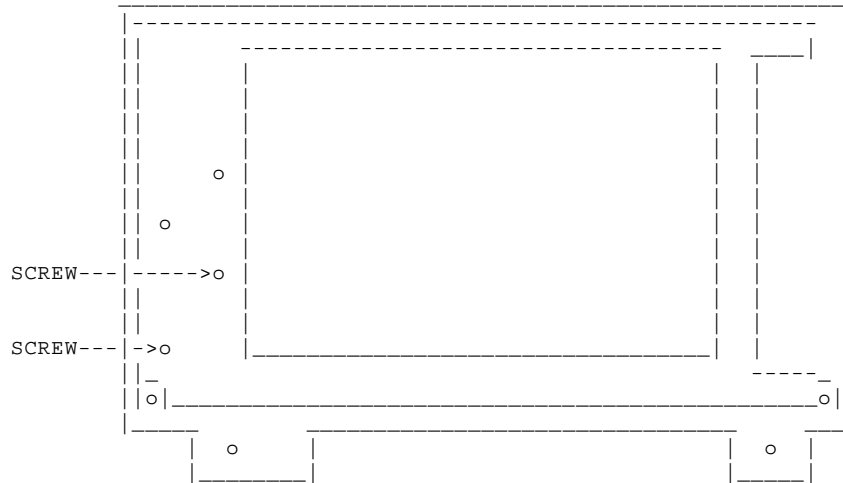
1. Remove and discard the two (2) identified screws.
LCD WITH BEZEL REMOVED

2. Place the EC label over the area that contained the screws.
This label has the FRU, EC, and LCD part number on it.
3. Replace bezel and attach using original screws.
4. Install new screw covers.
5. Place the ECA001 label inside the system on the base beneath the battery.

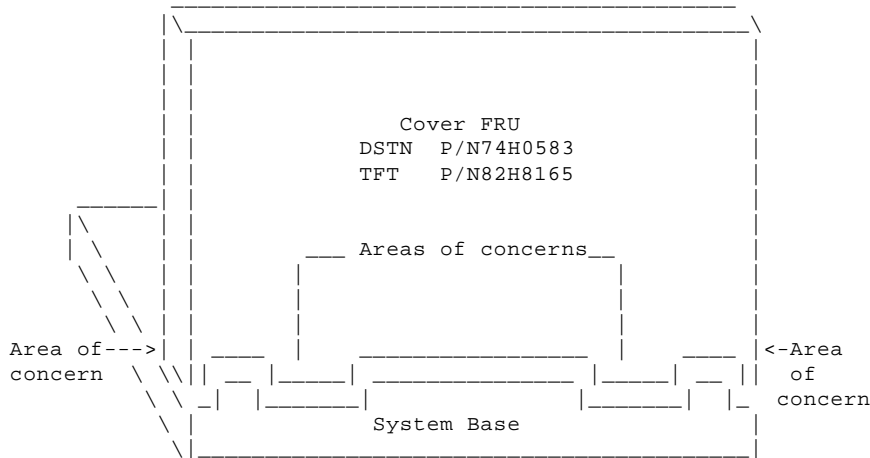
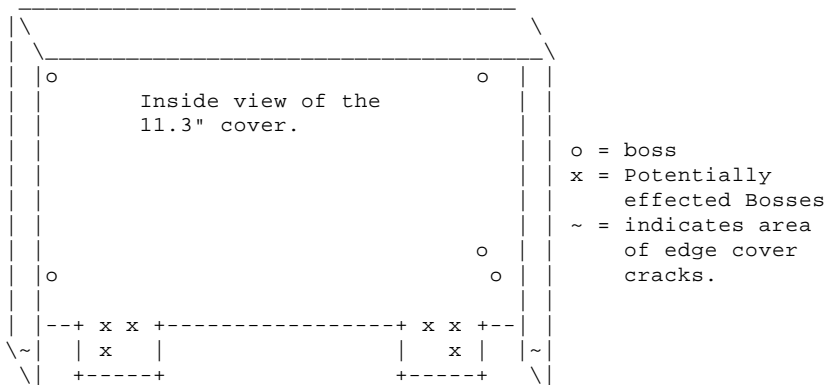
Check for cracks in the hinge area, lower LCD cover edge or in the area of the internal LCD attachment bosses as shown in the following diagrams.

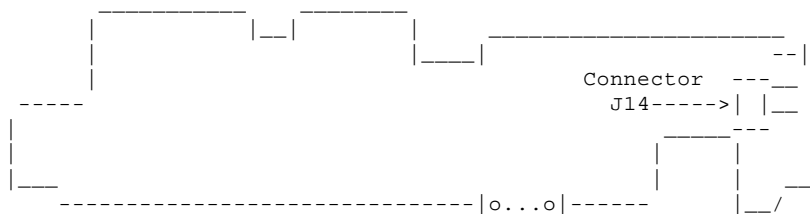
Fig 1. Video Card Bottom View

Figure two shows the FRU P/N85G1934 with a straight cable. This will cause excessive tension on the J14 Video card connector, if it is installed without being pre-bent. This condition could cause a J14 solder connection failure.

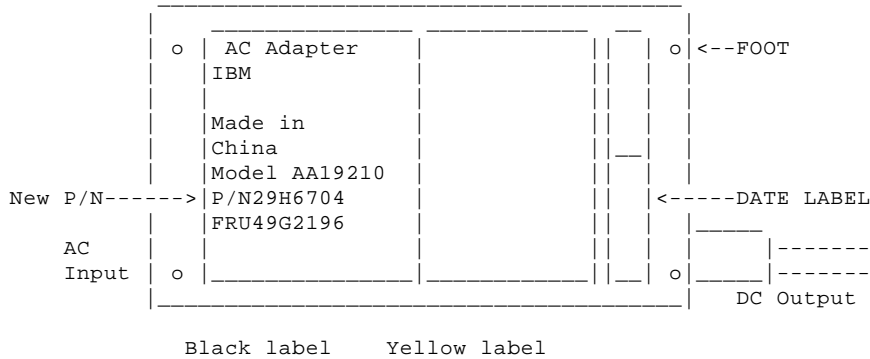
!!!! AC ADAPTERS WITH NEW P/N29H6704 ARE NOT AFFECTED !!!!

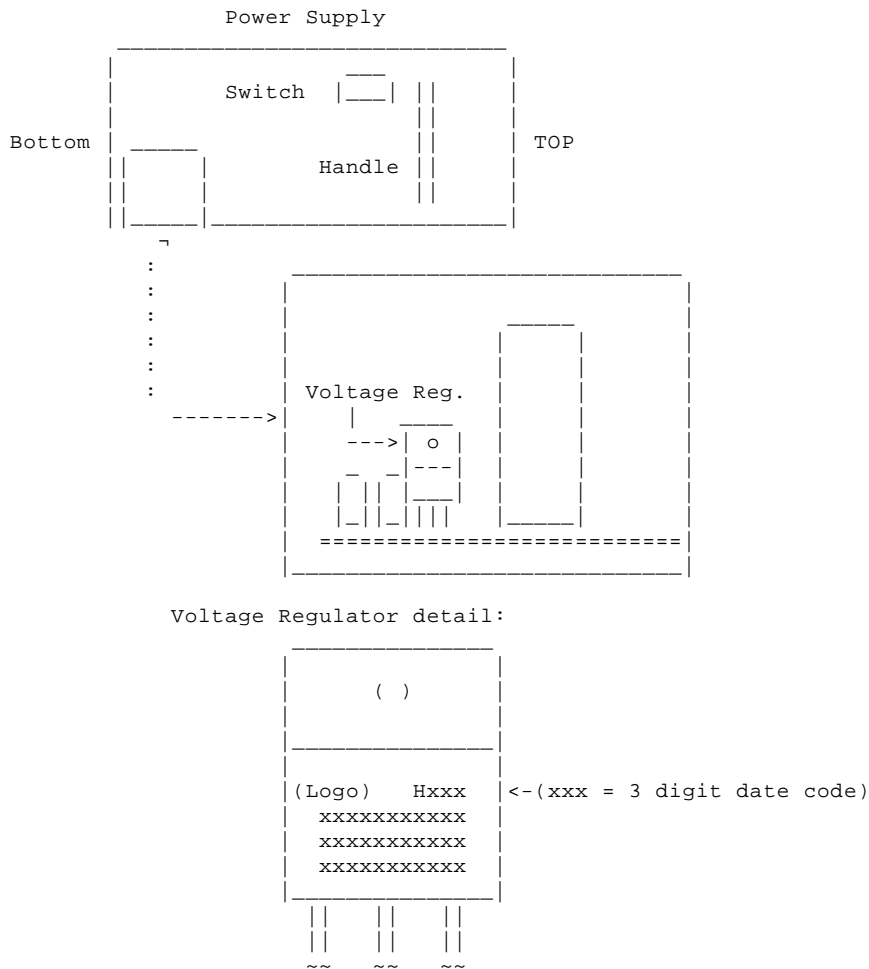
The Voltage Regulator in the suspect power supply will have a 3 digit Date Code lower than 707.

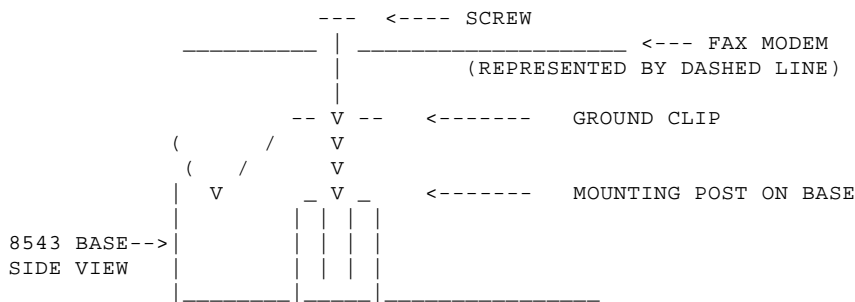
THIS CLIP IS CONDUCTIVE AND IF IT IS NOT FASTENED PROPERLY IT COULD CAUSE A SHORT BETWEEN THE BASE AND COMPONENTS ON THE SYSTEM, RESULTING IN PERMANENT DAMAGE TO THE SYSTEM UNIT AND/OR THE DATA/FAX MODEM CARD.

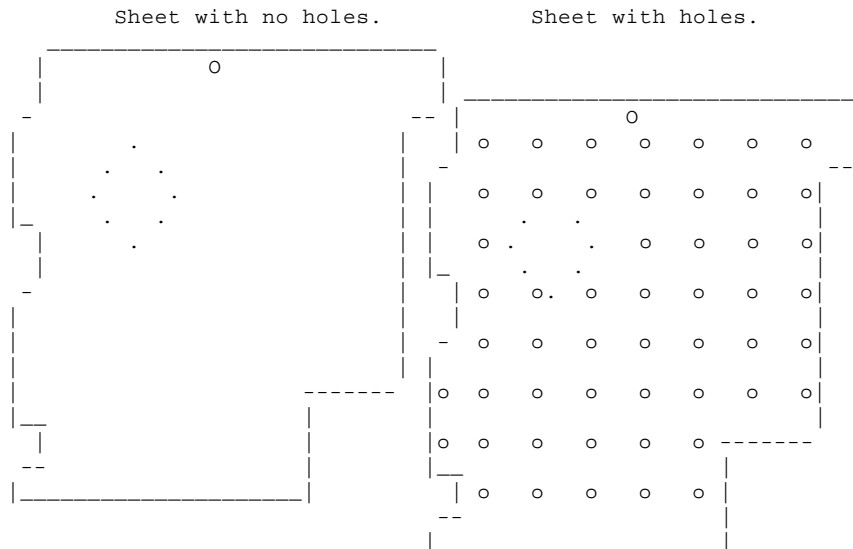
The following diagrams show an example of a sheet with no holes on the left and a sheet with holes on the right.

The part is referred to as a "KEYBOARD SHEET" FRU P/N46H4150 in the Mobile HMM volume 3 (MAY) manual on page 227, index 20. The holes stop the keys from sticking after being depressed by preventing a vacuum from forming between the bottom of the key and the rubber sheet.

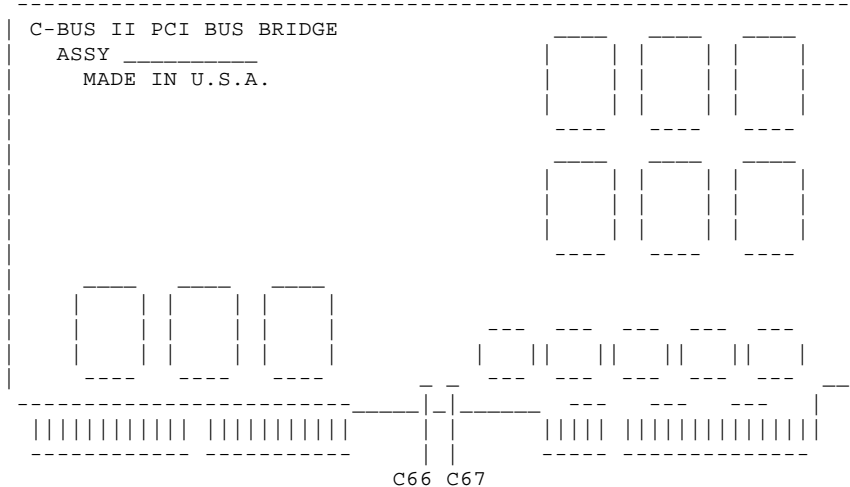
Some bridge cards were undercut at the EMC shield attach point which could cause a short to the C66 capacitor.
