Technical BULLETIN

2002 SXV700G, SXV700ERG

Hood & Belly Pan Misalignment & Hood Cracking

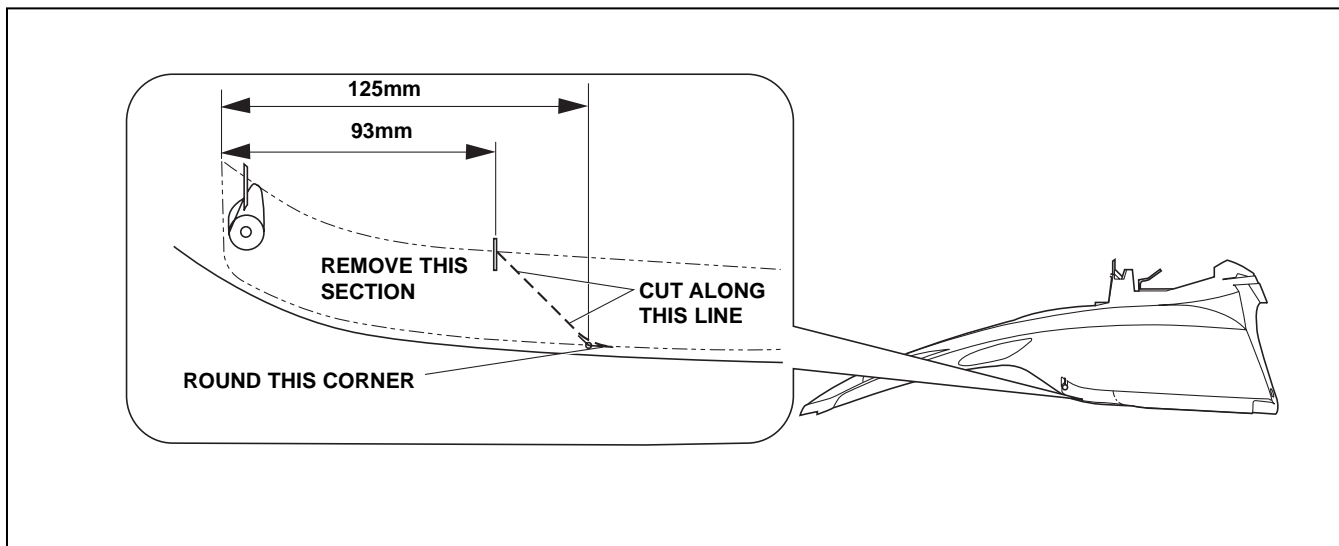
Problem: When riding in rough trail conditions, the hood can become dislodged and misaligned with the belly pan.

Cause: Belly pan flexing.

NOTE: Final material removal should be done with a file or sandpaper.

1. **Hood Modification:** Remove a section of the forward inside edges of both right-hand (RH) and left-hand (LH) locating channels as shown in the illustration below:
