# TECH EXCHANGE

- SUBJECTS:** 1. Oil Injection Line Disengages - 2002 Liquid-Cooled Models  
2. Fuel Pump Freezing Due to the Diaphragm Vent - 2002 SXViper Models

## Oil Injection Line Disengages - 2002 Liquid-Cooled Models

## Fuel Pump Freezing Due to Moisture in the Diaphragm Vent - 2002 SXViper Models

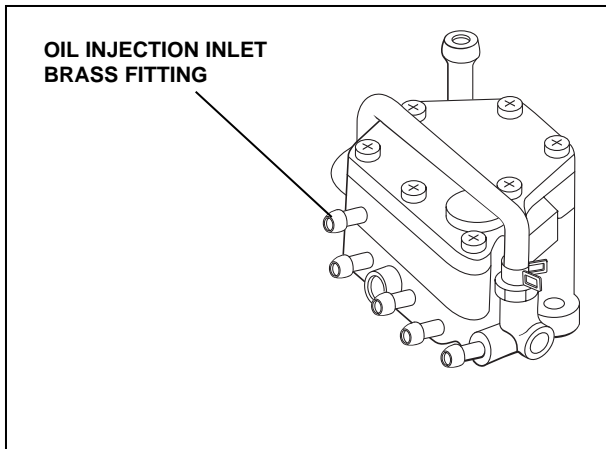
There have been some reports of the oil injection line coming off between the oil pump and fuel pump during Predelivery (PDI) or within one to two miles of use. The symptom is oil leakage into the engine and belly pan area.

In most cases, a blocked oil inlet fitting on the fuel pump is the reason (see illustration below). A blocked fuel pump oil inlet forces the injection line off the fuel pump brass oil inlet fitting or the oil pump outlet, resulting in oil pumped into the engine and belly pan area.

**NOTE:** The problem can be misdiagnosed as a loose or incorrectly installed injection line. If the line is just reinstalled, it will come off again in a short time.

If this oil leakage is noticed on a unit, inspect the fuel pump for blockage by attaching a hose to the brass oil inlet fitting and blowing through it. If the fitting is blocked, do not replace the fuel pump. Remove and disassemble the fuel pump, and repair the blocked fitting by drilling through it using a 2mm (5/64 in) drill bit. Clean the removed material out of the fuel pump before reassembling and installing it.

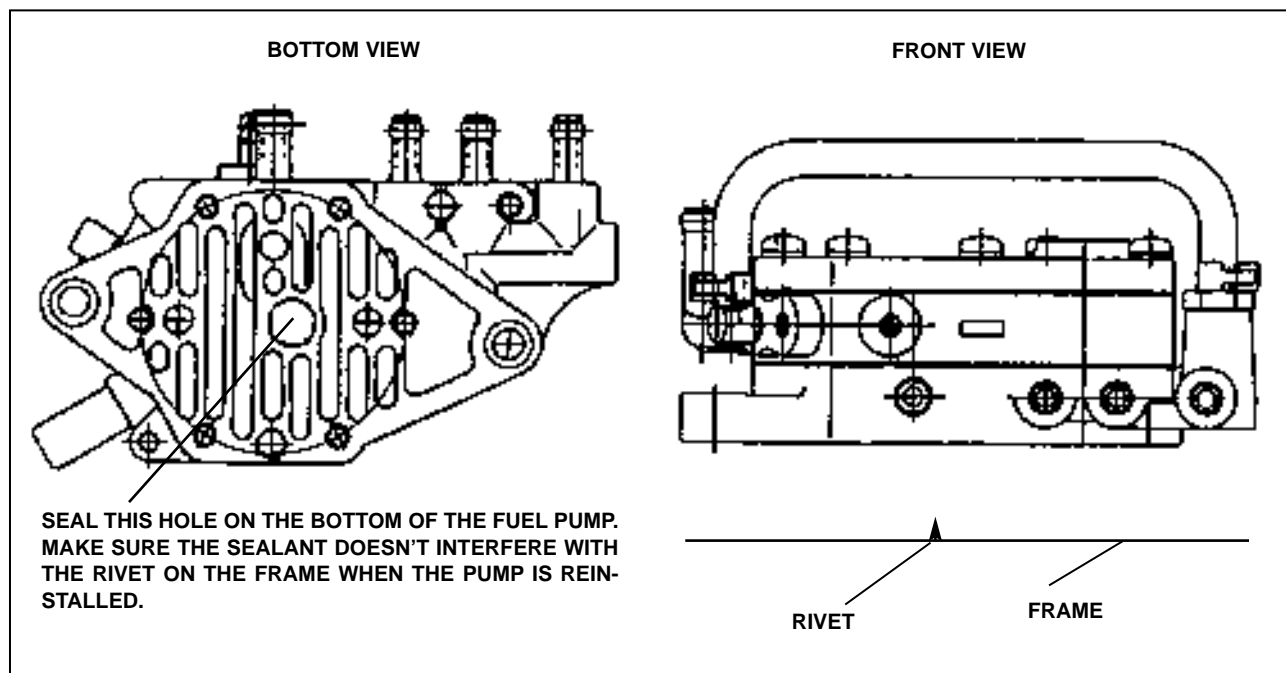
There have been some reports of a problem with snow or water entering the fuel pump diaphragm vent hole, freezing, and then preventing the diaphragm from pumping fuel. When this occurs, the engine may not start or run properly.

If you have a machine with these symptoms, remove the fuel pump, find the diaphragm vent

hole at the bottom of the pump (see illustration below) and seal the hole using silicone or epoxy. The fuel pump will function normally with the vent hole sealed.

**NOTE:** Recess the sealant so it does not contact the rivet mounted in the frame, below the pump, when reinstalling.
