## Battery Gunnison/New Battery Peck Hoist #1 Restoration

Ft. Hancock, New Jersey

*(Work completed 2002 through September 2021; outline remaining work)*

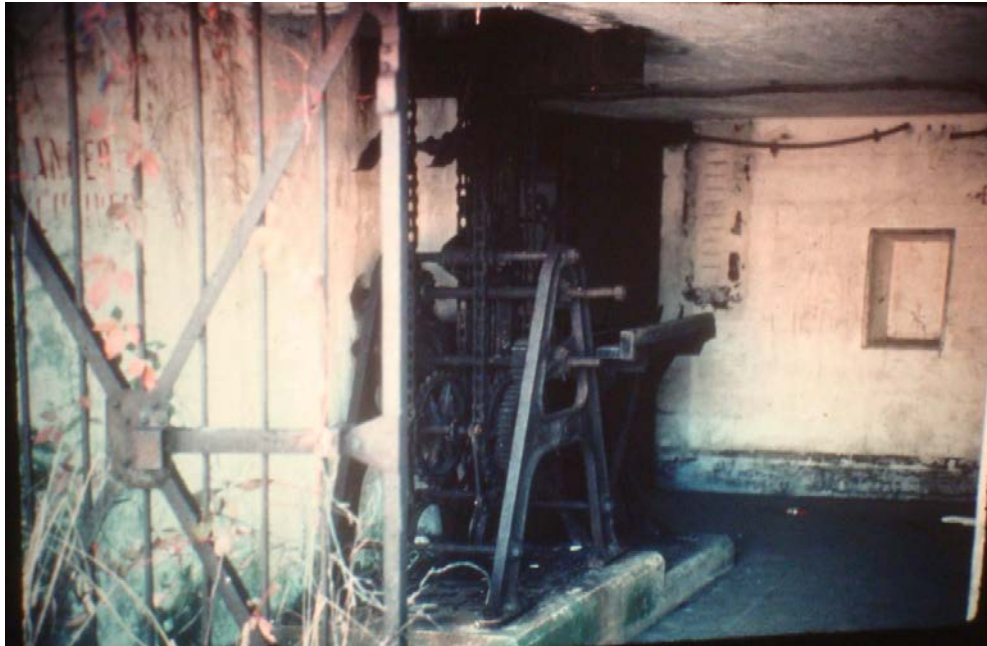
In 2004 to 2005, the Army Ground Forces Association restored the shell hoist for Gun #2 (north emplacement). The basic hoist was intact; however, the moving parts were rusted in place. The hoist required cleaning, oiling, greasing and painting. Several links were replaced in the chain and within six months the hoist was fully operational. The photo below is from the early 1980s and shows Gun #2 hoist in a much-neglected condition.

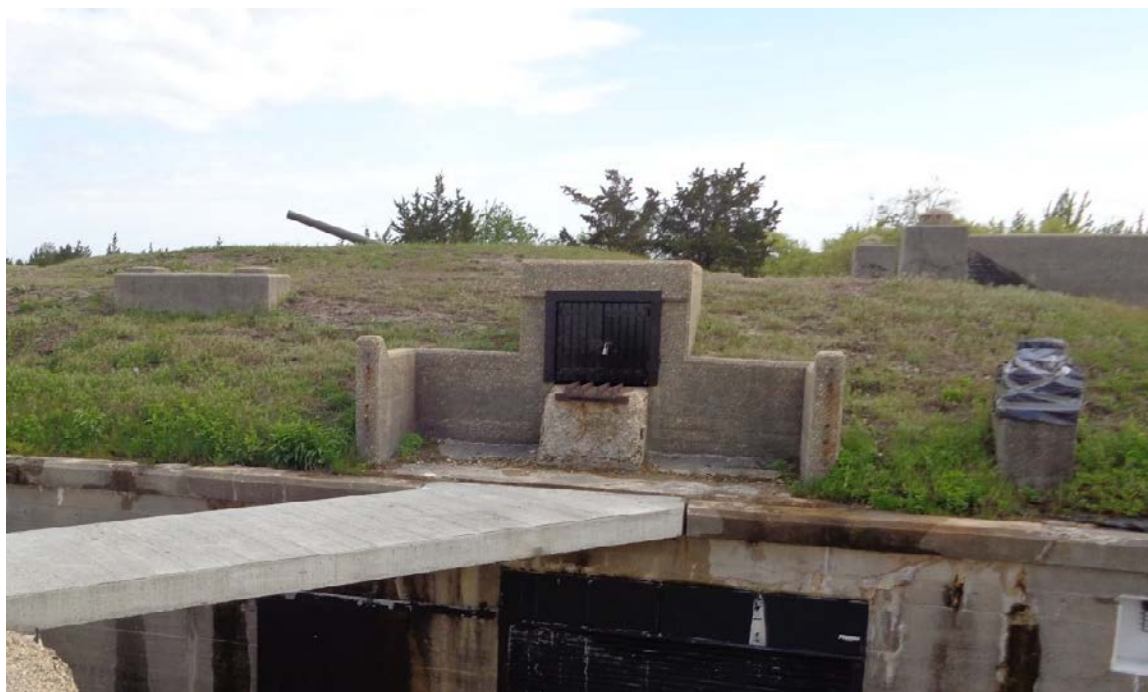
The upper delivery table for Hoist #2 is shown below in a general view including the ammunition bridge (without railing, summer 2017). The doors were installed in the 2006 timeframe by NPS. Notice the crumbling nature of the receiving table concrete base. The concrete deterioration will have to be addressed in the future.

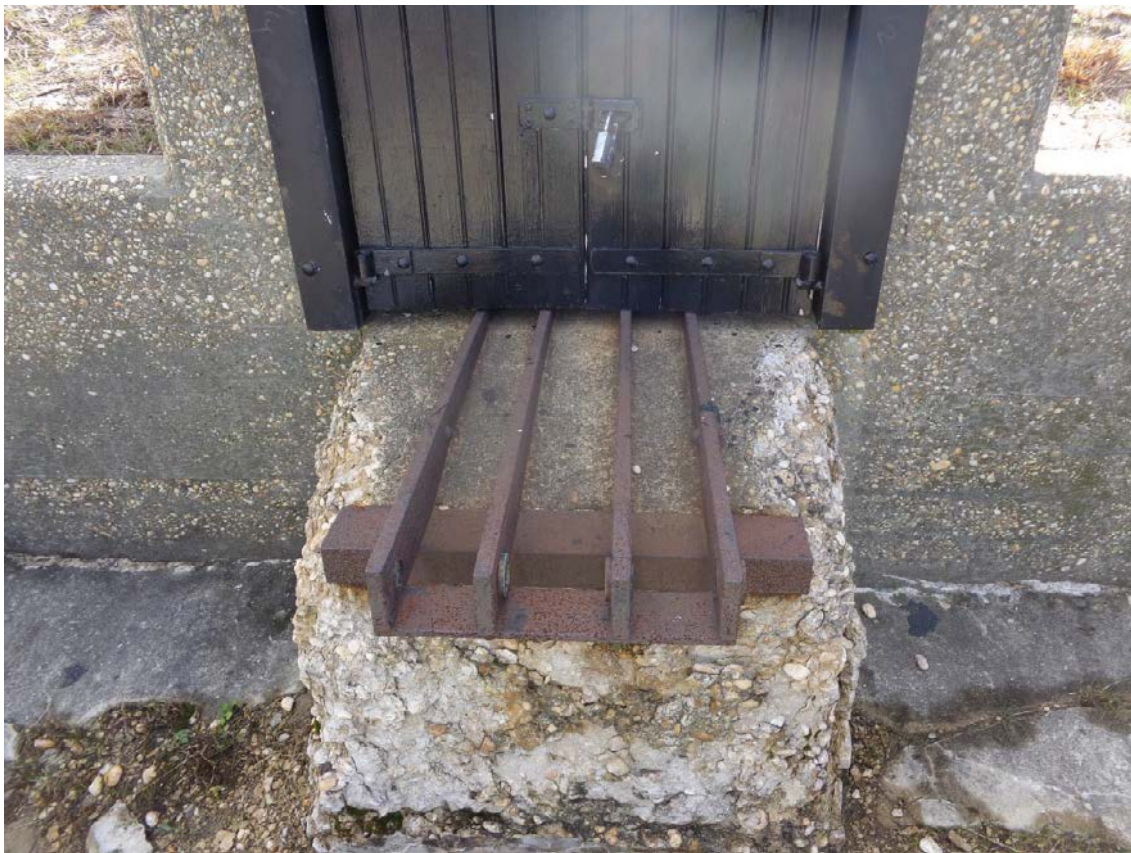
The photo below provides a close up view of Hoist #2 upper receiving table. While the rust will be removed and the metal painted, a more expansive project is required to address the concrete that is fracturing under freeze-thaw conditions of New Jersey's harsh winters. The table proper provides an excellent "as built" model for restoring the receiving table on Gun #1's hoist.

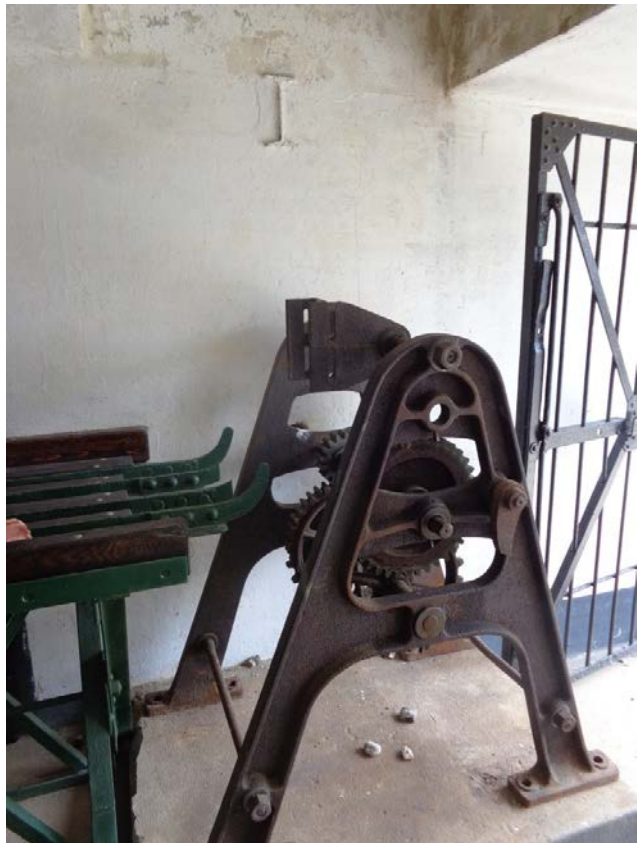
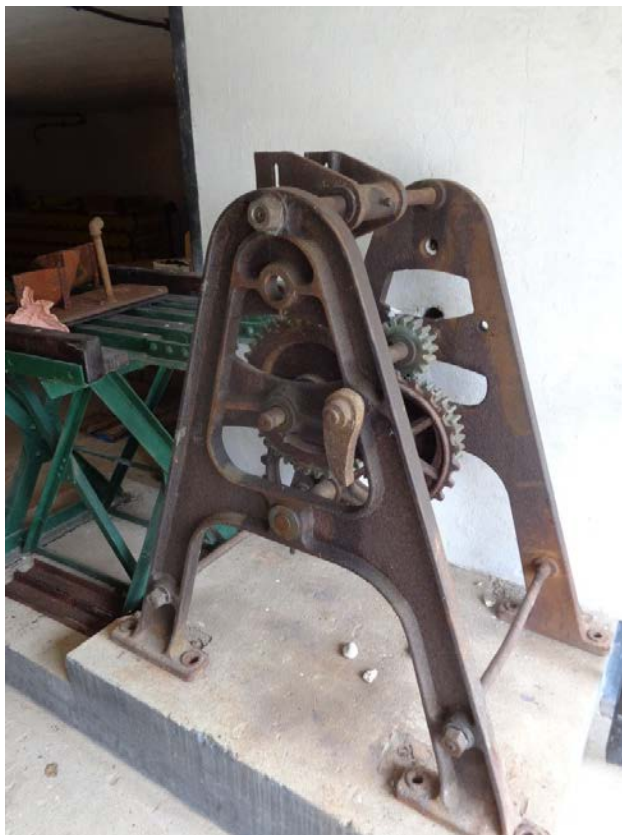
The photo below shows hoist #1 and its receiving table on their respective pads. Upon closer review, the primary shaft is missing from the hoist frame.

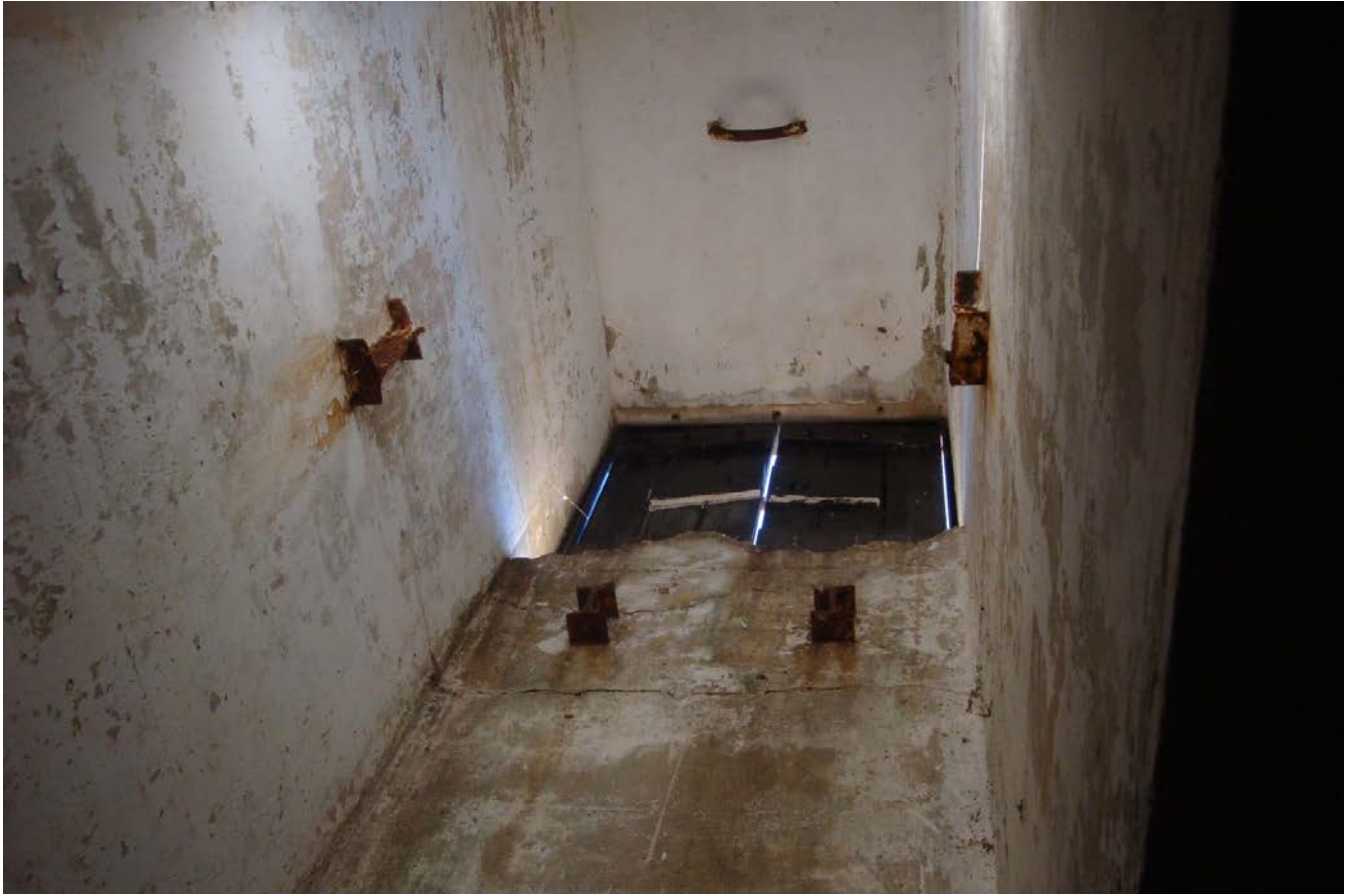
The shaft for Hoist #2 was gutted of metal fixtures when the hoist was removed in the early 1960s by the Army and Smithsonian Institution. The 7-inch beam was cut out (left to right) and will be replaced by a section of the same dimensions.

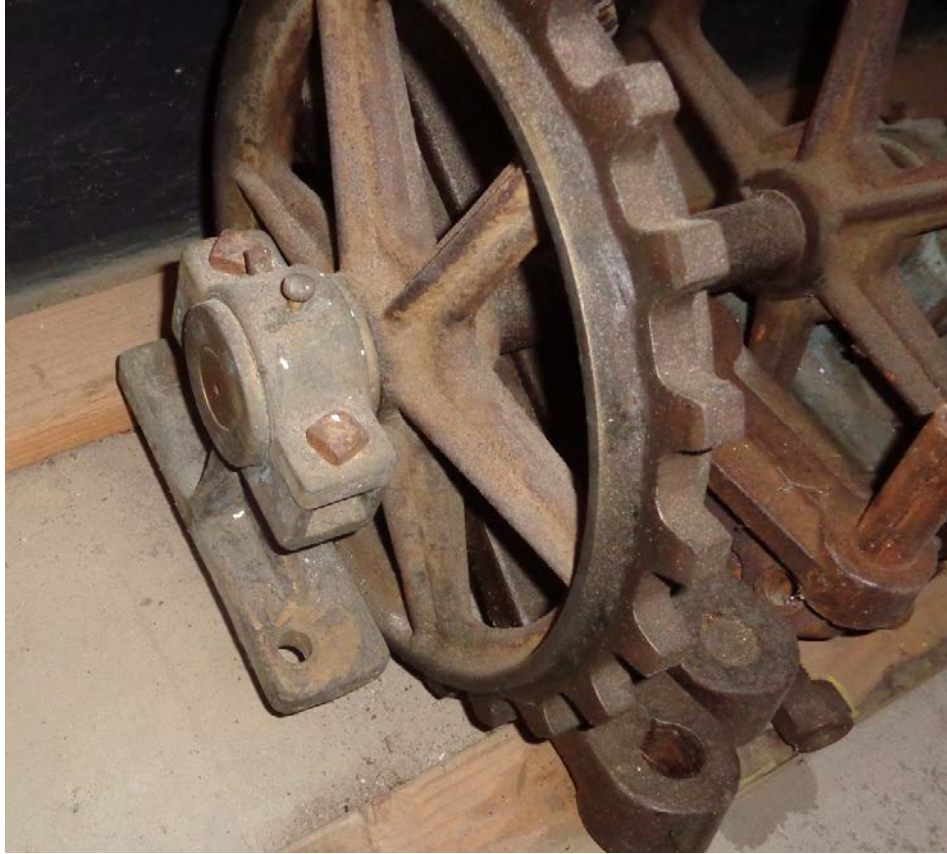
Hoist #1 upper chain gears and trunnions are in good condition. They are stored in the magazine pending reinstallation. The view below shows a trunnion close up.

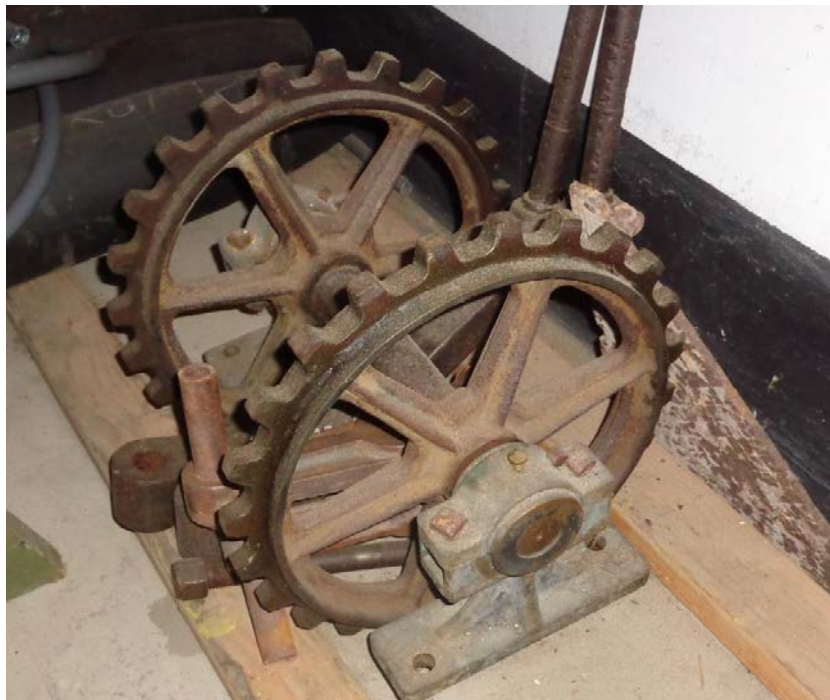
Another view of the upper chain gears and shaft shows the other trunnion. These trunnions are essentially complete with all parts to include oil caps and top covers. The trunnions for Hoist #2 are actually missing one of two trunnion covers and the other cover lacks the oil fill plug.

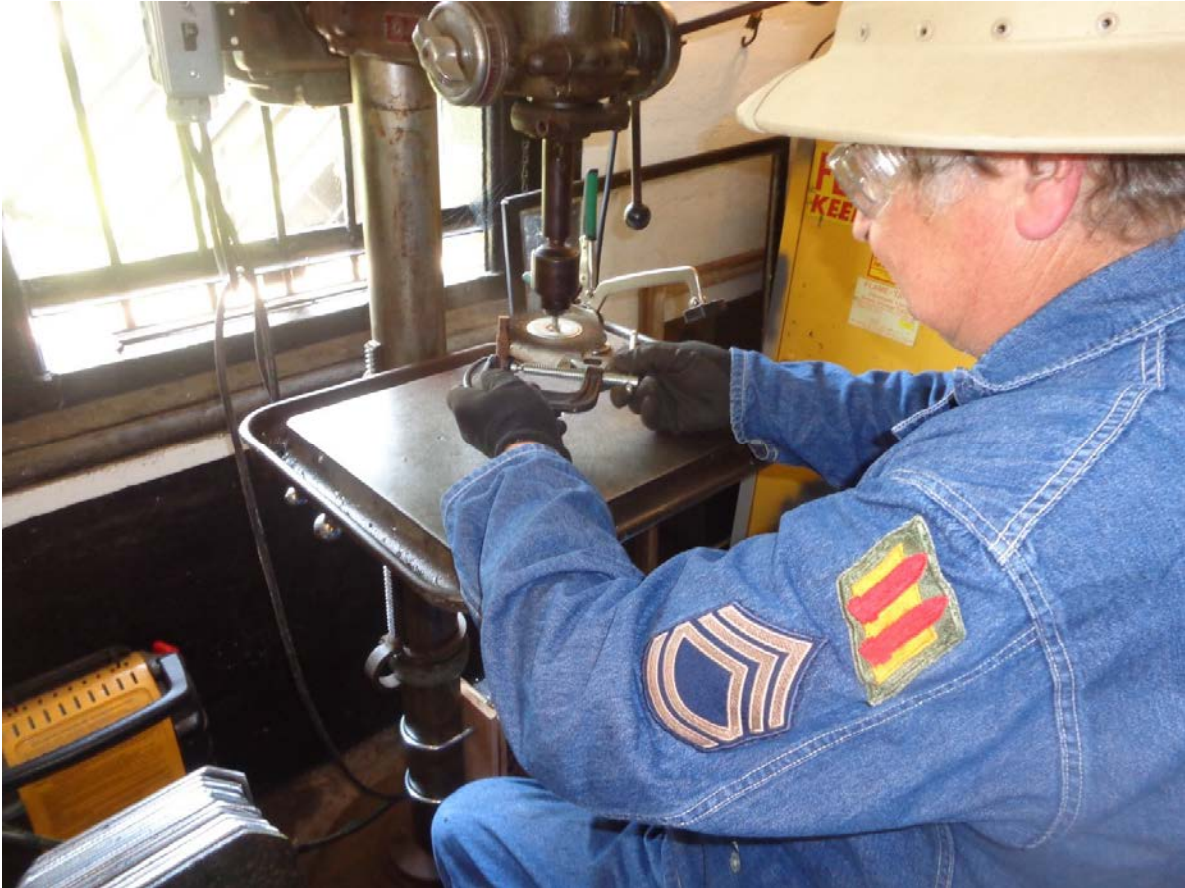
On 2 July 2020, TSG Weaver removed the rust from a group of hoist links. These links are fairly badly rusted and he removed all the rust and assembled the parts into usable links.

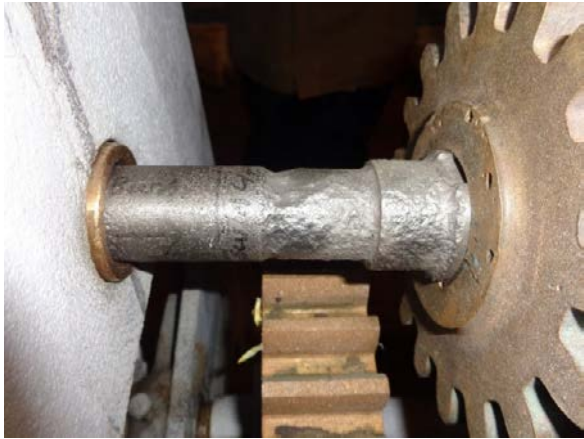
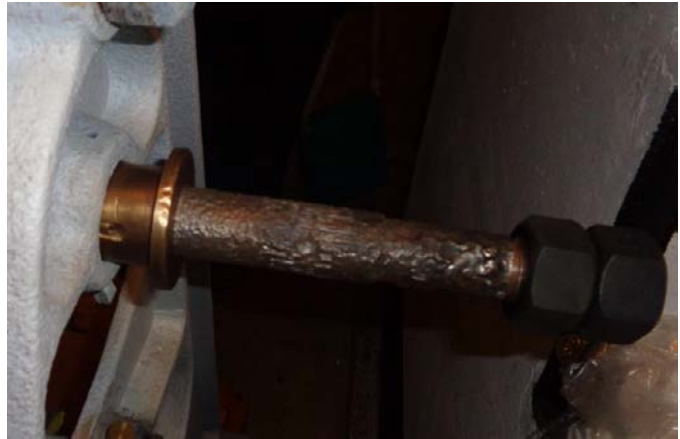
The top shaft was rehabilitated by the AGFA team. The shaft is shown in place with the bearing surfaces showing deep pitting prior to using weld to fill in the rusted areas.

The restoration of the upper shaft involved three people. T-3 Brodzinski built up the rusted bearing surfaces with weld. Jim Wolf then used his large lathe to turn down the built up weld to make a smooth bearing surface. The top two photos are before and the bottom two are after welding buildup.

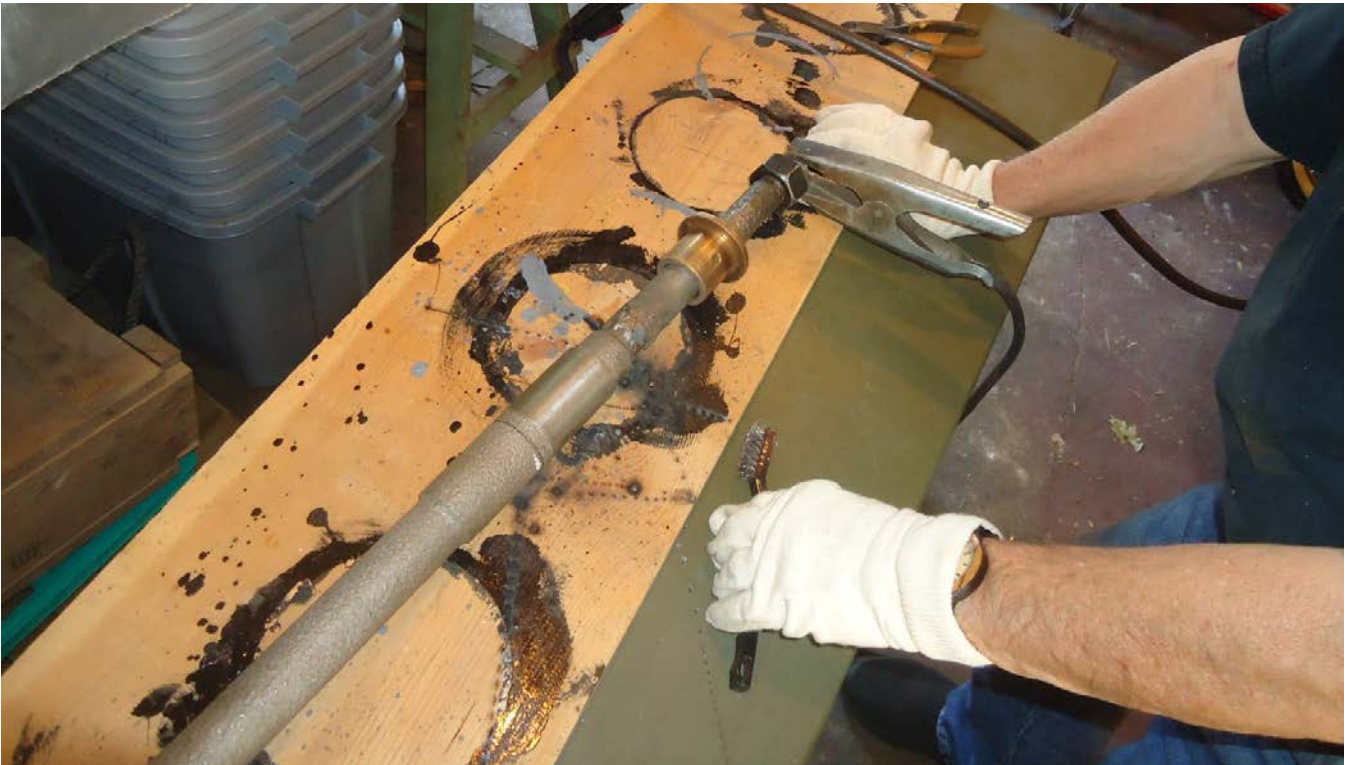
The photo below shows T-3 Brodzinski preparing the clean off some of the byproduct of the weld in order to continue building up the weld on the very badly rusted areas.

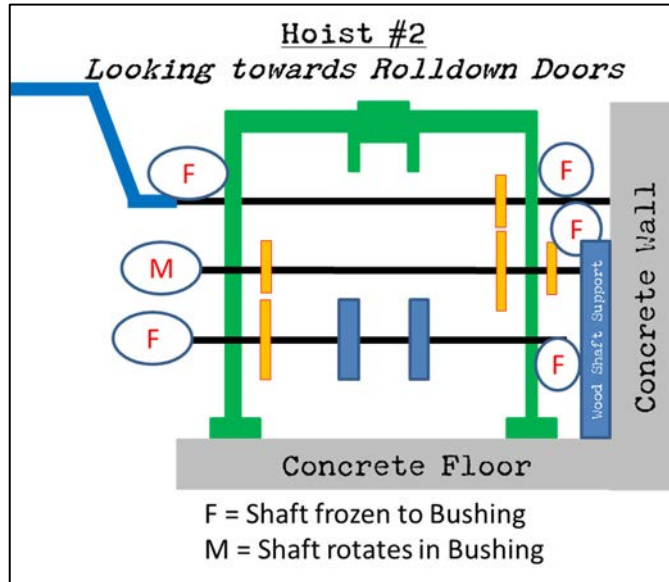
Another key issue was freeing the bronze bushings on Hoist #1 frame. The two drawings that follow show both Hoists #1 and #2. Hoist #2 was restored in the 2003 to 2005 timeframe by TSG Weaver and CPT Prostack. Of the six bronze bushings; only one allows the shaft to ride within the bushing. All the rest of the bushings are frozen to the shafts and the bushings proper ride within the frame. This does not degrade performance of the hoist. However the center shaft with the one movable bearing (left) allows the right bearing which is frozen to the shaft to back out towards the wall. In 2005 a 2x6 inch board was placed between the hoist and the wall to keep the shaft in place as the hoist is articulated.
