Restoration of the Range Board Operator's Station *Ft. Hancock, New Jersey*

Army Ground Forces Association has completed the rebuild of the Range Board Operator's platform station on Gun #1. The platform and stairs were originally constructed in 1943 with the conversion of the battery. We will interpret the elevation data function for the guns as outlined in the battery emplacement book and Field Manual (FM) 4-75 - Service of the Piece 6-inch gun BC - 1940.

Restoring the Range Board Operator's Platform *Ft. Hancock, New Jersey*

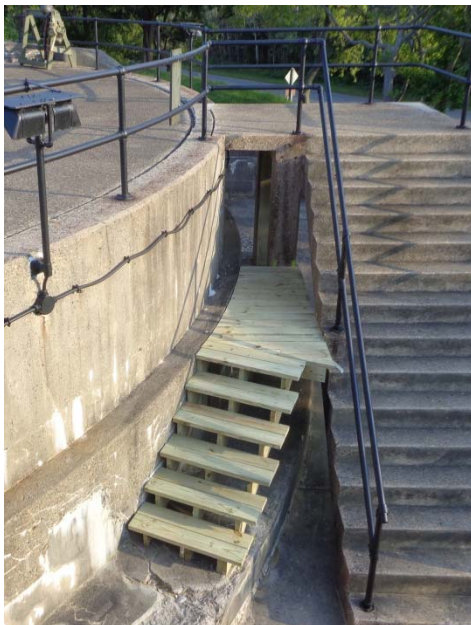
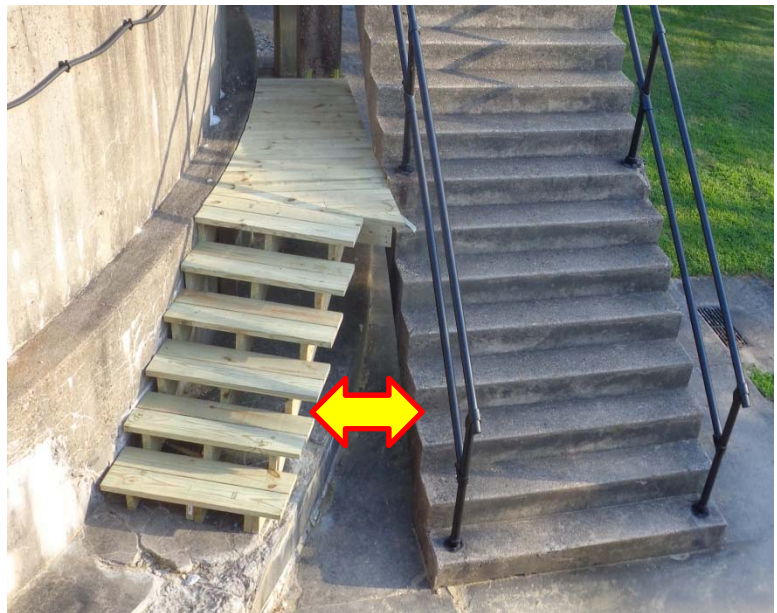
The stairs as originally designed and installed lacked a guard rail. In the photos below notice the yellow arrow in the right photo. The arrow shows a potential safety hazard that was addressed in the original Army plans.

To solve the safety problem between the two sets of stairs, AGFA has installed a single 2x4 handrail secured on top of two 4x4 posts, about 34 inches above the front of the risers (steps). Three guard rails have also been installed. The Guardrail is shown superimposed on the 1943 drawing below in blue for the 4x4 posts and green for the 2x4 hand rail and 5/4x6 guard rails. The posts are bolted to the stringer with two carriage bolts apiece. AGFA purchased all required wood to finish the guard rail installation.

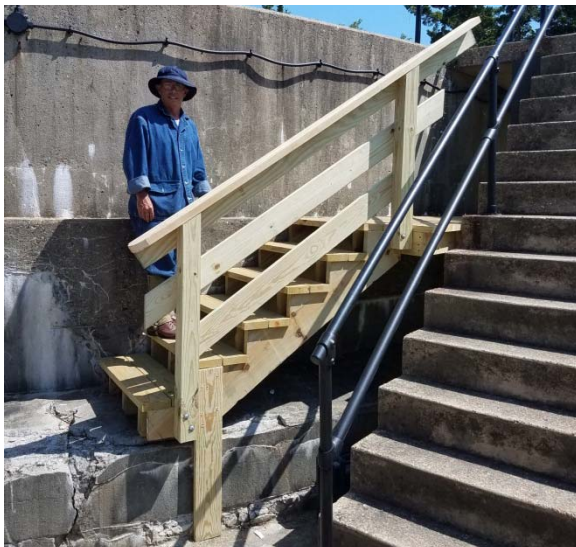
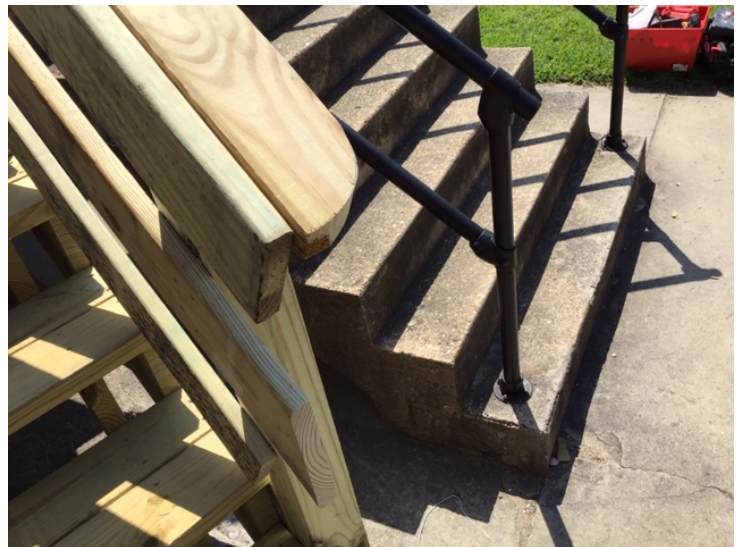
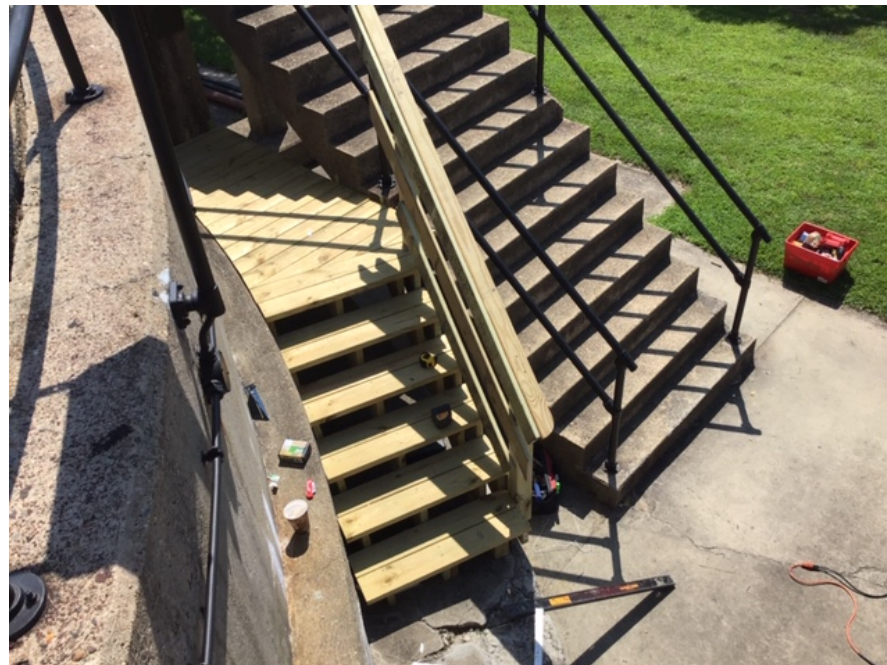
The guard rail as installed is shown below. Final finish touches such as rounding corners were applied.

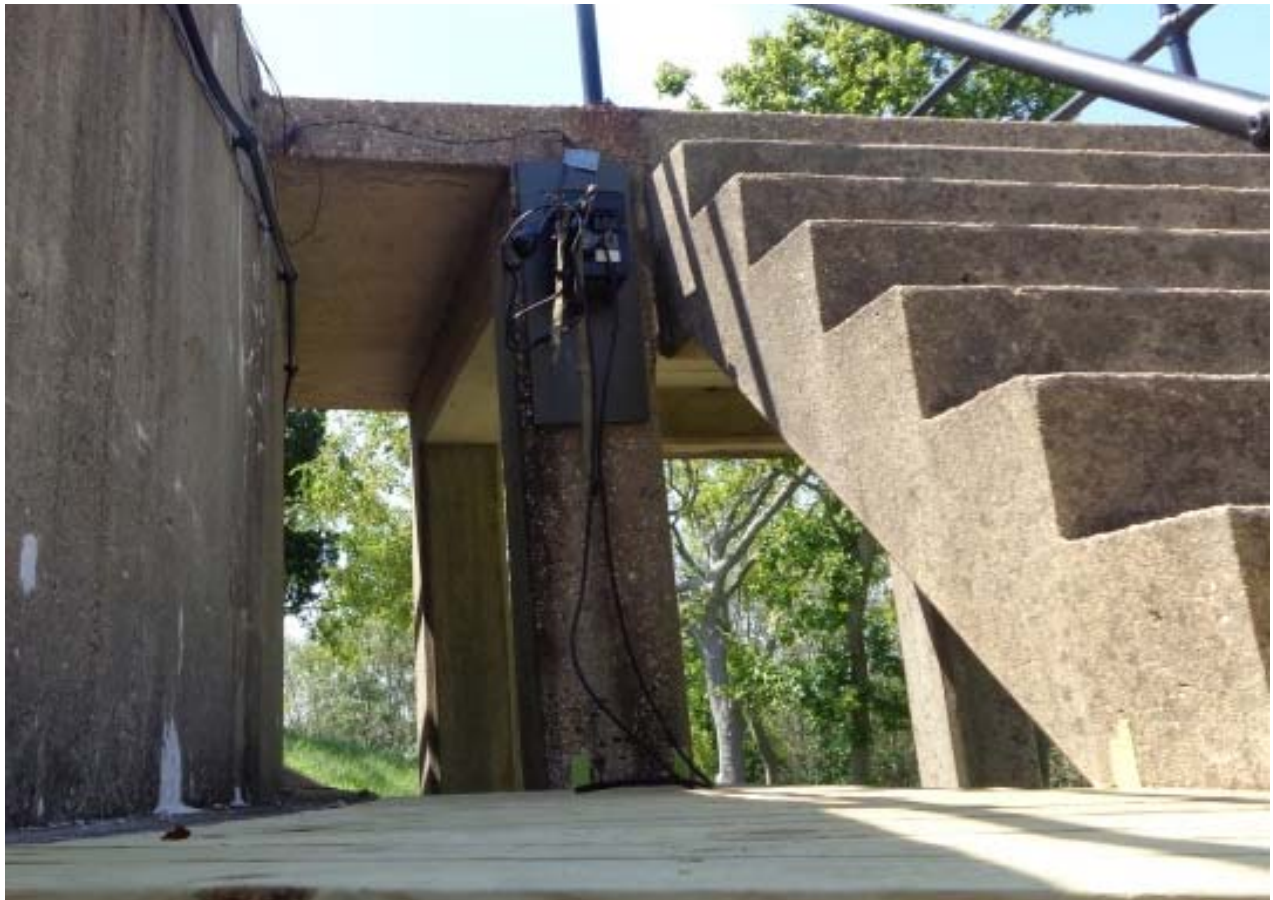
The other component of the elevation board platform station is the EE-91 fire control telephone. The EE-91 fire control telephone is shown mounted on a wooden board. The location of this mount is using the existing anchor holes. The holes match the pattern required for the BE-75 gun telephone box. The wood board is temporary pending replacement by a BE-75 gun telephone box.

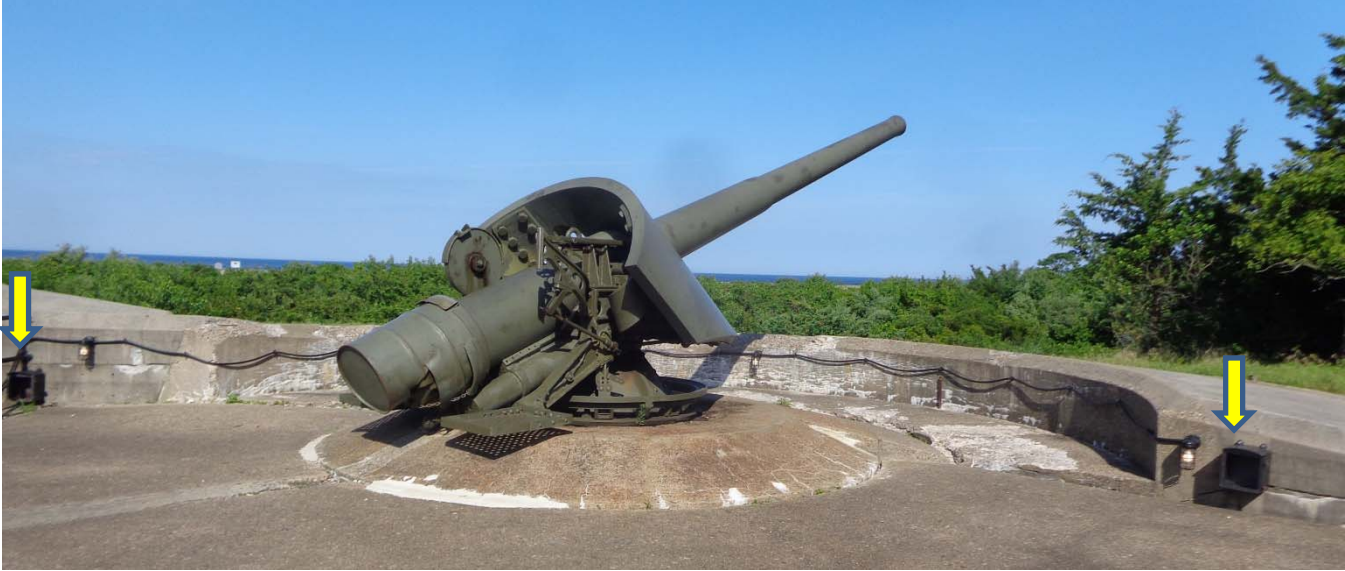
There are a total of three such boxes required for each gun emplacement. Both emplacements at Battery Gunnison/New Battery Peck have the gun pointer and gun commander's telephone boxes. Both of these boxes are shown in the photo below on the extreme right and left of the photos (See arrows). We are looking for a third box.
