## **5.0 DEORBIT/ENTRY**

### 5.3 HARDWARE FORENSICS

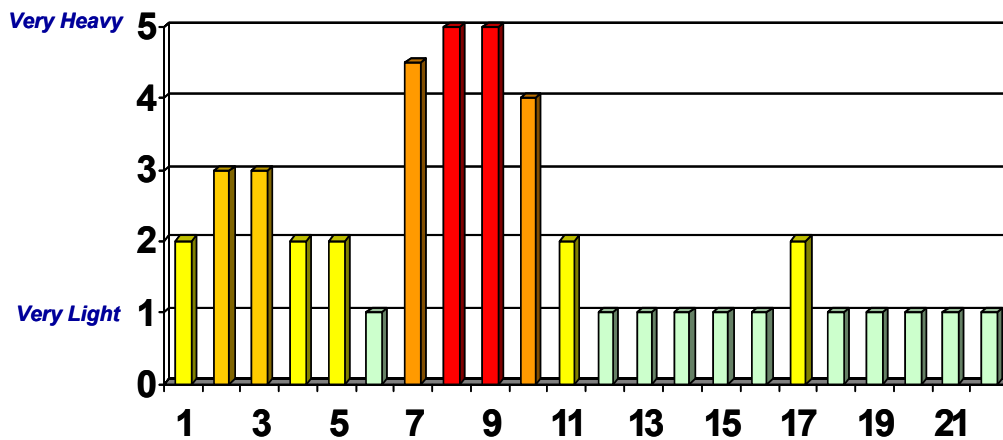
The forensic data indicate that the panel 8/9 area was subjected to extreme entry heating over a long period of time leading to RCC rib erosion, severely slumped carrier panel tiles, and a substantial slag deposition on the upper portion of RCC panels 8 and 9. Figure 5-2 shows the slag deposition (both metallic and oxide) in the RCC panel 8/9 area relative to the other parts of the wing leading edge, and Figure 5-3 shows samples of the severe slag deposition on the panel 8 rib. A review of all recovered debris indicates that this is the most probable area of a breach into the wing since there are no other debris pieces that exhibit the unique characteristics observed in this area.

**Figure 5-2. Slag deposition in the RCC panel 8/9 area relative to the other parts of the left wing leading edge**

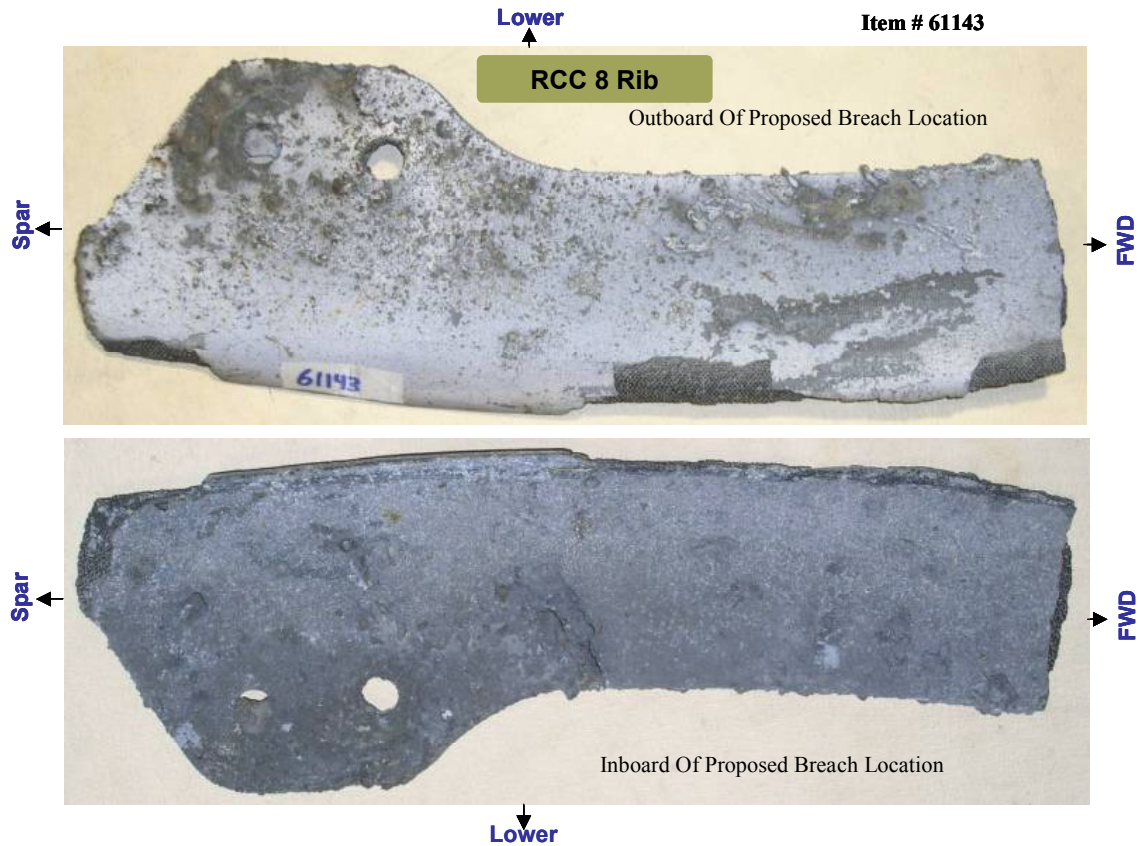
**Figure 5-3. Samples of severe slag deposition on the panel 8 rib**

Based on the slag deposition on the upper RCC panel 8 and the rib erosion at the panel 8/9 interface, the most likely area of damage was the bottom portion of RCC panel 8. The outboard apex on the panel 8 upper inboard rib shows knife edge erosion, and the rib tapers from a design thickness of 0.365 inches to 0.05 inches. The surface of the panel 8 outboard rib and matching heel piece show a similar sign of erosion, as does the panel 9 upper inboard rib. The erosion on both the panel 8 and 9 rib is on the inboard side, indicating that flow is coming from the panel 8 location. Additionally, several lower carrier panel tiles in the RCC panel 9 area also show significant slumping and erosion that is consistent with a hole or breach in the lower part of RCC panel 8. Figure 5-4 and Figure 5-5 show an example of the rib erosion and the flow on the lower carrier panel 9.

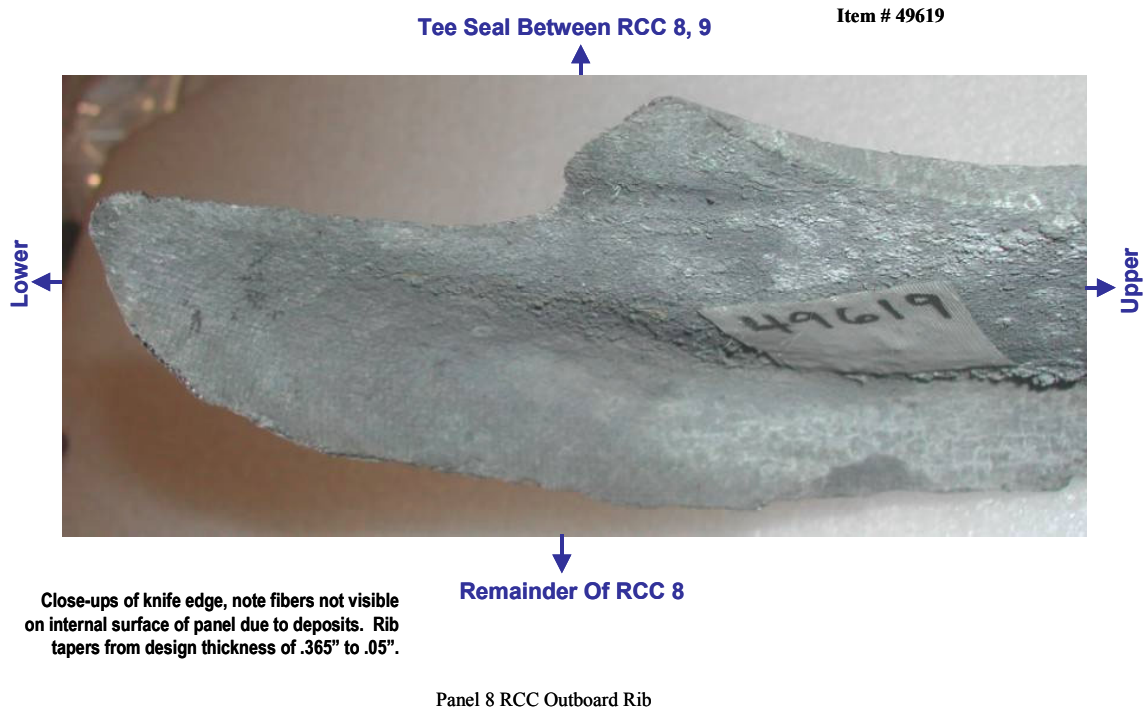
these inner surfaces indicate flow from the panel 8 direction toward panel 9. This is also consistent with the knife-edge erosion shown in Figure 5-4 below. The proposed flow direction leading to the erosion and slag deposition on the lower carrier panel 9 tiles can be seen in this view as well. The detailed flow, erosion, and deposition are best viewed in Figure 5-5. The last significant feature in Figure 5-6 is the heavy slumping that is observed on the upper carrier panel 8 tile (50336T) in the upper right portion of the drawing.

**Figure 5-4. Example of rib erosion**

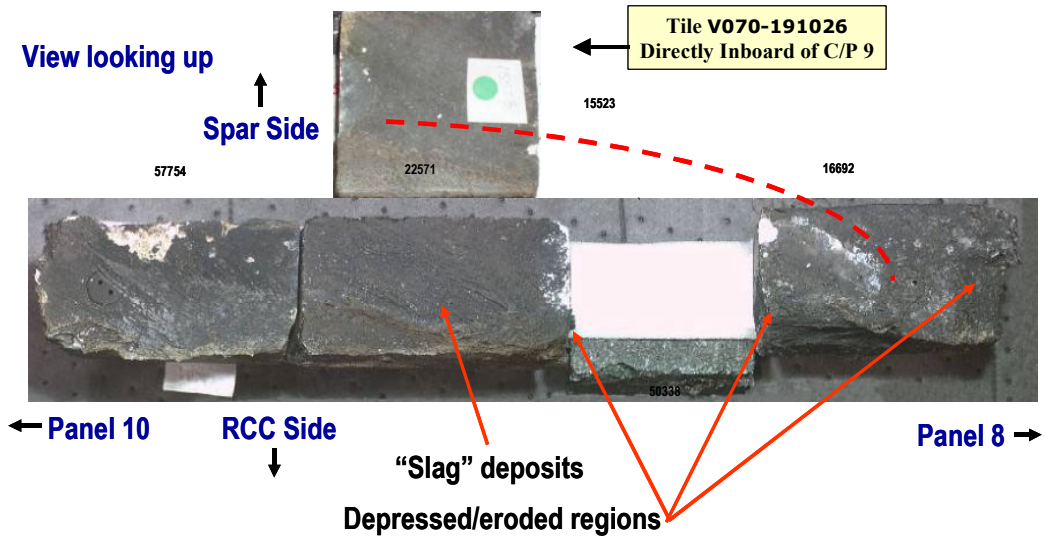
Figure 5-5. Flow on the lower carrier panel 9 tiles

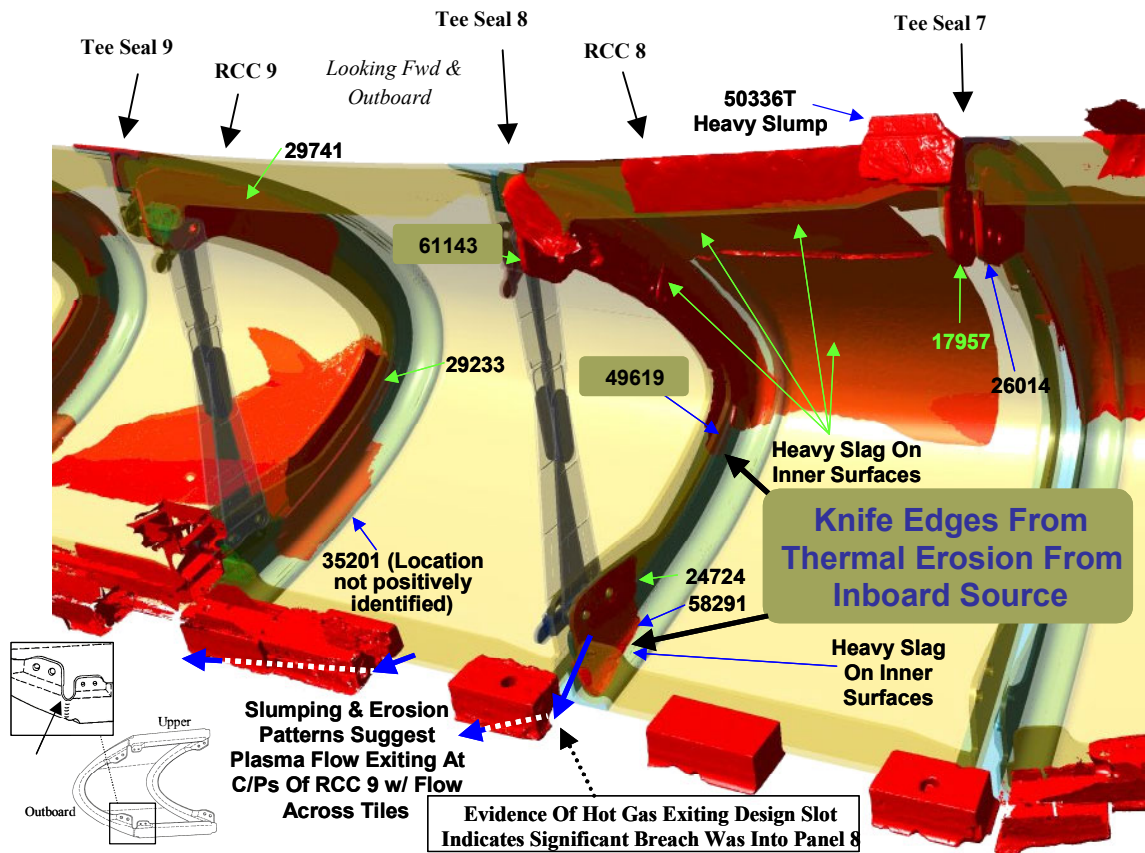
Figure 5-6. CAD drawing of the recovered debris showing overall slag deposition and erosion patterns

This forensics analysis further corroborates the breach location to be the lower portion of RCC panel 8 below the apex, approximately midway between the apex and where the RCC panel meets the carrier panel. Based on the flow patterns, the breach was in an area that caused the flow to impact the spanner beam associated with Tee seal 8 and create the knife edge erosion shown in this area in Figure 5-6.

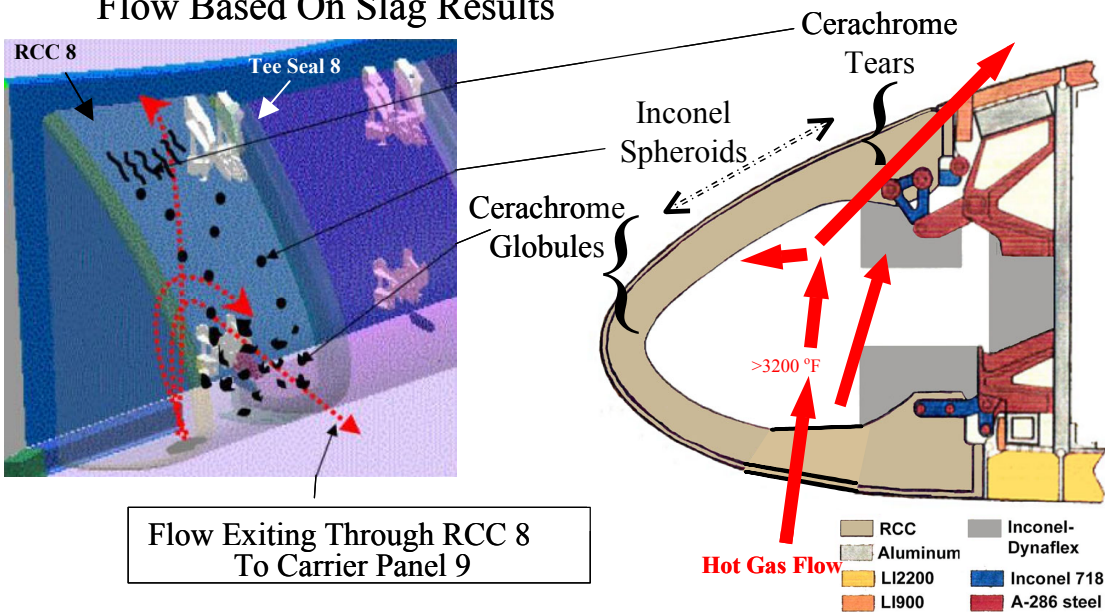
The flow appears to have entered through this breach and into the lower aft corner, exiting through a slot toward carrier panel 9. The flow burned through the horse collar and eroded and slumped the carrier panel tiles. The flow continually grew the hole in panel 8 as time progressed and it eroded the remaining aft flange part of RCC panel 8 and the forward flange on RCC panel 9. Although the lower carrier panel 9 tiles are slumped and eroded, there must have been an RCC rib protecting the adjacent carrier panel 8 tiles since there is no erosion or slumping of these tiles. Compared to the severely eroded carrier panel 9 tiles, the three recovered carrier panel 8 tiles are in relatively pristine condition, and likely separated due to backside heating with no indications of mechanical damage occurring prior to vehicle break-up.

As time progressed, the Cerachrome and Inconel wing spar insulators were eroded, and eventually hot gas flow impinged on the wing leading edge, burning through the honeycomb spar. Figure 5-7 depicts the possible flow direction and deposition of various metals as determined by this analysis.

**Figure 5-7. Analysis results show possible flow direction and deposition of metals**

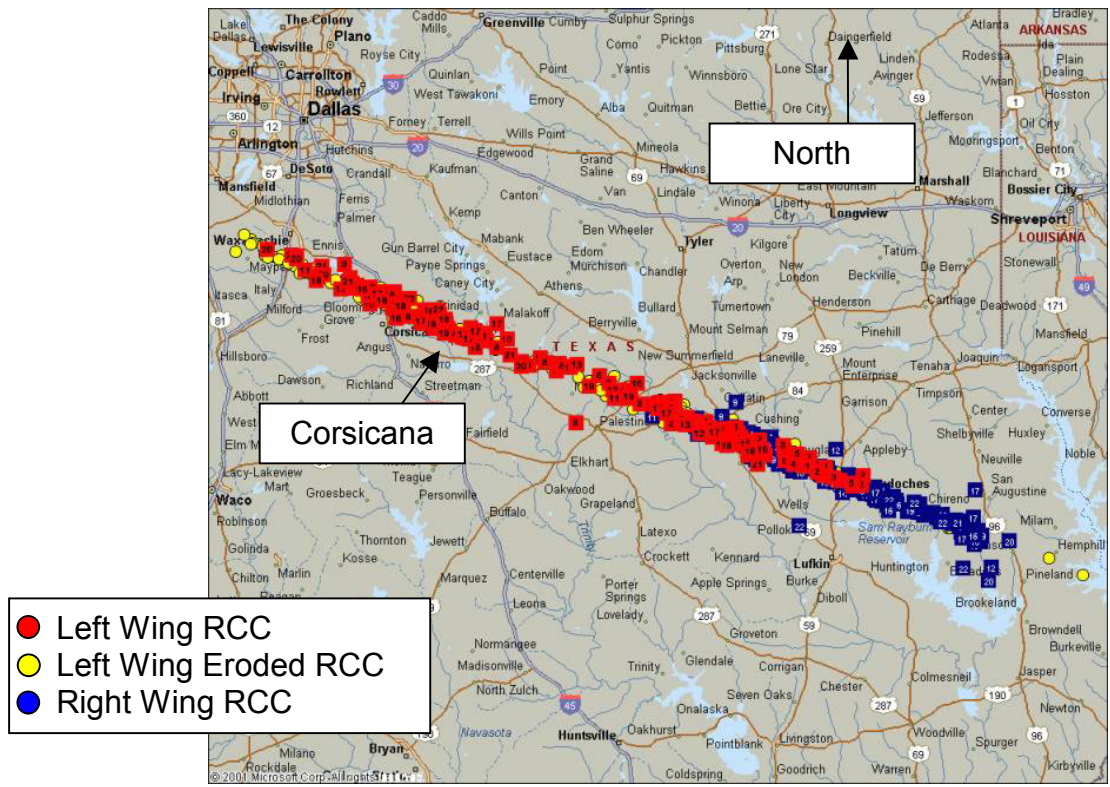
In addition to the slag deposition and flow analysis, there are two other significant pieces of data that point to a breach in the RCC 8/9 area as the initial damage. The first item is the location of the leading edge RCC in the debris footprint. Figure 5-8 shows the recovered RCC for both the left and right wing and its location in the debris footprint. The eroded RCC pieces from panels 8 and 9 are found in the westernmost part of this debris footprint near Waxahachie, Texas, along with other pieces of RCC panel 8. Left wing RCC panel 9 and other aft panels appear to have been lost relatively early in the break-up sequence since their footprint spans the western to center part of the footprint. This is indicative of a left wing breach in the panel 8/9 area. The forward portion of the RCC panels on both the left and right wings (panels 1 through 7) are found from the center to eastern part of the debris footprint possibly indicating that these were lost in a secondary aerodynamic break-up.

**Figure 5-8. RCC panel debris location**

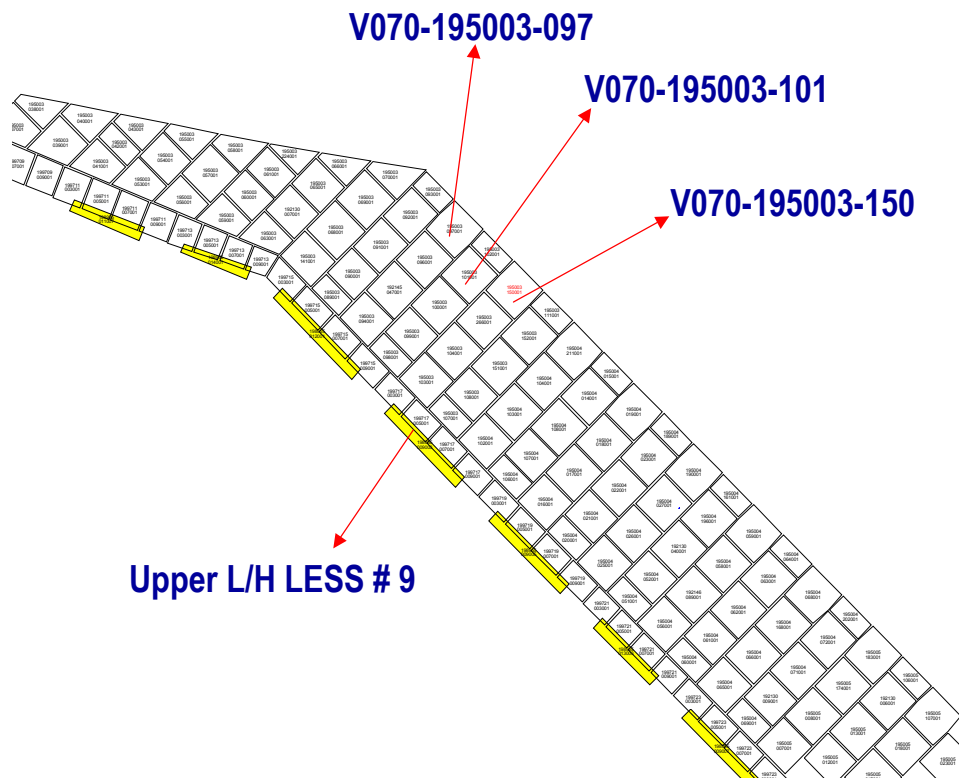
The second additional piece of data is an upper left wing tile recovered near Littlefield, Texas. Littlefield is a small town near the Texas/New Mexico border along Columbia's ground track. This tile is the westernmost piece of debris that has been found to date in the debris recovery efforts. Due to the unique features of the tile (thickness, shape, paint, etc.), the tile must be from the upper wing area in the RCC panel 9 area. Figure 5-9 shows the only three possible locations for this tile.

The tile departed the orbiter more than one minute prior to final break-up due to prolonged internal heating of the upper wing skin in the area shown in Figure 5-9. The tile shows indications of backside heating and an RTV debond. It was not a failure in the densification layer, which would have been caused by mechanical loading. This piece of recovered debris is not very significant on its own merit; however, it is consistent with the previously discussed forensics data (rib erosion, carrier panel 9 tile slumping, etc.) and other events that will be discussed later in Section 5.4.

**Figure 5-9. Three possible orbiter locations of the Littlefield tile on left wing**

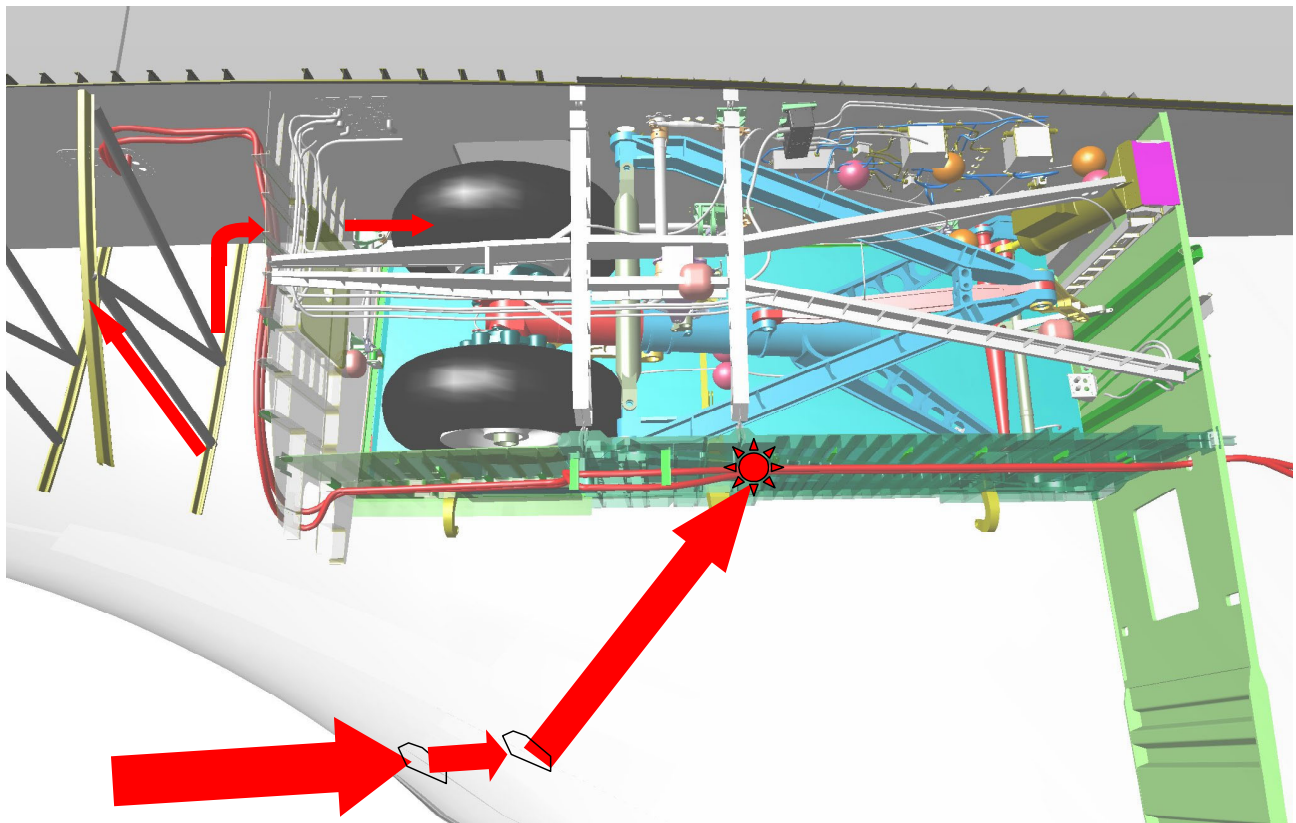
Immediately after the breach, hot gas inside the wing began to heat the remaining wire bundles that contained real-time telemetry and the recorded MADS measurements. Figure 5-29 shows an inside-the-wing view of the approximate breach location based on this wire failure analysis. The view on the left is of the panel 8/9 spar location. This area is not visible in the right photo, which contains the transition spar and a view of the three wire bundles along the outside of the wheel well wall. Figure 5-31 shows the overall spar breach location with respect to the rest of the wheel well. The distance from the spar to the wheel well wall in this area is approximately 56 inches, as shown in Figure 5-32. Figure 5-33 shows a sketch of the venting of the left wing into the payload bay, driving the direction of the internal flow depicted in Figure 5-31. Note the 142 square inch vent into the midbody fuselage located forward of the wheel well.

**Figure 5-31. Hot gas begins to fill left wing**

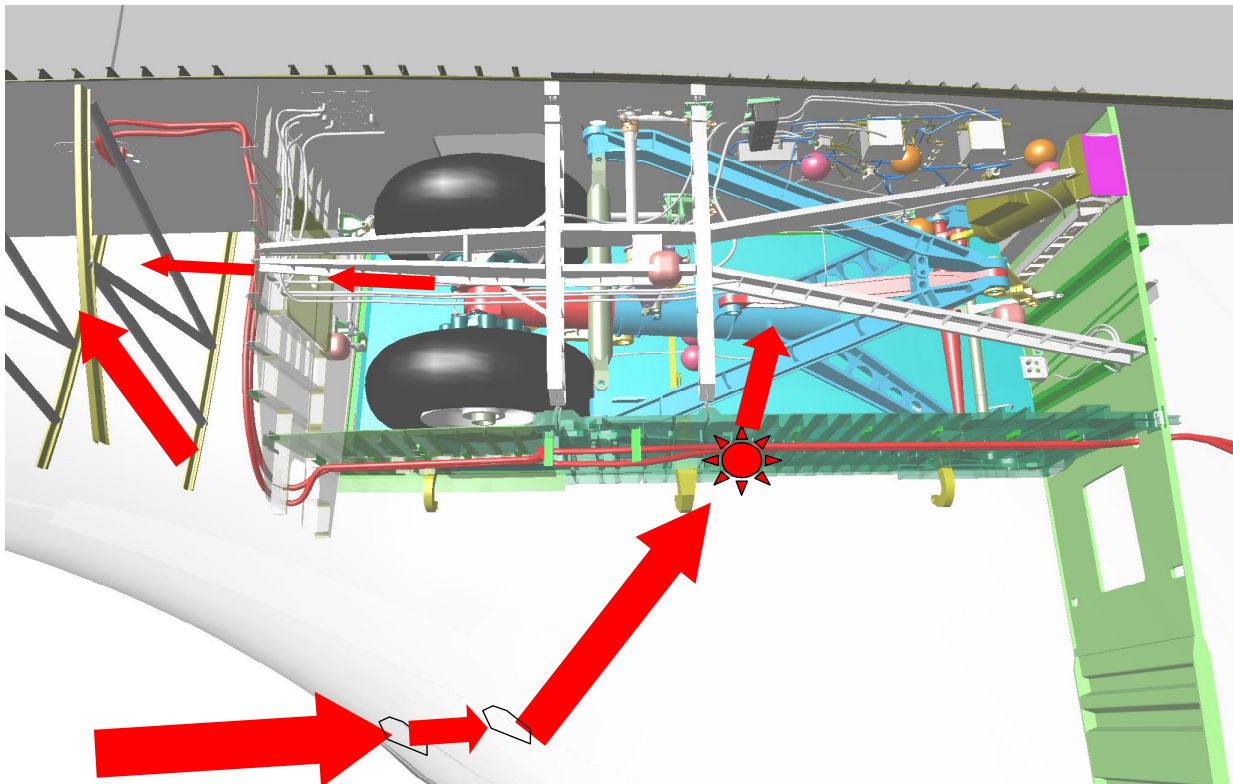
Immediately after the wheel well wall was breached, a hot gas plume began to flow on to the left main gear strut (depicted in Figure 5-47), leading to excessive strut erosion. A wheel well wall breach in this area is consistent with the erosion pattern observed on

**Figure 5-47. Hot gas breaches the wheel well**

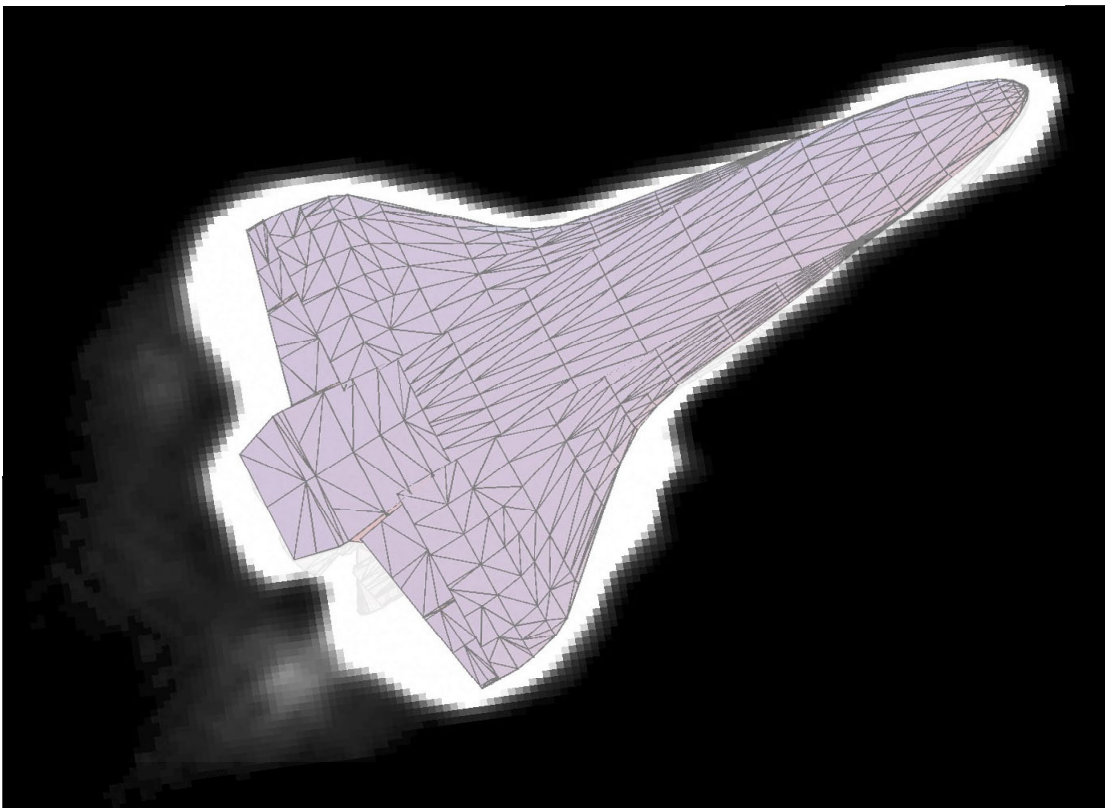
Imaged at 8:57:14 EST (EI + 785 sec.), the Kirtland photo could indicate a flow disturbance on the leading edge of the left wing and/or flow leaving the leading edge of the left wing (see Figure 5-48). It also appears to show a disturbed flow leaving the trailing edge of the left wing. Other images, not shown here, also show disturbed flow on the upper side of the left wing, indicating that the damage and venting through the upper RCC vent was deflecting the flow upward. The Kirtland photo is a digital still image taken by off-duty employees of the Starfire Optical Range at Kirtland Air Force Base, New Mexico, during the STS-107 entry using a 3.5 inch telescope through a computer controlled 1 meter rotating mirror.

**Figure 5-48. Kirtland photo**
