Lake Sarah (Hennepin County)
Eurasian Watermilfoil Survey &
Curlyleaf Pondweed Post-Treatment Inspection
May 23, 2017

Prepared for the Lake Sarah Improvement Association

Report Date: May 25, 2017

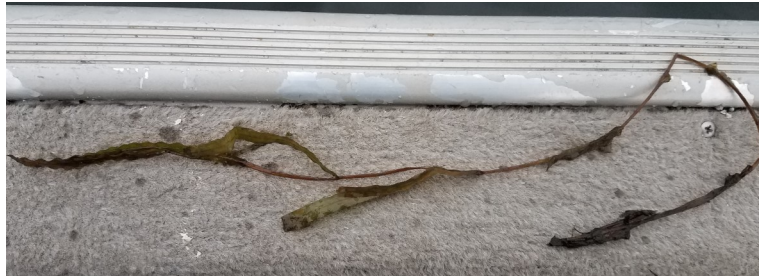
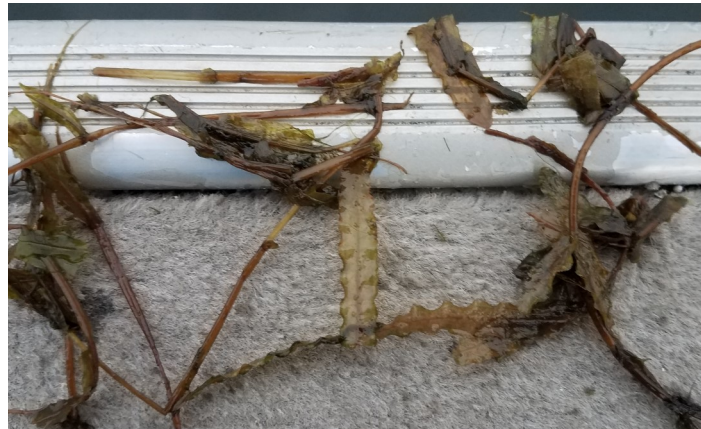
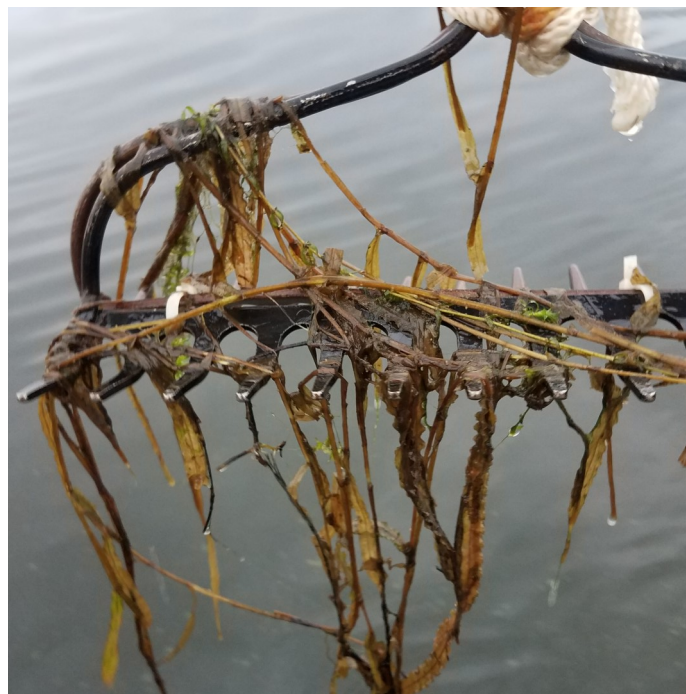
A whole-lake Curlyleaf Pondweed treatment occurred on May 4, 2017. This survey, conducted 3.5 weeks after the treatment, serves as the post-treatment inspection. In all areas of the lake examined during this survey, any CLP found had characteristics of decaying, dead plants. Plants appeared to be laying over on the bottom of the lake, leaves and stems appeared brown and were very brittle and breaking apart. The 2017 treatment appears to be successful. Pictures of CLP from the survey are below.

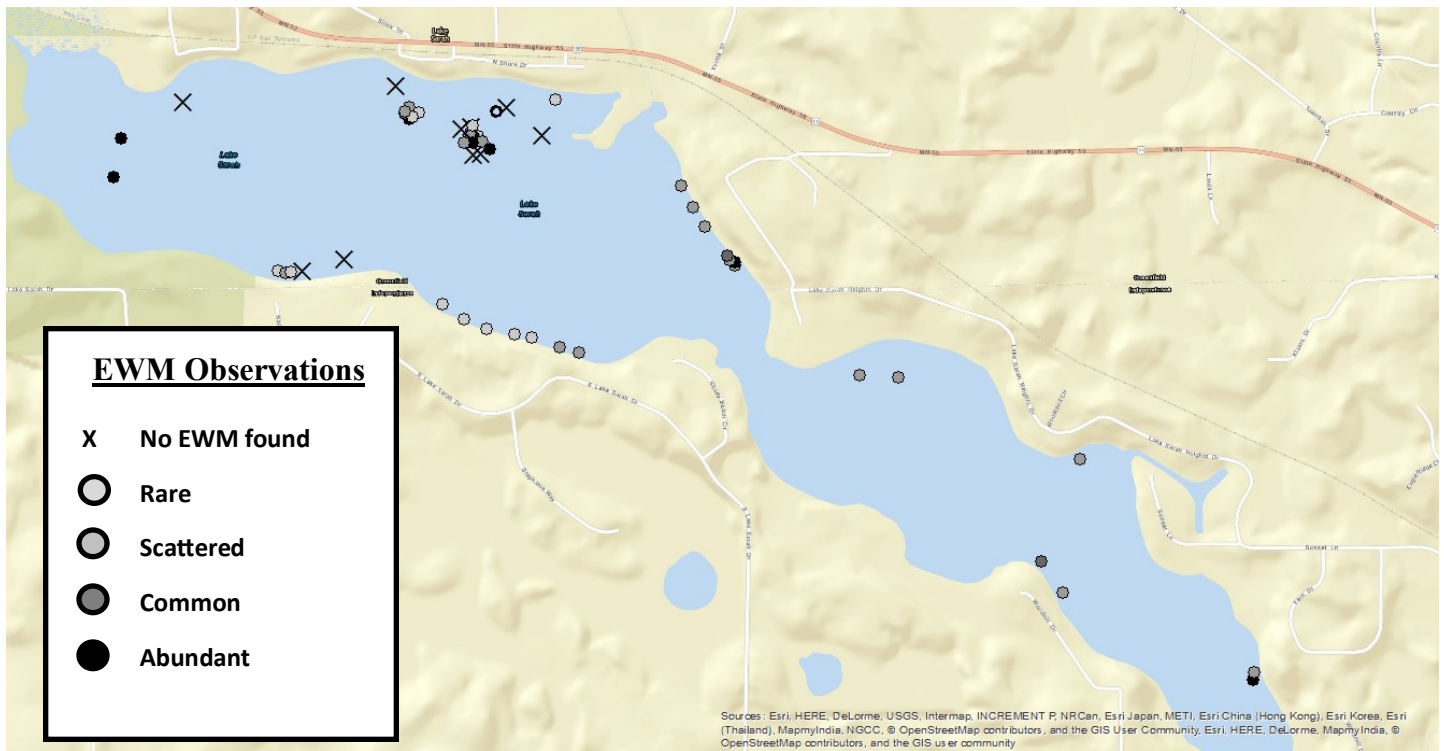
Figure 2. EWM Locations and Estimated Abundance

Based on observations from this survey and past surveys, Eurasian Watermilfoil appears to be less abundant in 2017 than previous years. Elodea and Coontail appeared to be more abundant and growing in historical areas usually occupied with more EWM. EWM plants were mostly scattered, with some dense patches found in several areas of the lake. Each area of the lake will be discussed in the following sections of this report, with some management recommendations for each area.

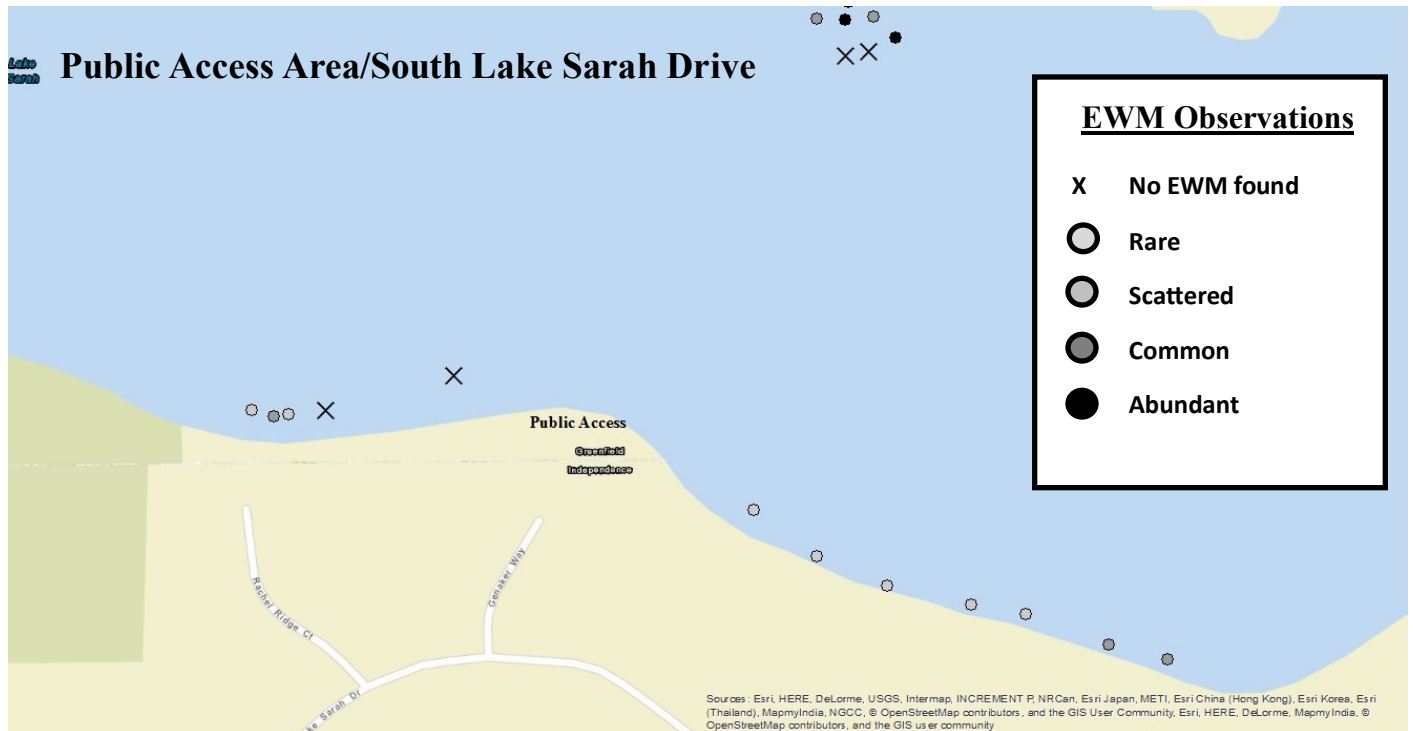
The shoreline west of the public access had a small patch of EWM in 4 to 5 feet of water. Light growth of Elodea and Coontail were mixed in. No treatment is recommended here, EWM is common in the small patch, but the whole area is very small, not impeding navigation, and the small size would make for an ineffective treatment.

The area to the east of the public access, along South Lake Sarah Drive, has scattered EWM plants along the shoreline in 2 to 4 feet of water. Elodea is very common throughout this whole area, and is much more abundant than EWM. Elodea would also appear to be more of a nuisance along this shoreline than EWM currently is. Treatment is not recommended in this area. While EWM is scattered along the shoreline, it is not the dominant plant in this area, and is not impeding navigation. The narrow size of this treatment area, coupled with deeper depths along the outside boundary, would make for an ineffective treatment.

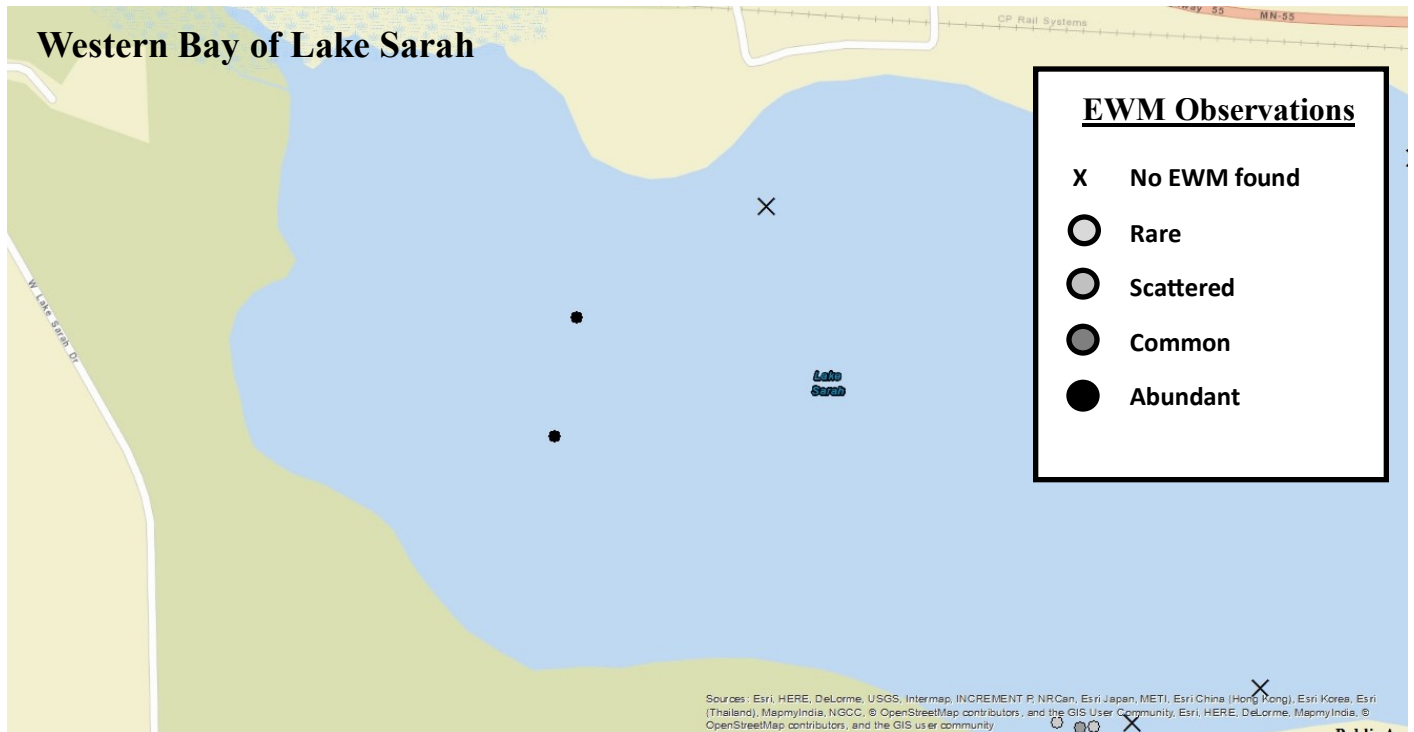
This area was not surveyed extensively as it's along undeveloped shoreline, and is not a navigational path for most watercraft. However, as you can see from two sample points taken in the bay, dense EWM is present throughout much of the bay. No treatment is recommended due to limited navigational use in this area of the lake.

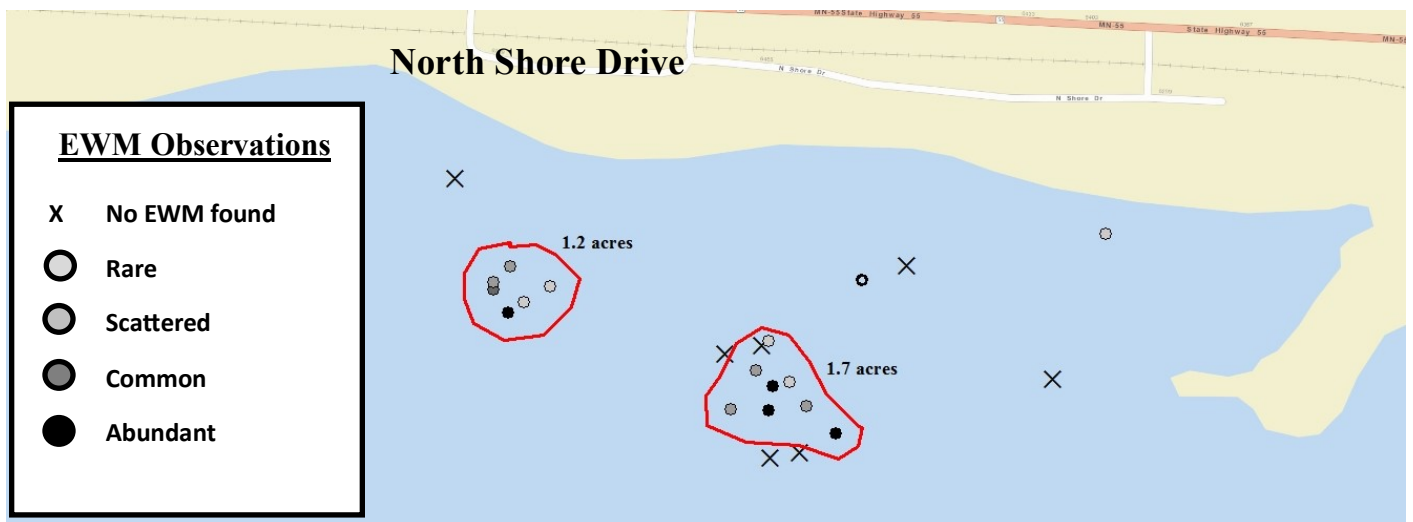
Along North Shore Drive, EWM was found in two dense patches further out from shore. Closer to shore, Elodea is the most dominant plant and could be considered to be at nuisance levels in many locations. Both of the EWM beds have abundant EWM, and would be an impediment for navigation if watercraft use these areas. Both of these areas are dominated by EWM, with some Elodea mixed in. Treatment could be warranted in these locations. The size of the treatment areas are still rather small for an effective treatment with more selective herbicides, such as 2,4-D. If treated in calm conditions for 24 hours at a high rate, treatment could be effective. Alternatively, another treatment option could be the use of diquat. Diquat is non-selective contact herbicide and would have some impact on surrounding native plants. However, treatment with diquat would require much less contact time (~3 hours), thus have a higher likelihood of treatment success. In both treatment options, some regrowth of EWM should be expected.

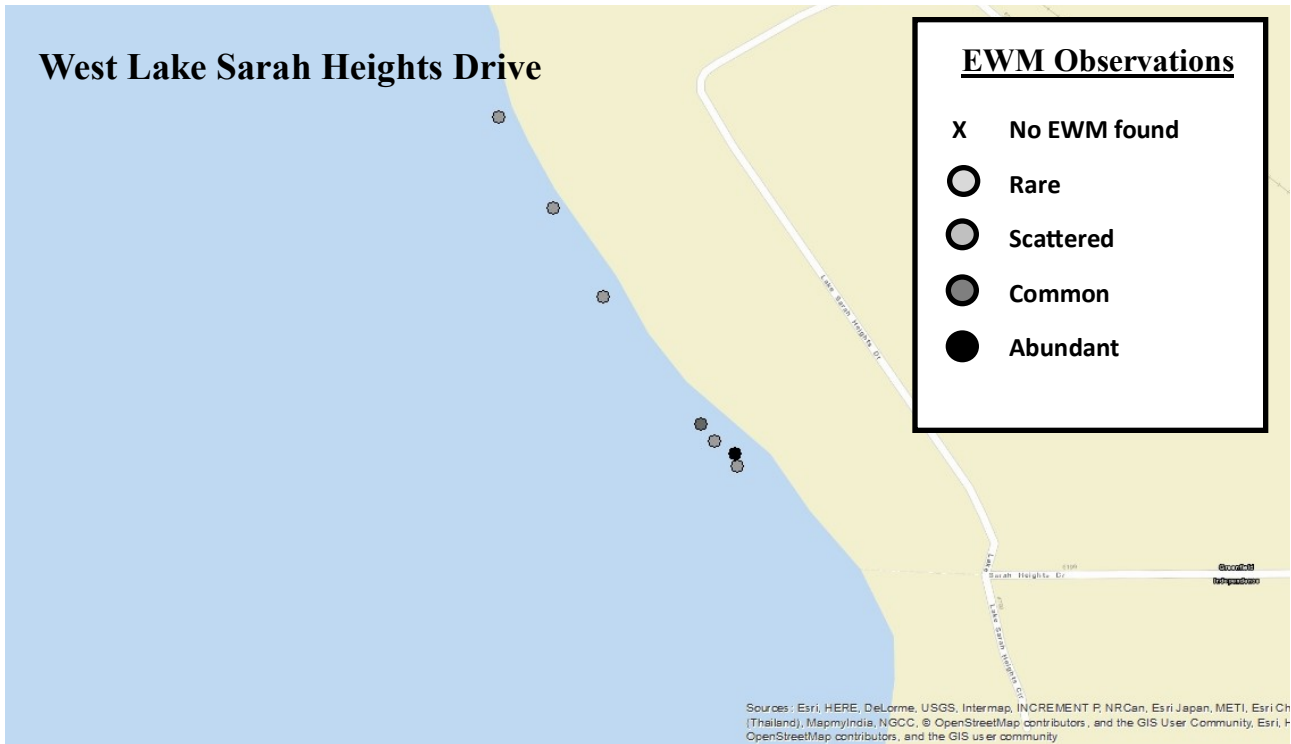
Along West Lake Sarah Heights Drive, EWM of varying densities was found along the shoreline. For the most part, plants were scattered in 2 to 3 feet of water, with one patch having more abundant EWM. EWM in this area should not provide much impediment to navigation, however, the small dense patch shown on the map above could provide some localized navigational issues. The small size of this site would limit the effectiveness of any treatment, however, diquat could provide some localized control for the patch. Overall, no treatment is warranted in this area, unless the one small patch was viewed as a navigational concern for residents in the area, in which case, the use of diquat could be explored.

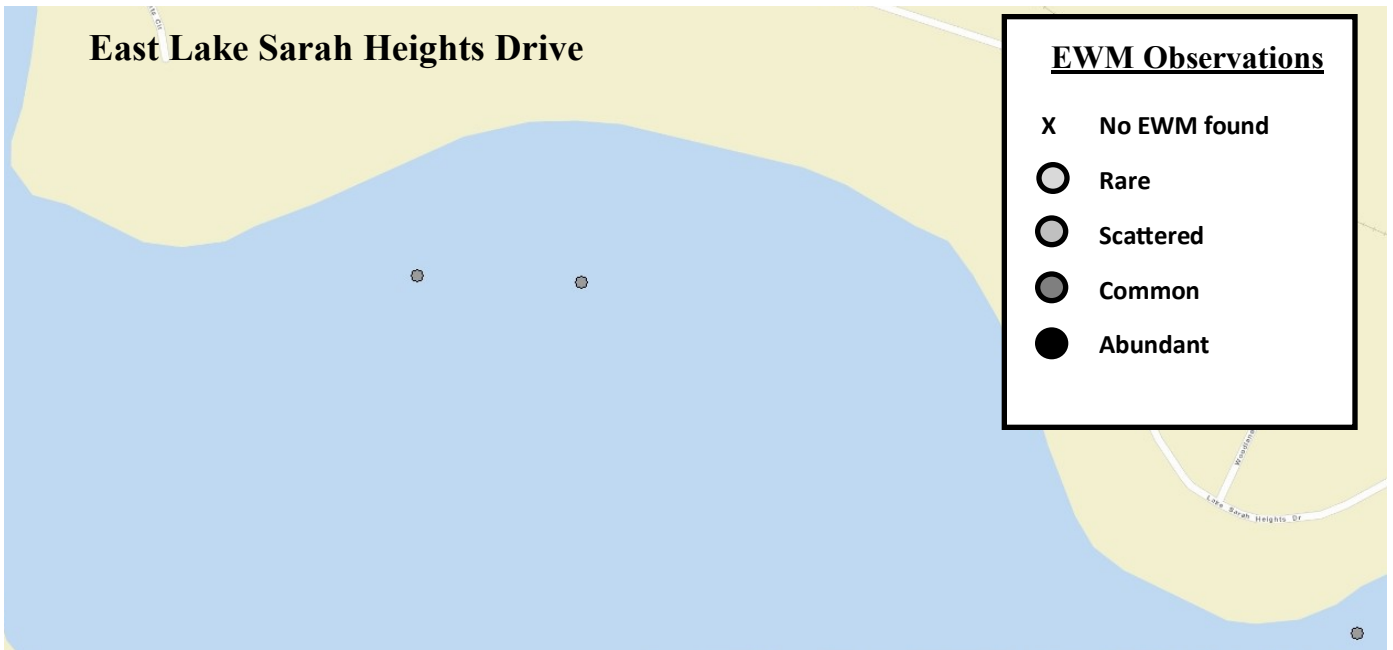
EWM was rare in this area of the lake, with the exception of some scattered patches as noted on the map. It's possible a few other scattered patches are present, but were not observed during the survey. Elodea and Coontail appeared to be much more abundant throughout this area of the lake. At this time, no treatment is warranted due to scattered patches not providing much impediment to navigation.

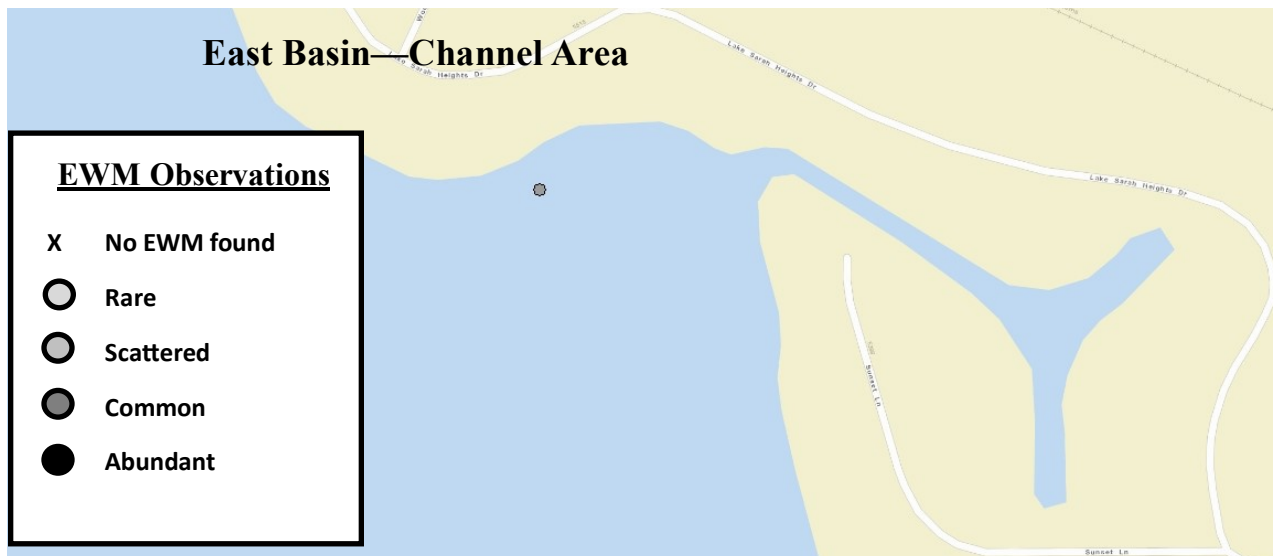
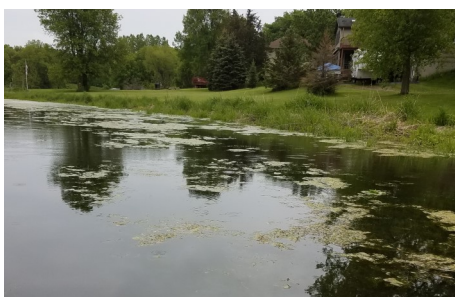
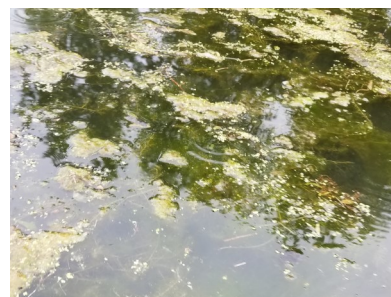
No Eurasian Watermilfoil was found in the channel area, but some scattered plants were found along the shoreline outside of the channel, as shown on the map. EWM growth was light, and no treatment is needed. The channel itself was dominated by Elodea and Coontail, with filamentous algae growing on top. Pictures are below.

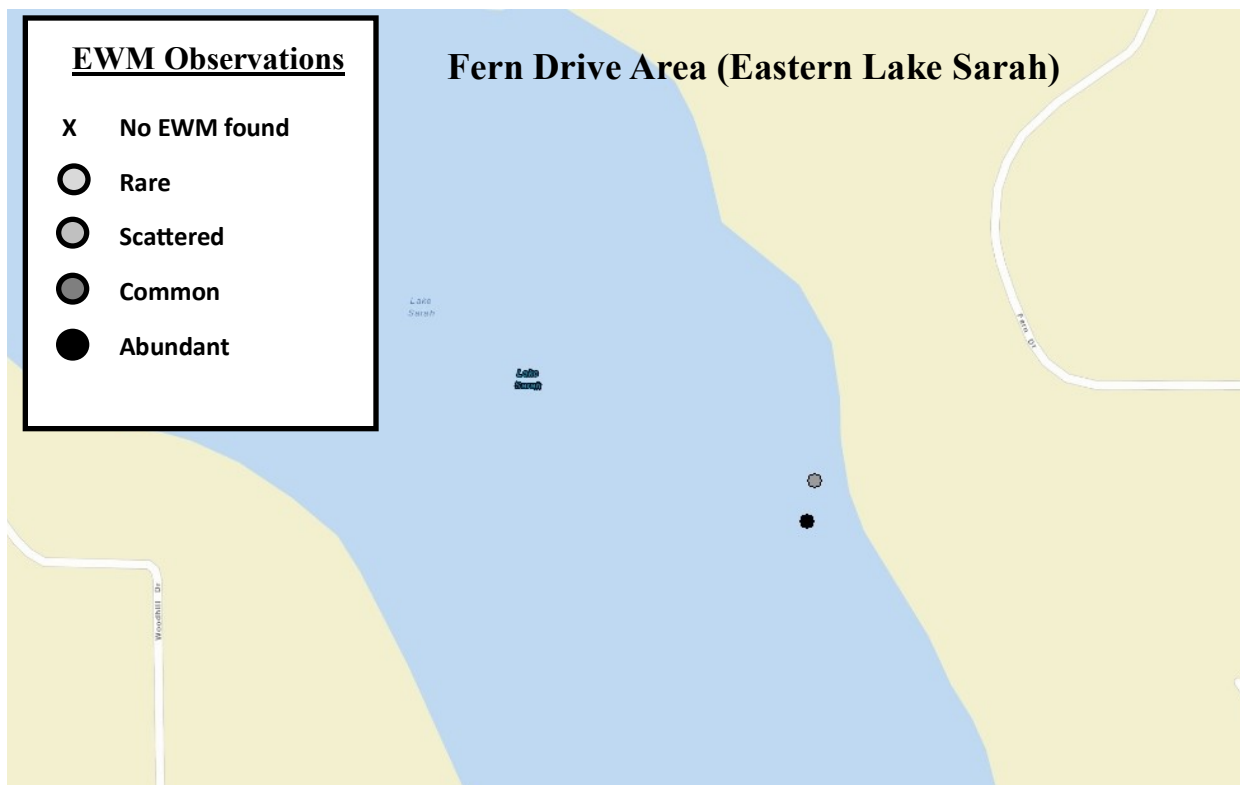
One patch of EWM was found near the Fern Drive Area in 5 to 6 feet of water, the patch was small, but did contain abundant EWM. Given the small size of the patch, it should not impede navigation. If localized control is desired, the use of diquat herbicide should be explored due to the small size of the area.

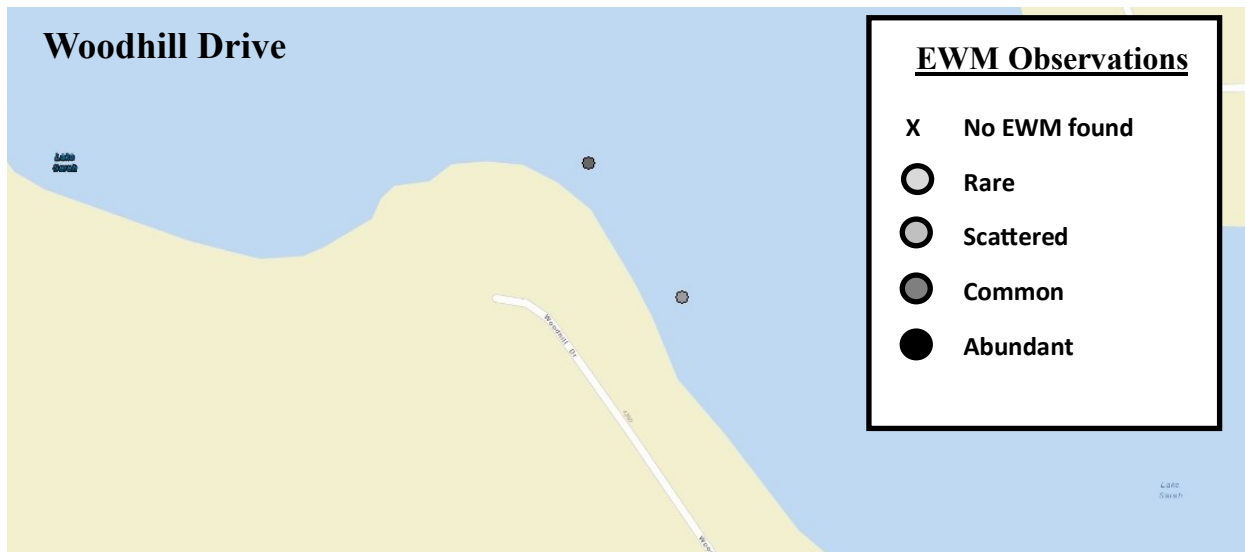
A couple patches of EWM were found along Woodhill Drive in 3 feet of water. The patches are isolated enough where they shouldn't interfere with navigation, so no treatment is warranted.

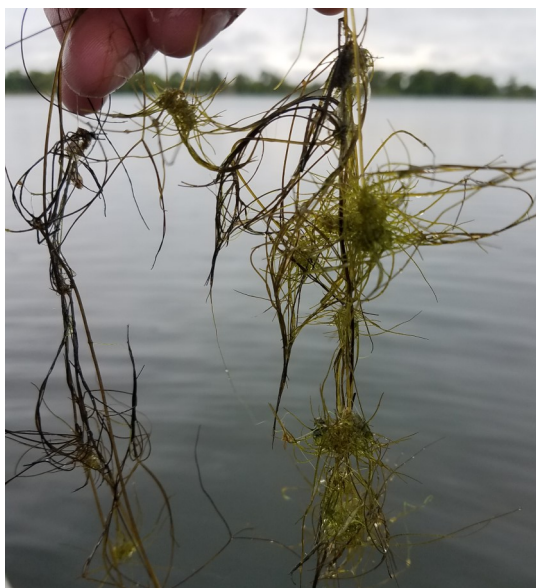
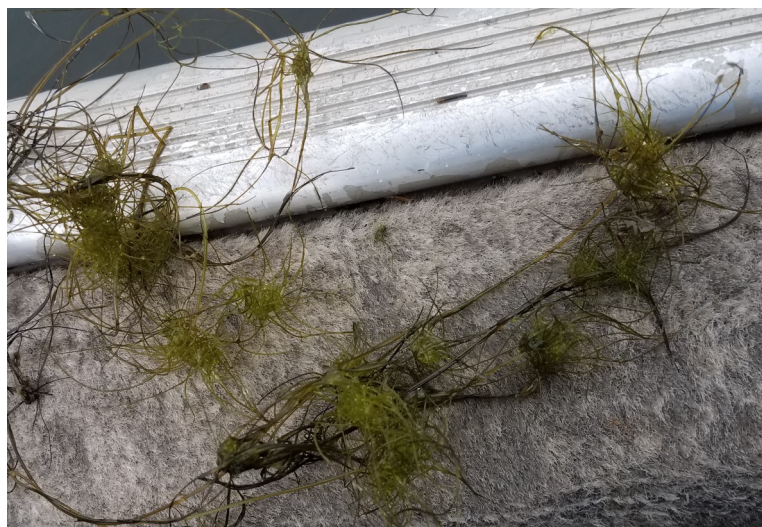
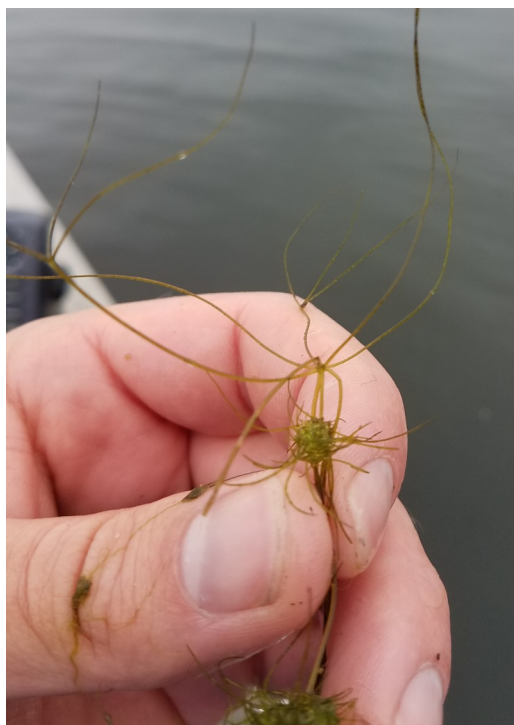
A new native plant species not previously found in Lake Sarah was discovered during this survey. It appears to be a Stonewort species, of which there are many native varieties. It is not the invasive Starry Stonewort, and future plant surveys should determine how widespread the plant is. It's feasible the plant sprouted from a seed that has always existed in the lake, and with recent reductions in CLP and improvement in water clarity, conditions may have been right to sprout the plant. Samples will be collected and sent to an expert for final identification, since there are many look-alikes for these species. Temporary identification of the plant is Bird's Nest Stonewort, *Tolypella intricata*. More about this new species will be discussed in future survey reports once more information is gathered.
