6-inch M1900 Seacoast Gun Elevation Counterweight Project
Design, Fabrication and Installation
Ft. Hancock, New Jersey
(October 2019 to April 2022)

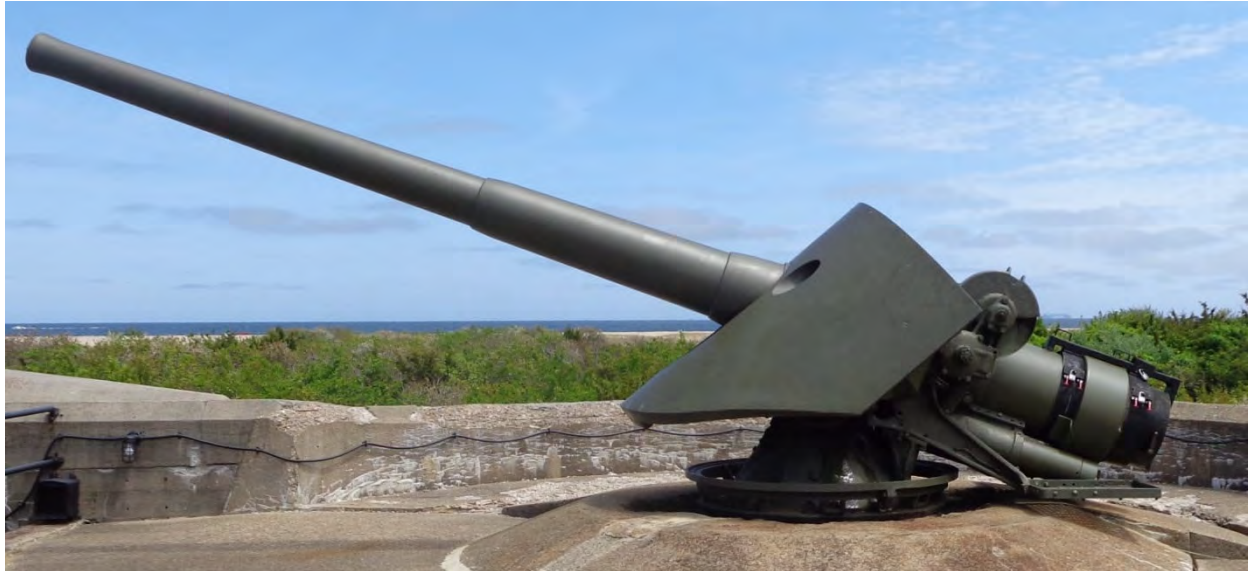
The two M1900 6-inch guns at Battery Gunnison/New Battery Peck are fully articulable. They traverse and the gun tubes elevate. The photo below shows Gun #1 with the gun tube fully elevated to 20 degrees.

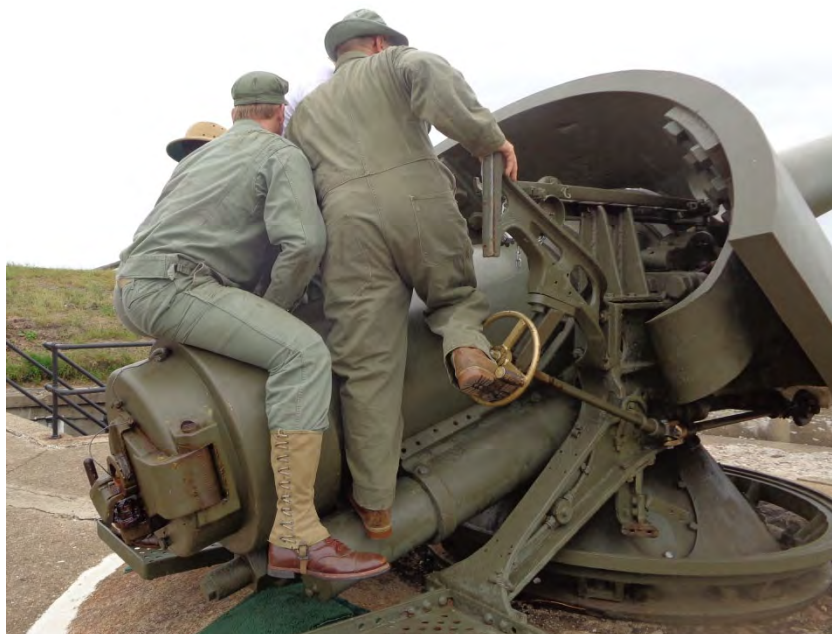
When AGFA began work at Battery Gunnison/New Battery Peck, the gun tubes were out of balance by about 1,200 pounds. In accordance with TM 9-428, the normal elevation effort required is 2 pounds of pressure. The missing weight is due to the removal of the recuperator springs, shafts and dampers. There are two of these cylinders, one on each side of the gun. In order to elevate the gun tubes (which are muzzle heavy), it typically required five or six grown men to sit on the breach area. The picture below shows four men preparing to replicate the missing weight. The left foot of the gentleman on the right is resting on the right recuperator spring cylinder.

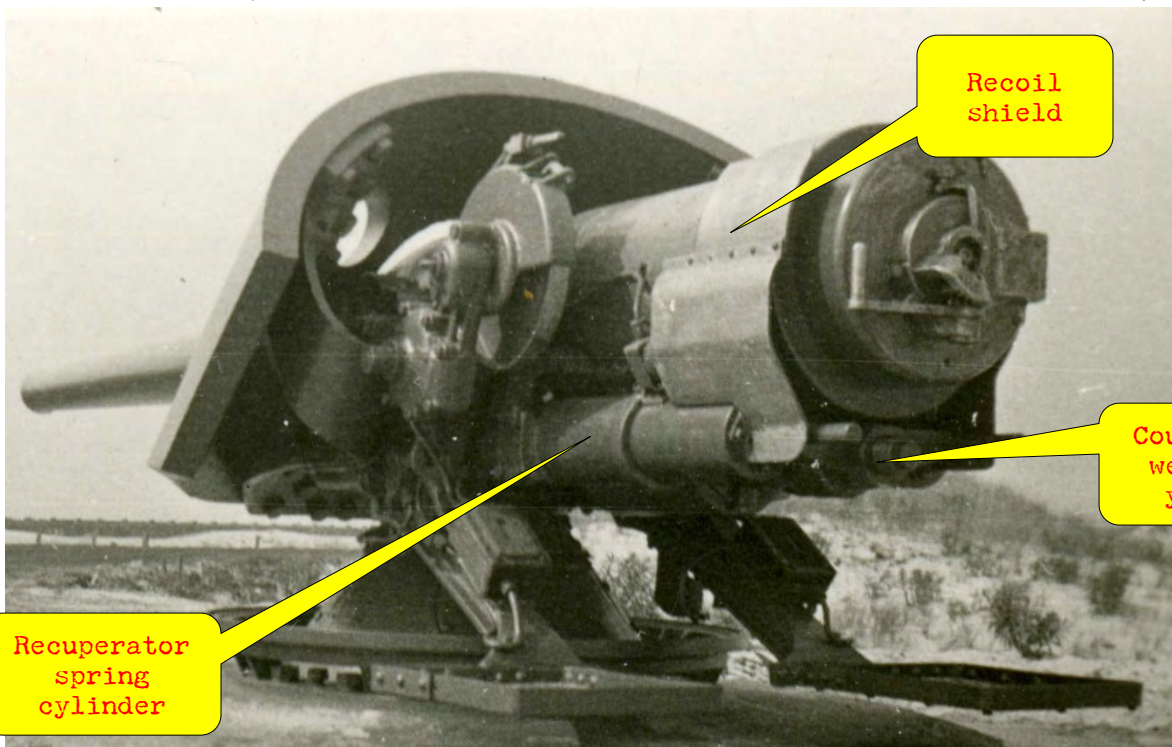
The guns were missing the Recoil shield and the yoke at the back of the gun. These are shown in this 1937 photo of one of the guns of Battery Kessler at Fort Tilden in the 1930s (Gateway National Recreation Area collection number 4193).

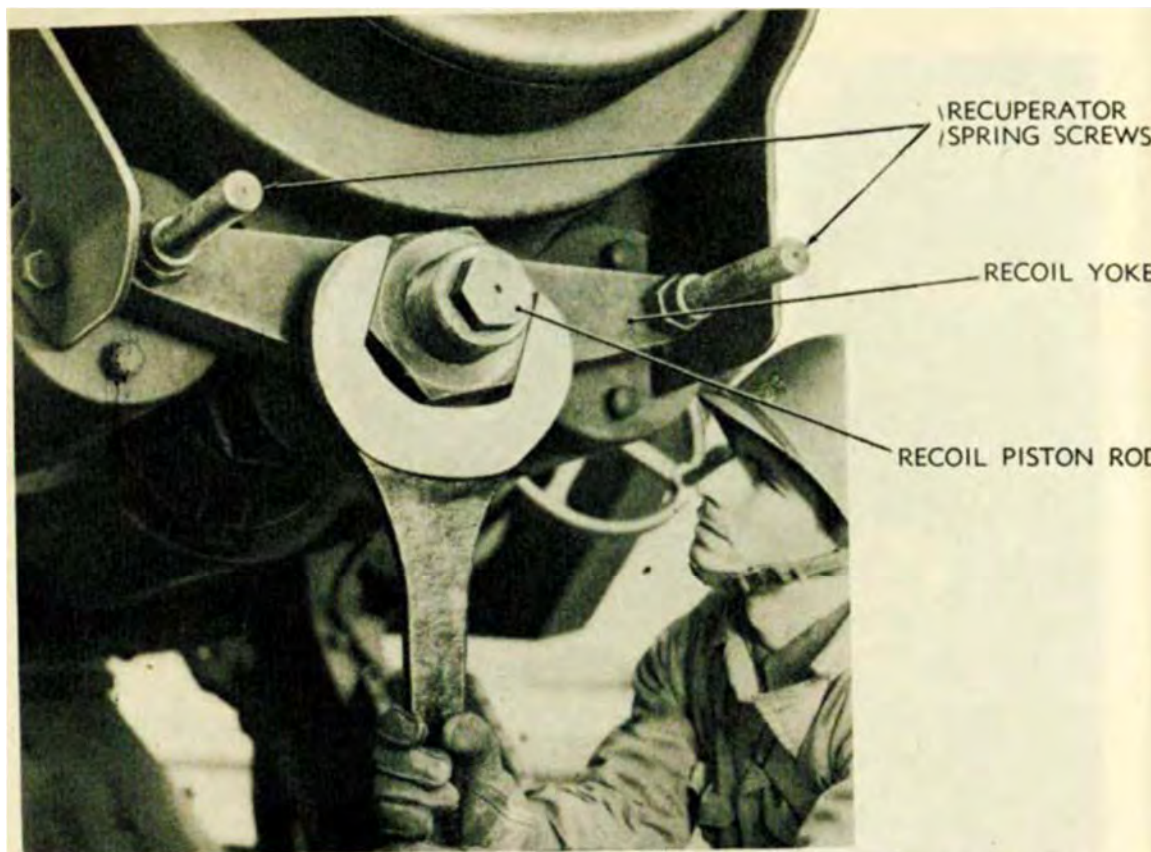
The two photos below show recoil yoke, recoil piston rod and recuperator spring screws. This photo is from page 52 of TM 9-424 - 6-inch M1900 Seacoast Gun, Mar 1945.

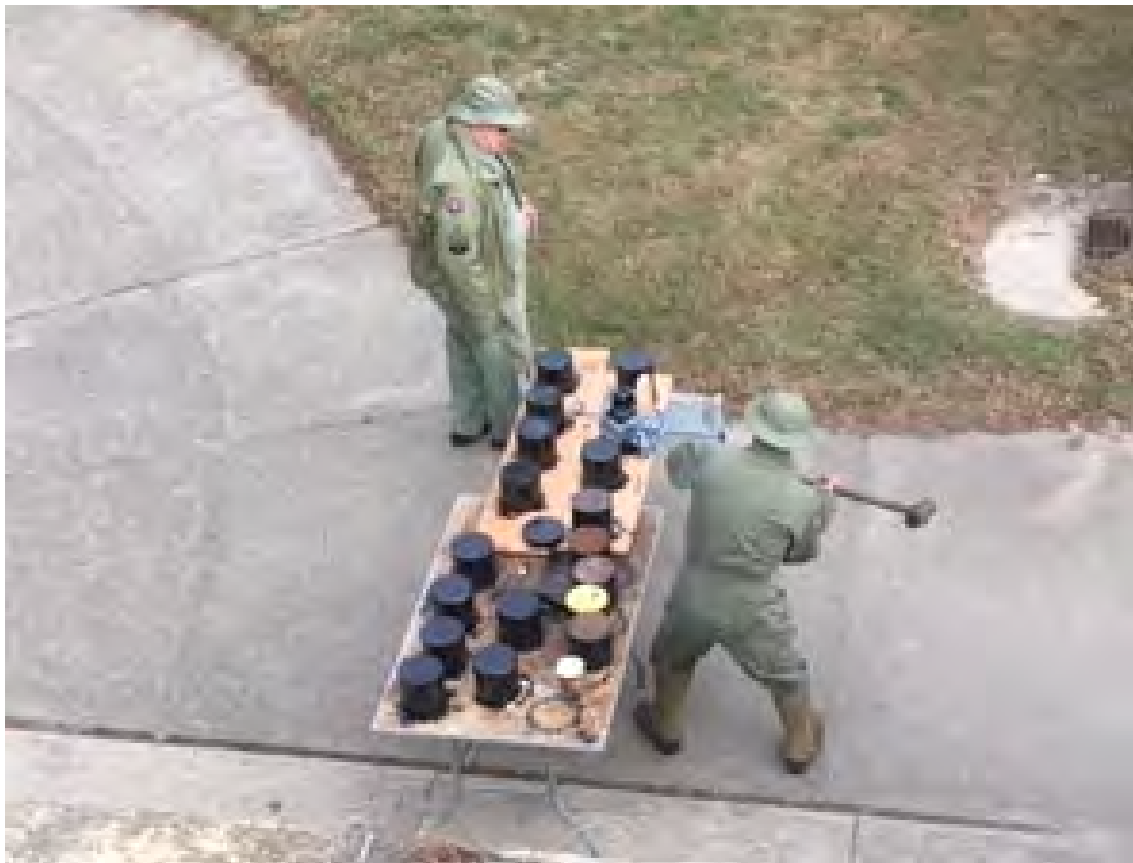
In the photo below, the 18 slugs have been coated in POR-15. After hardening, they are stuck to the table and PVT Morrison is using a sledge hammer to break them free as T-4 King looks on.

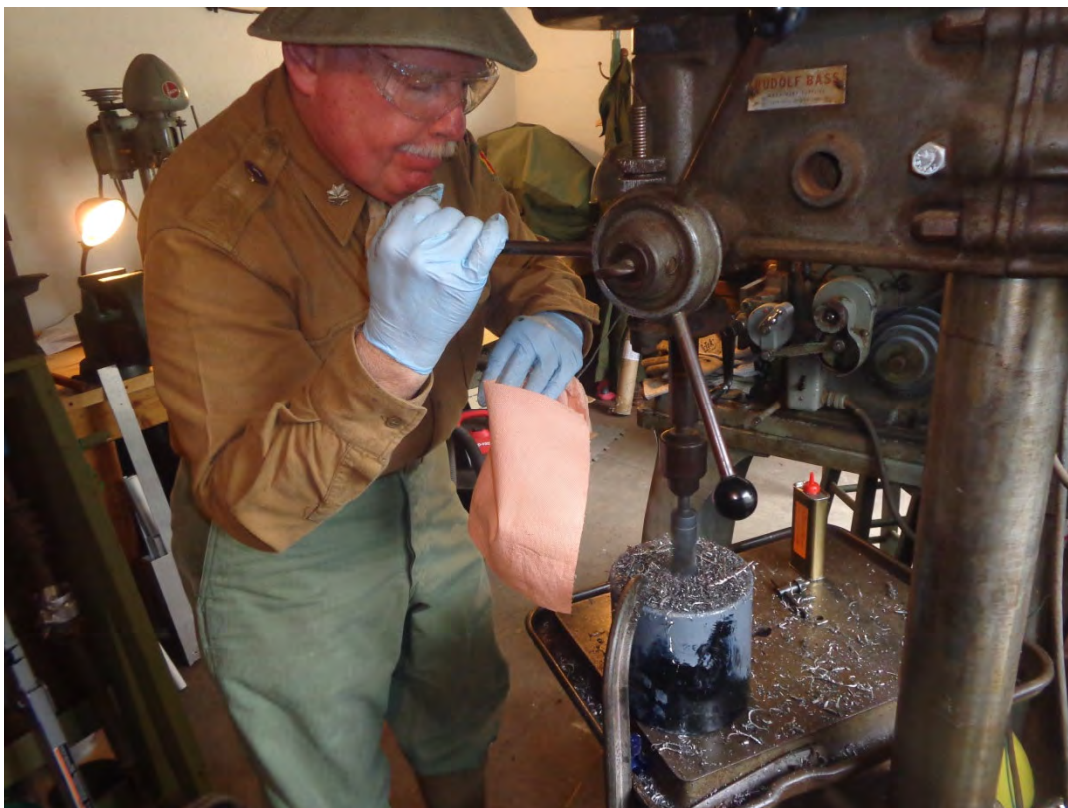
The breach end of each recuperator spring cylinder has a 1-1/8-inch diameter hole. In order to get the slugs out of the cylinders it was decided to drill a hole into the top of two of the slugs to enable the seating of a metal rod to either guide the slugs down into the cylinder or to enable the slugs to be removed from the cylinders. In the photo below, LTC Welch drills a 1-inch hole into the top of one of the two slugs.

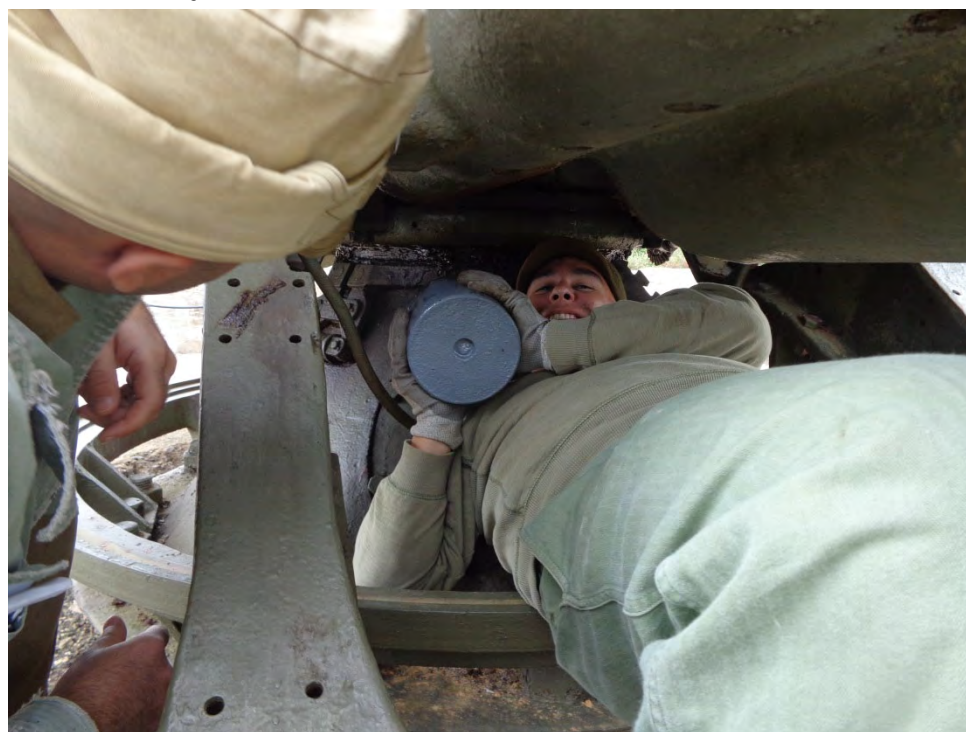
Below SSG Minton lifts the first of the slugs into the cylinder. Notice this slug has the half inch hole for the steel rod to seat for removal or as a guide during installation into the cylinder.

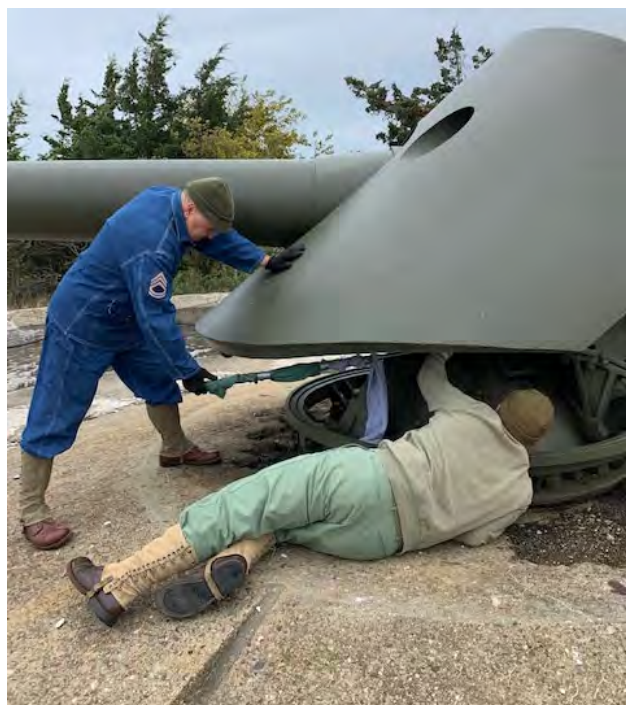
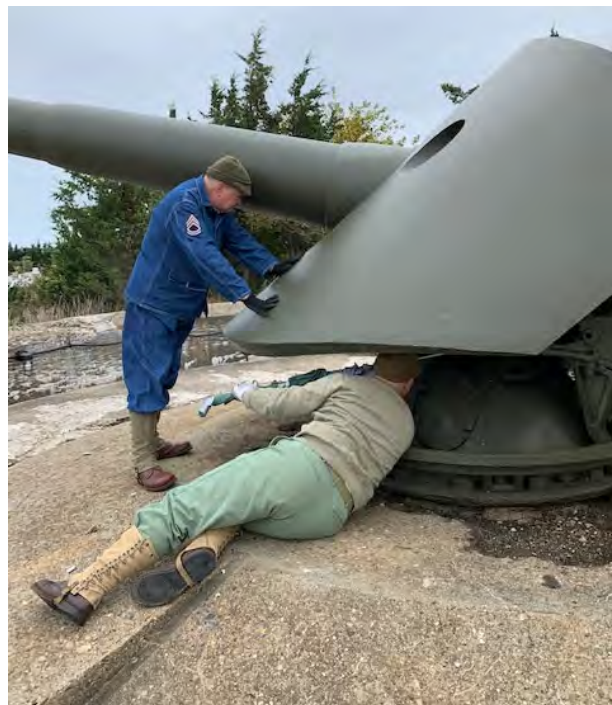
As the slugs move down into the cylinder, sometimes they need an assist. Below TSG Weaver and SSG Minton use the 1 inch steel rod to push the slugs into the cylinders.

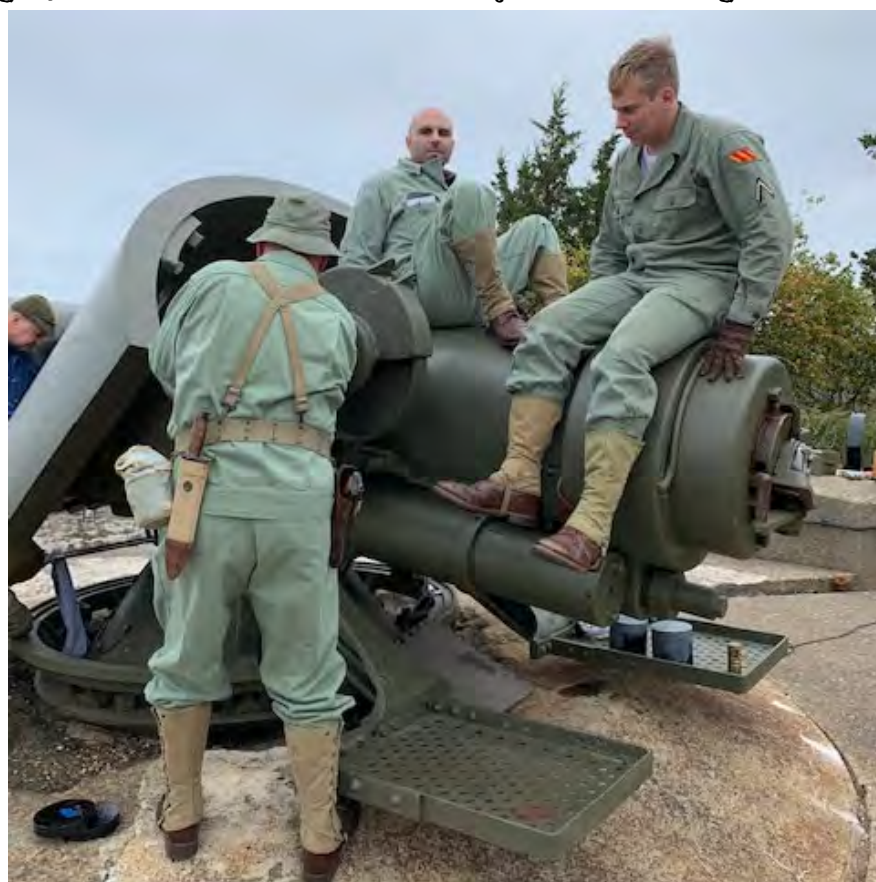
With all 18 slugs in the cylinders the additional weight is 740 pounds. Adding PVT Budjos and PVT House to the breach area adds an additional 400 pounds. With this additional weight, LTC Welch is able to easily elevate the gun tube.

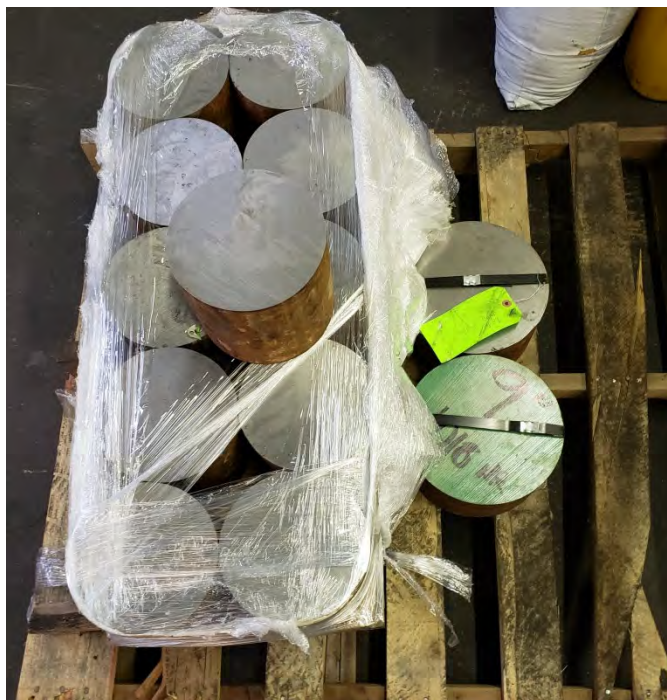
T-4 King researched options and found 7-inch diameter six-inch-long slugs that weigh about 70 lbs. each. A shipment arrived in early November of eleven 7-inch slugs and two 9-inch "cap slugs" (right of wrapped stack) for the backs of each recuperator cylinder for Gun #1. This cost AGFA about \$1,000 total. Also sent with this shipment was four of the 1-1/8-inch diameter stainless steel threaded rod to simulate the recuperator rods. We later discovered the rods were in fact 1-1/4-inch.

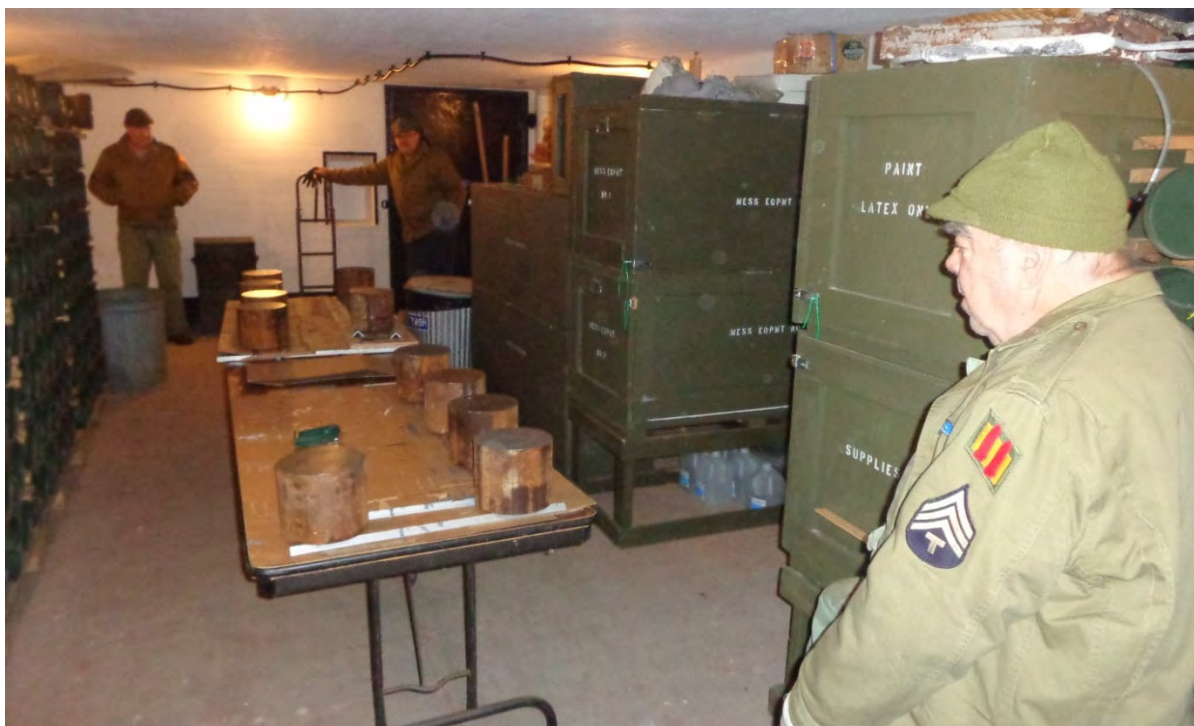
That weekend the slugs were treated and prepared for POR-15 application. Below TSG Weaver, T-4 Ciemniecki and T-4 King stand by after placing the slugs on the table for POR-15 application. The two slugs nearest the camera are the large 9-inch pair for external attachment to the recuperator cylinders.

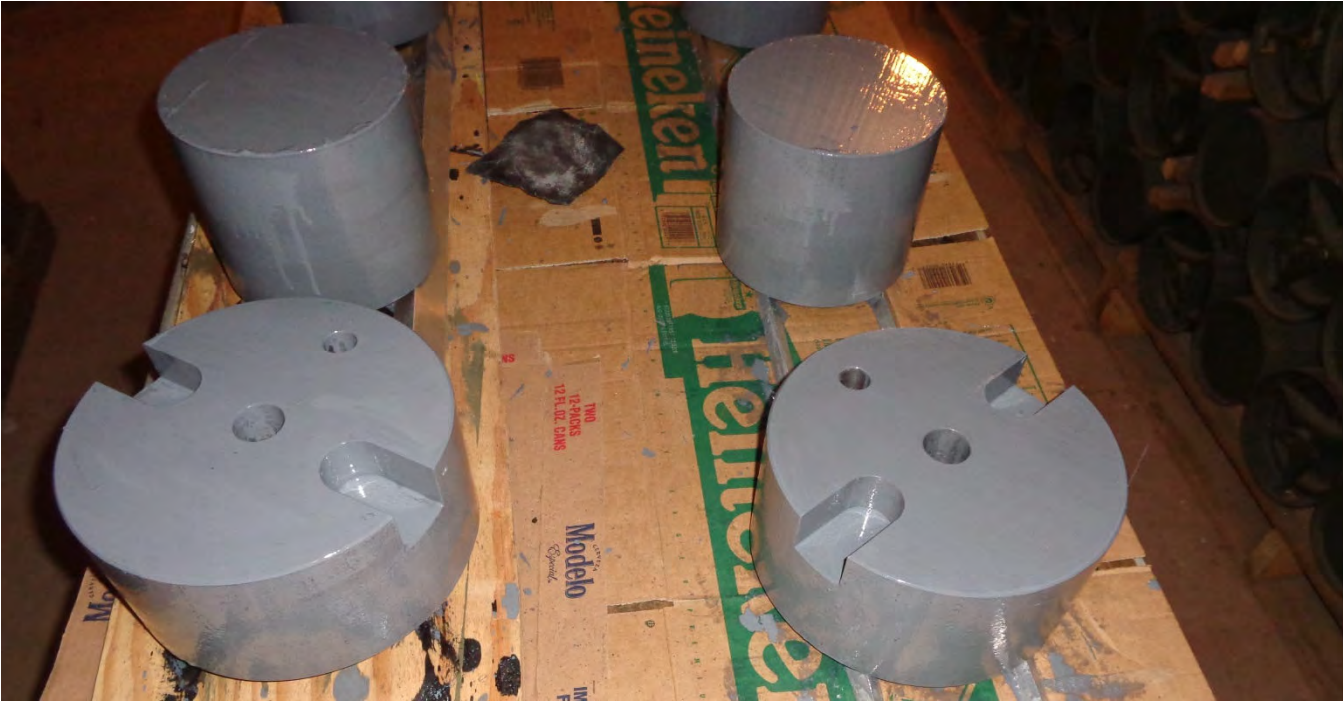
The difference in size of the exterior cap slugs for the recuperator cylinders is apparent in the photo below.

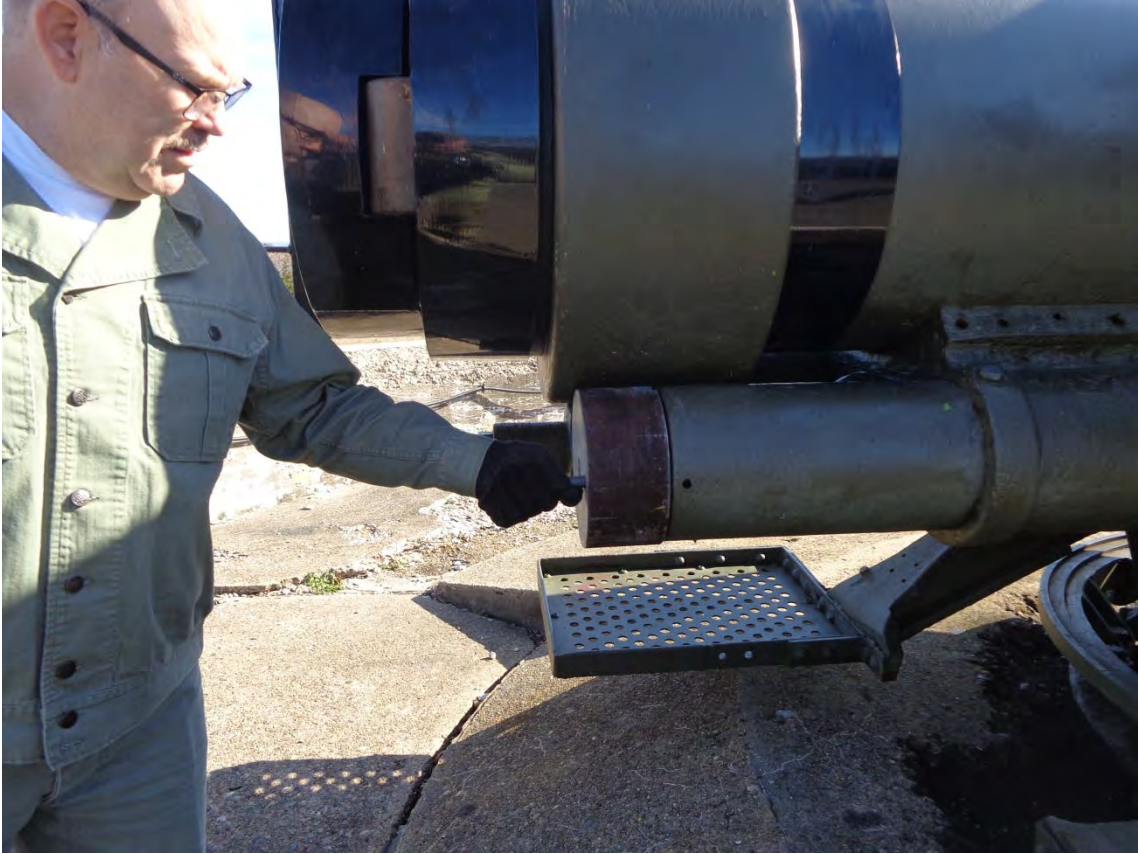
Below T-4 Ciemniecki inserts a bolt to hold one of the end slugs onto the cylinder of Gun #1 to confirm they fit.

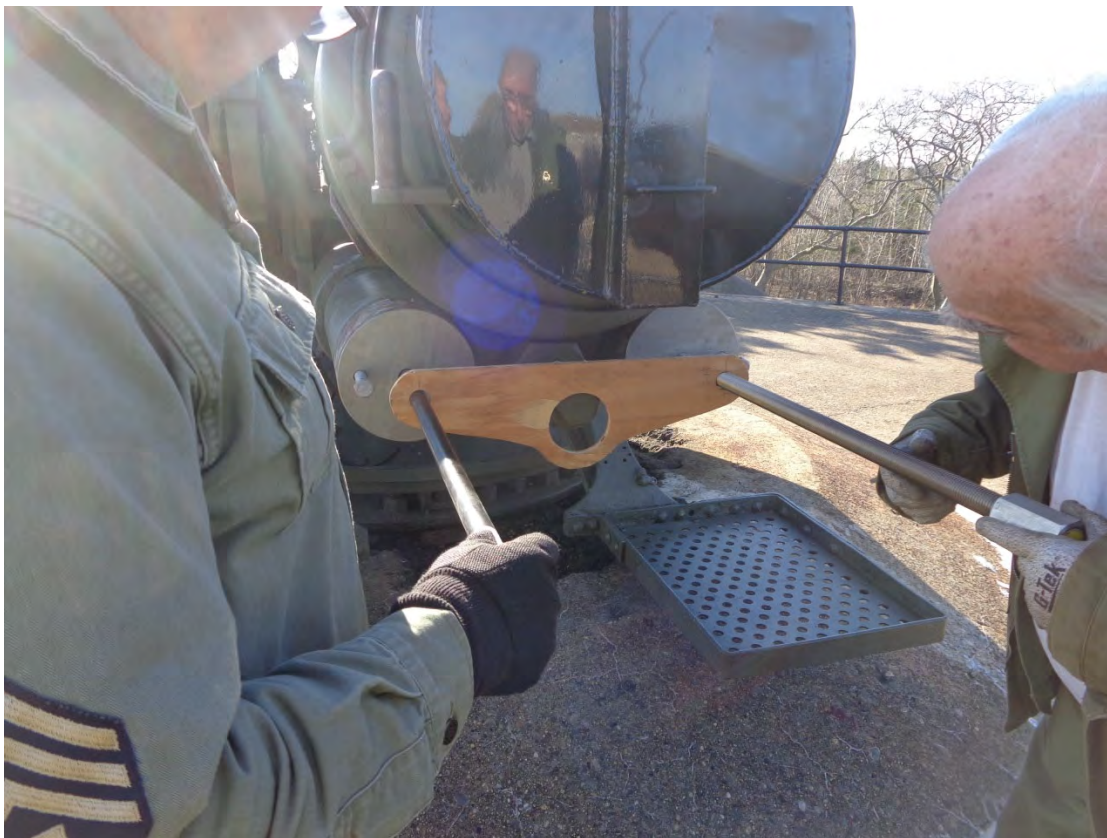
The team also tested the new "yoke" pattern concept. This pattern will be sent to a foundry to make a copy of the "pattern" for a 100 to 150 pound cast iron yoke for the guns. The two stainless steel threaded rods simulate the spring rods.

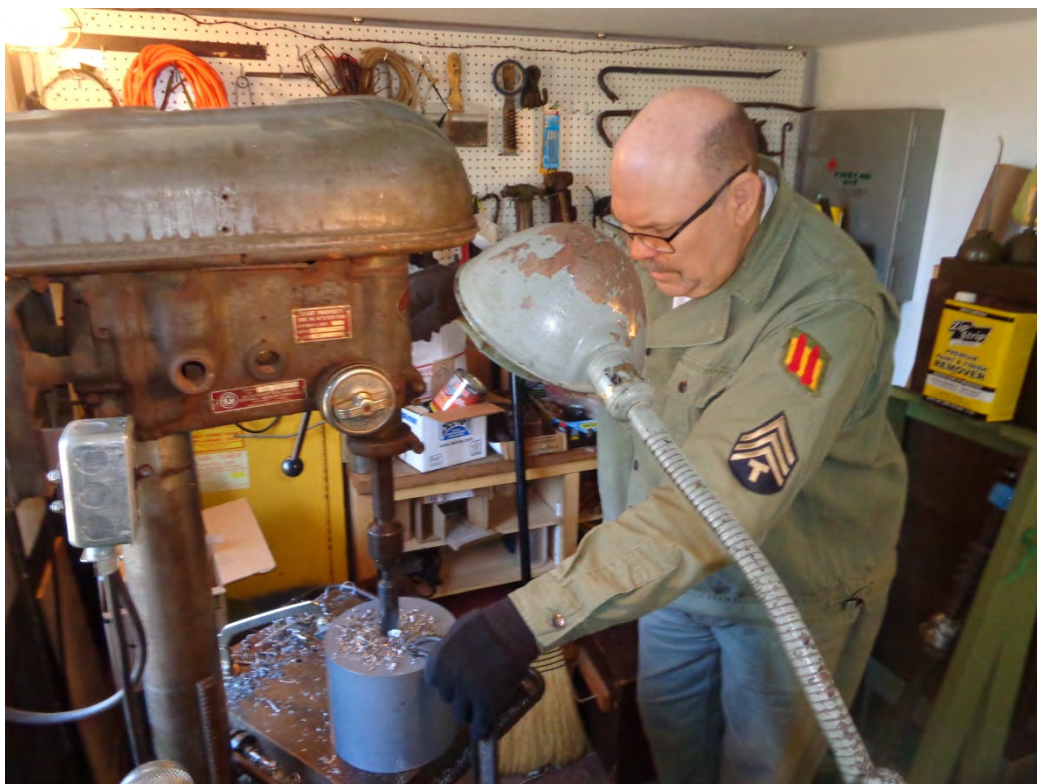
Below T-4 Ciemniecki drills the half inch deep seating hole into the center of one of two 7-inch steel slugs.

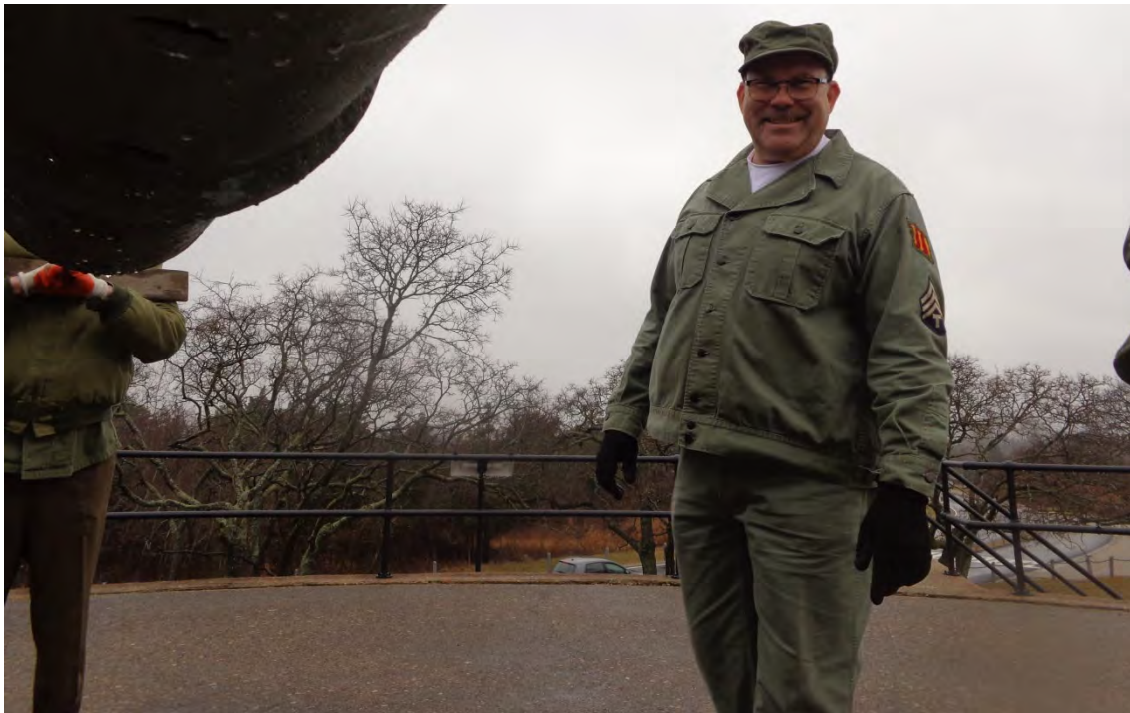
On the weekend of 3-5 January 2020, the team moved to swap out six of the 5-7/8-inch slugs with three 7-inch slugs. This increased the weight from 740 pounds to about 900 pounds.

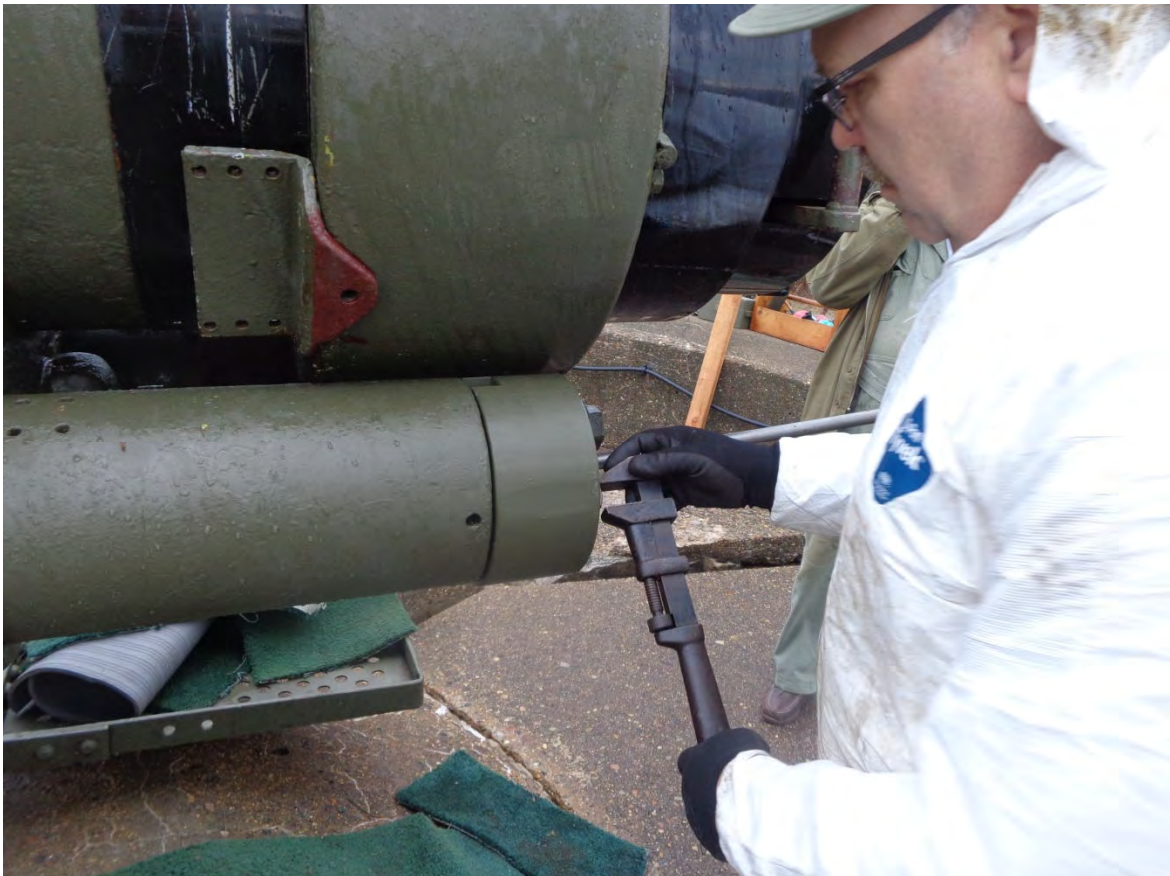
Below T-4 Ciemniecki installs the newly painted end slugs onto Gun #1. Total weight is now approximately 1000 pounds.

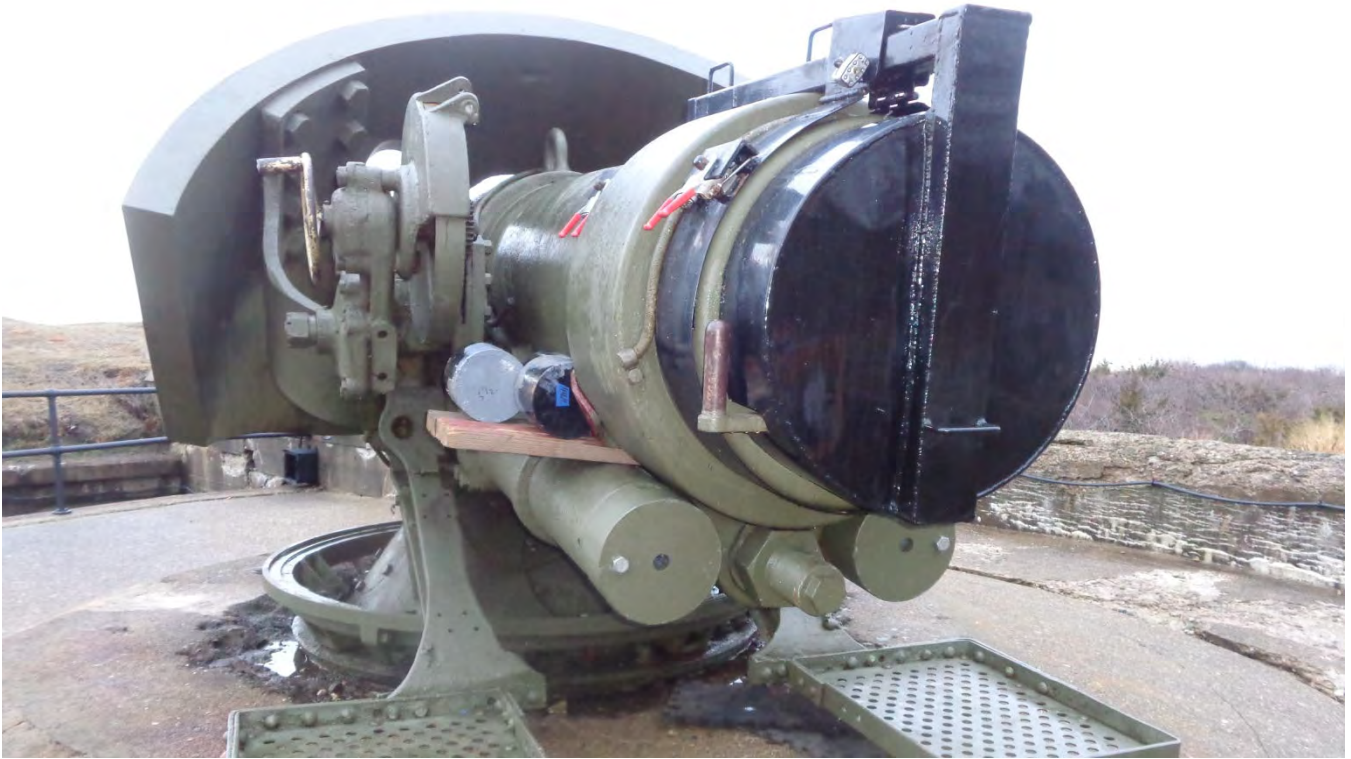
The photo below shows both slugs installed.

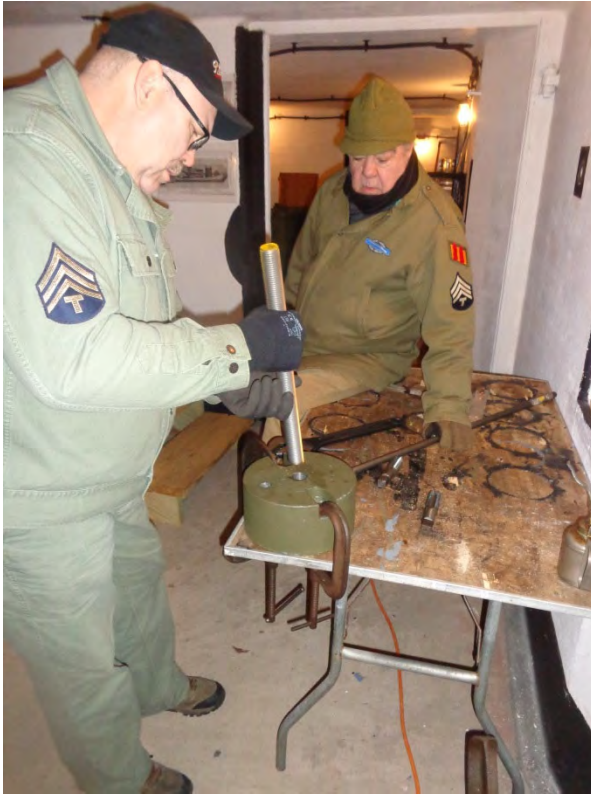
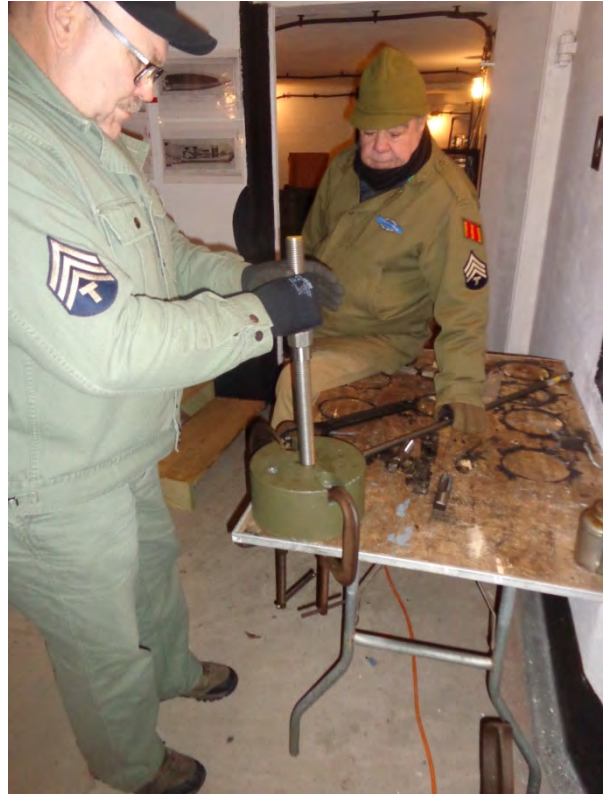
On 9 January 2020, after some testing, T-4 King and T-4 Ciemniecki determine the treading of the end slugs is off center. This is a problem and the two slugs will require re-threading.

27 January the end slugs returned fully threaded and ready for POR-15 treatment and installation on Gun #1.

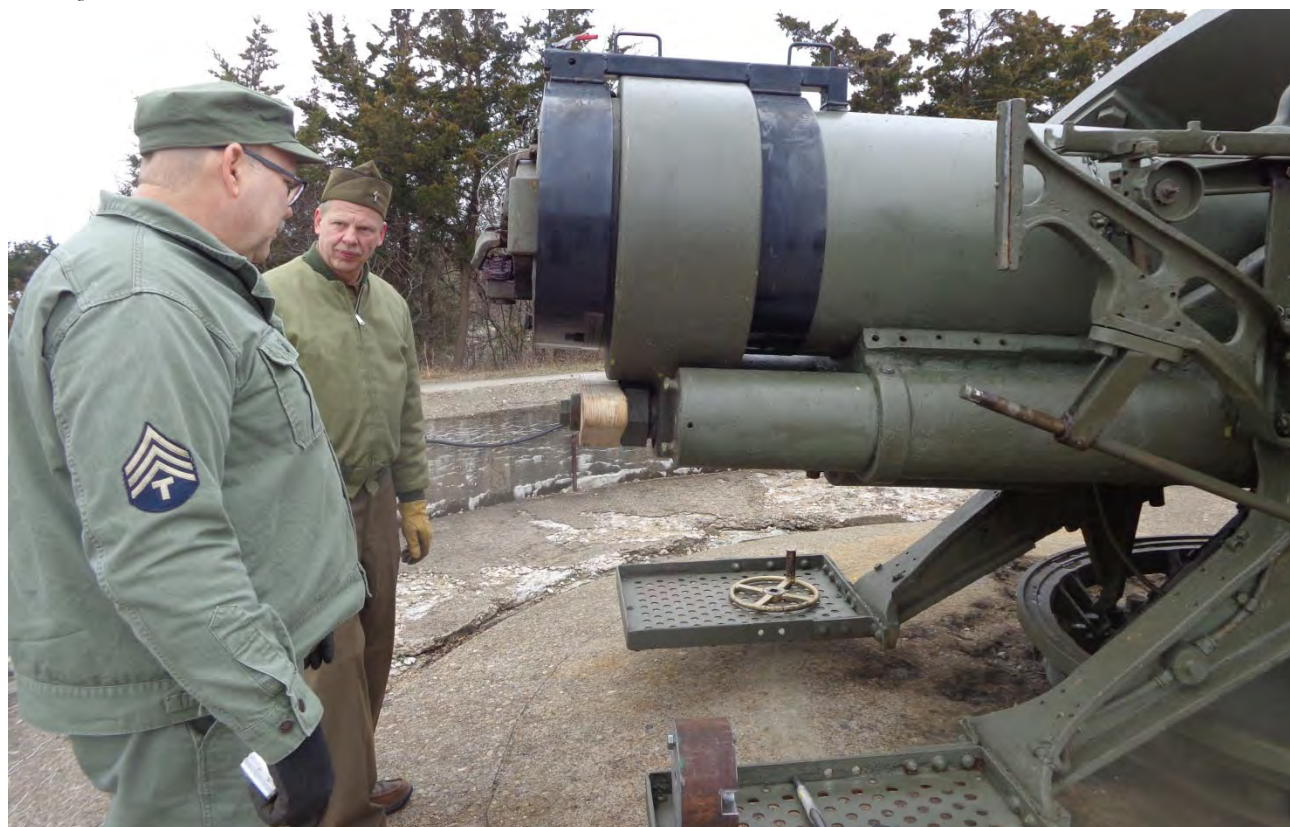
A test fit of the pattern is conducted to ensure that it fits and that it clears the emplacement at maximum elevation.

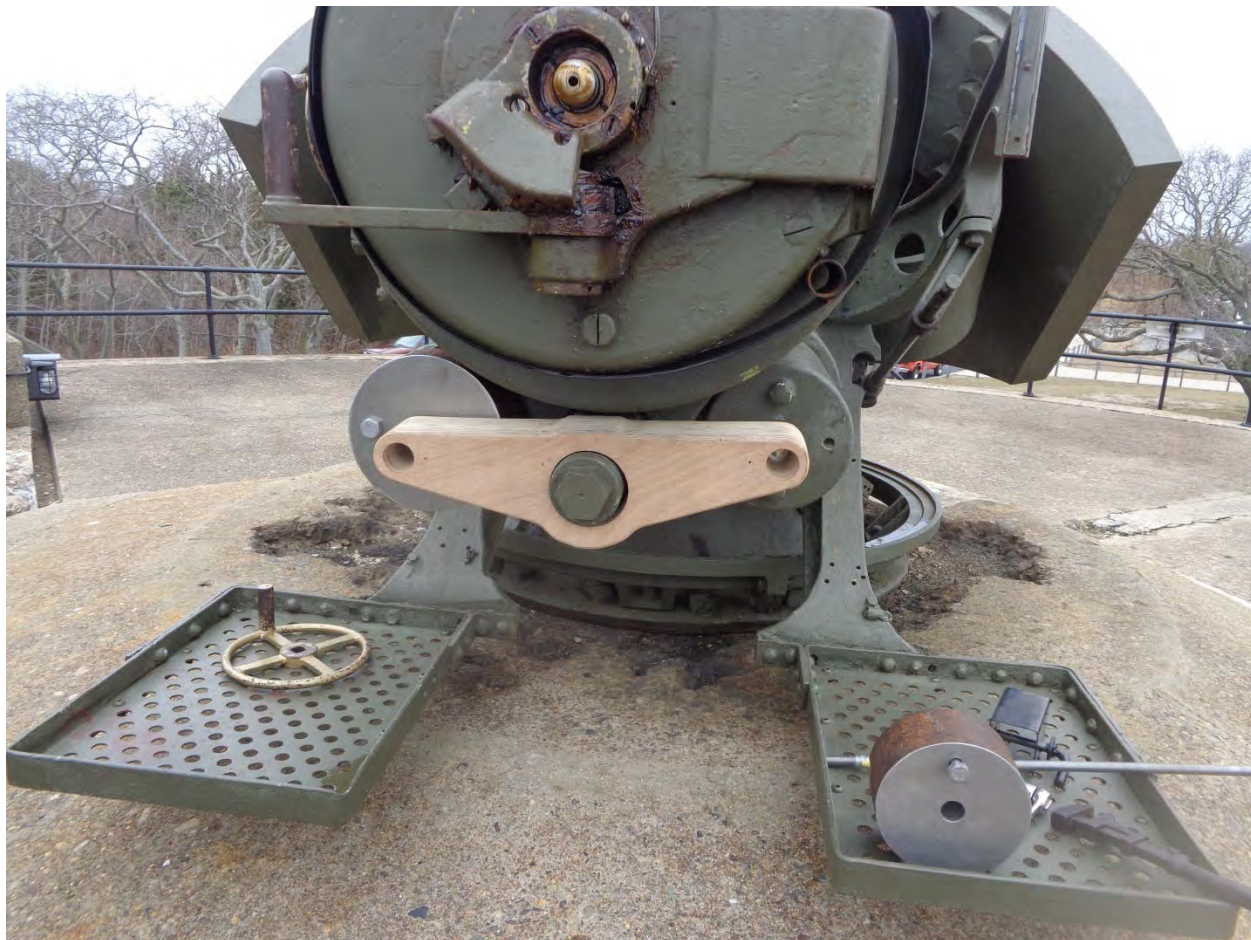
Below the yoke is shown on the gun - however, another problem is discovered - the yoke is too small for the threaded rods to fit properly.

15 March T-5 Ciemniecki and T-5 King are hard at work making a new yoke pattern.

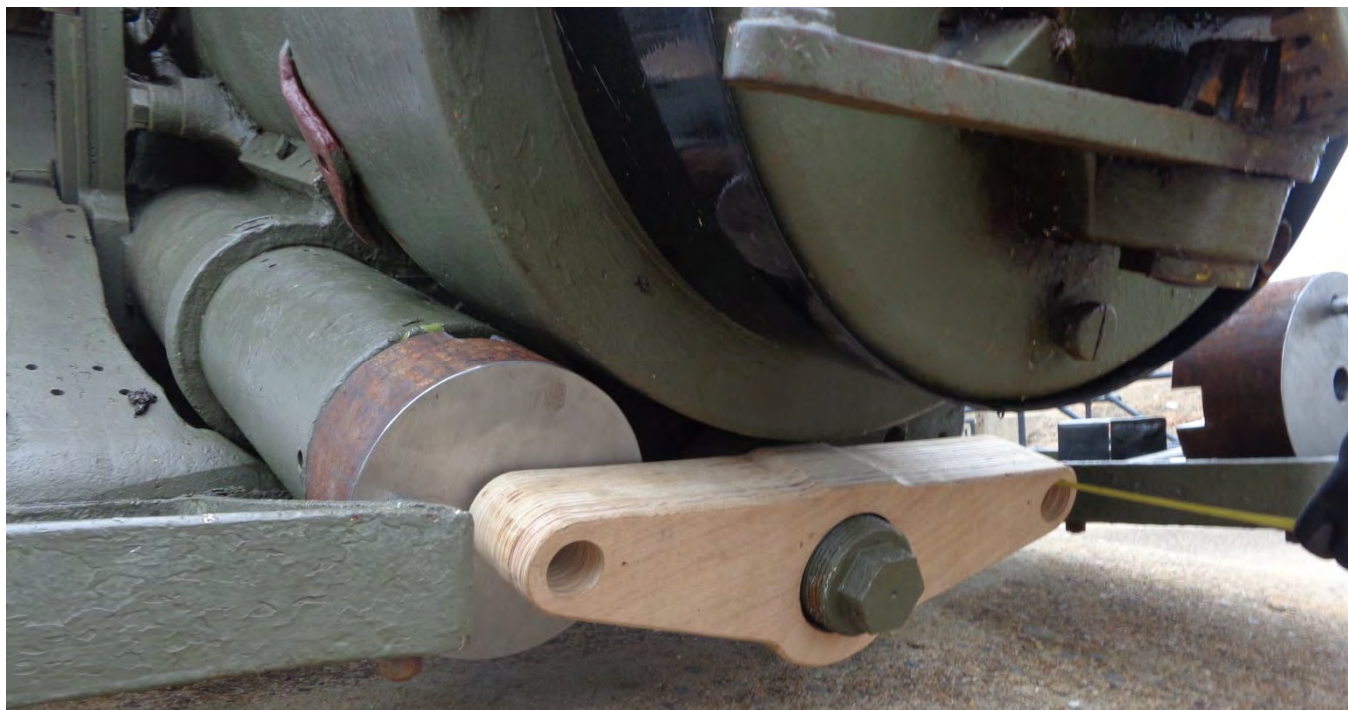
However, at maximum elevation it is determined that the yoke clears the emplacement to ensure no problems with 360-degree traverse of the gun carriage.

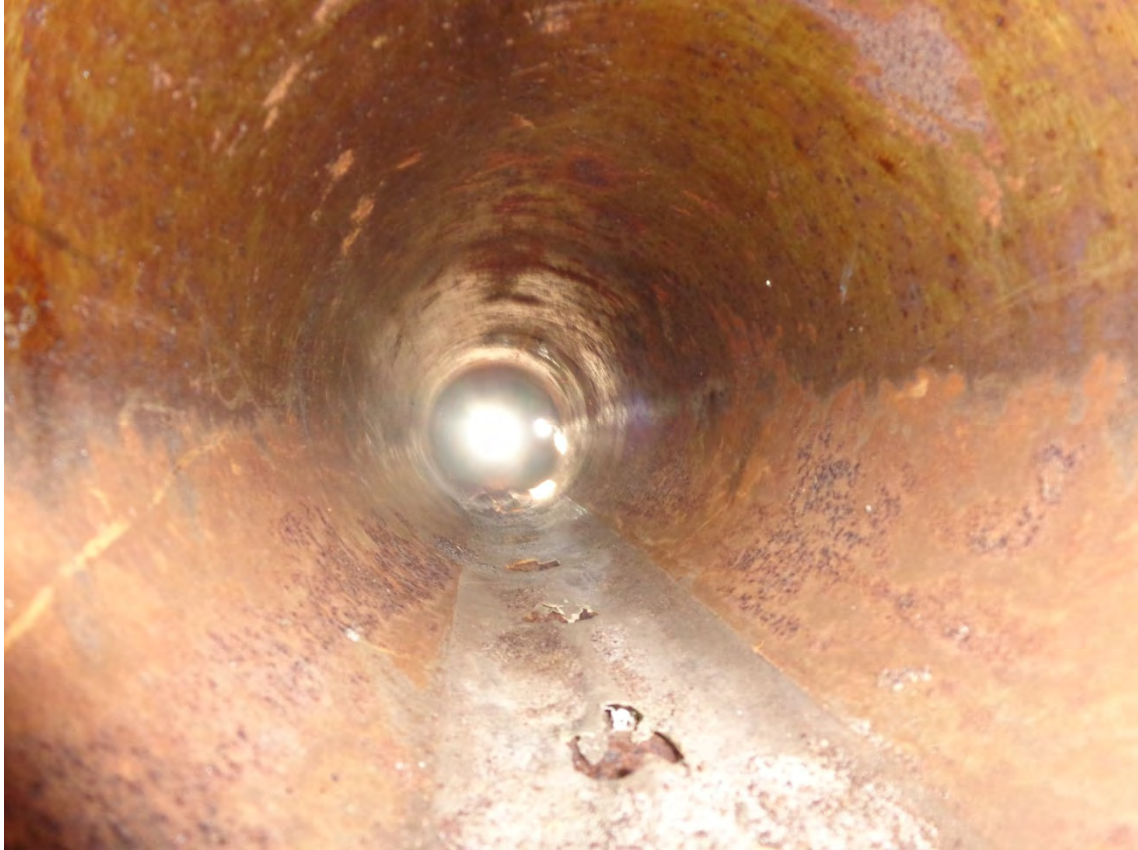
The photo below is of the inside of one of the recuperator cylinders.

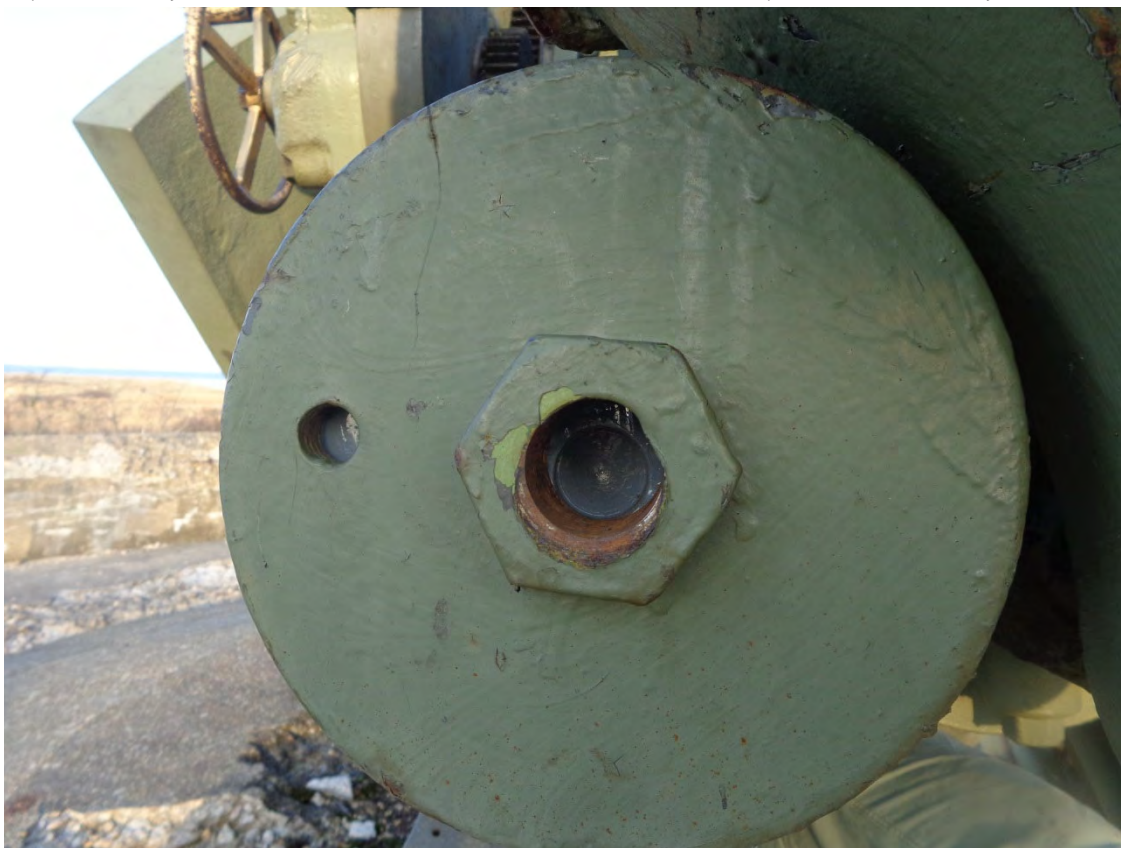
In March 2000 we discovered that the back of the recuperator cylinder for Gun #2 was different from those of Gun #1. Gun #2 is shown below. The center hole is for the recuperator rod. This difference in design of the cylinder also helped explain the difference in the yoke design between the guns. The differences in design may be attributed to different builders - one carriage was manufactured at Rock Island Arsenal (Illinois) and the other at Watertown Arsenal (Massachusetts) in 1903.
