6-inch M1900 Seacoast Gun Elevation Counterweight Project
Design, Fabrication and Installation
Ft. Hancock, New Jersey
(October 2019 to April 2022)

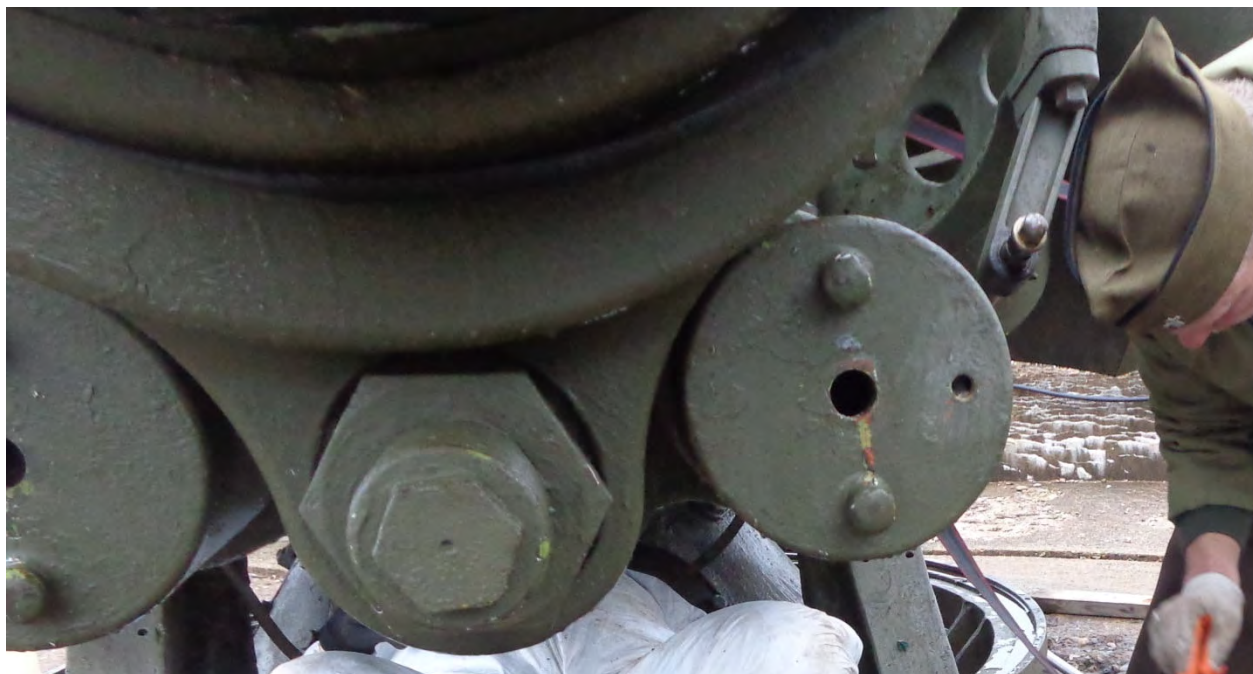
Gun #1 cylinders are shown below and the difference from Gun #2 is noticeable. Instead of a large "hex" pattern protrusion, there are two opposing smooth protrusions opposite each other with the recuperator rod hole in the center.

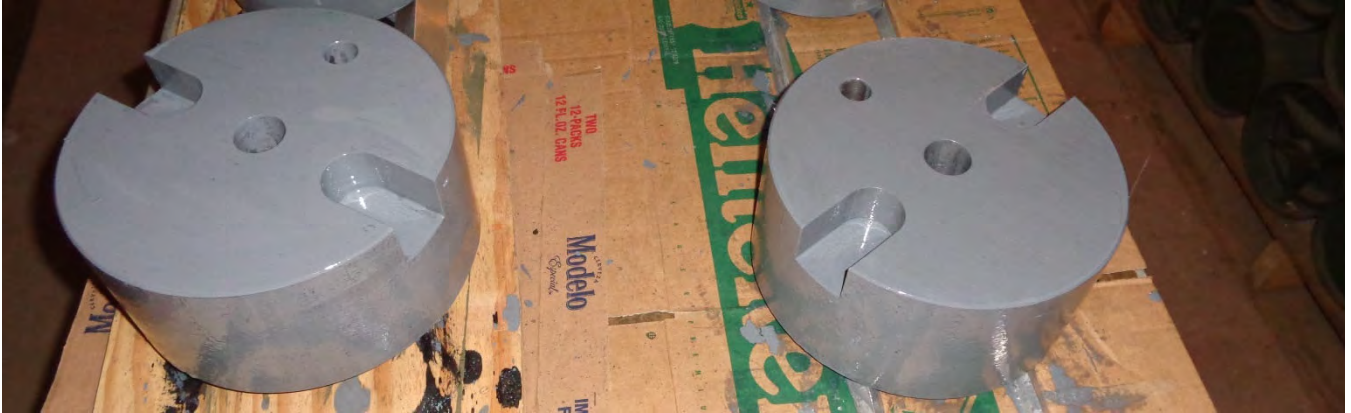
The two end slugs for Gun #2 are shown below just after they were coated with POR-15. However, for Gun #2 these slugs were useless.

The backs of the cylinders on the guns are different, and the second set of cylinder end slugs had to be modified from the Gun #1 design to fit Gun #2. This modification was done by Mike Brennan in his machine shop. He filled in both of the indents for the two protrusions on the backs of the recuperator cylinders of Gun #1 and then cut a circular hole into the back of the slugs to accept the "hex" protrusion at the back of each recuperator cylinder on Gun #2. The photo below shows both slugs upon return from Mike's shop in August 2020. The slugs were prepared for POR-15 on 27 August and were ready for treatment.

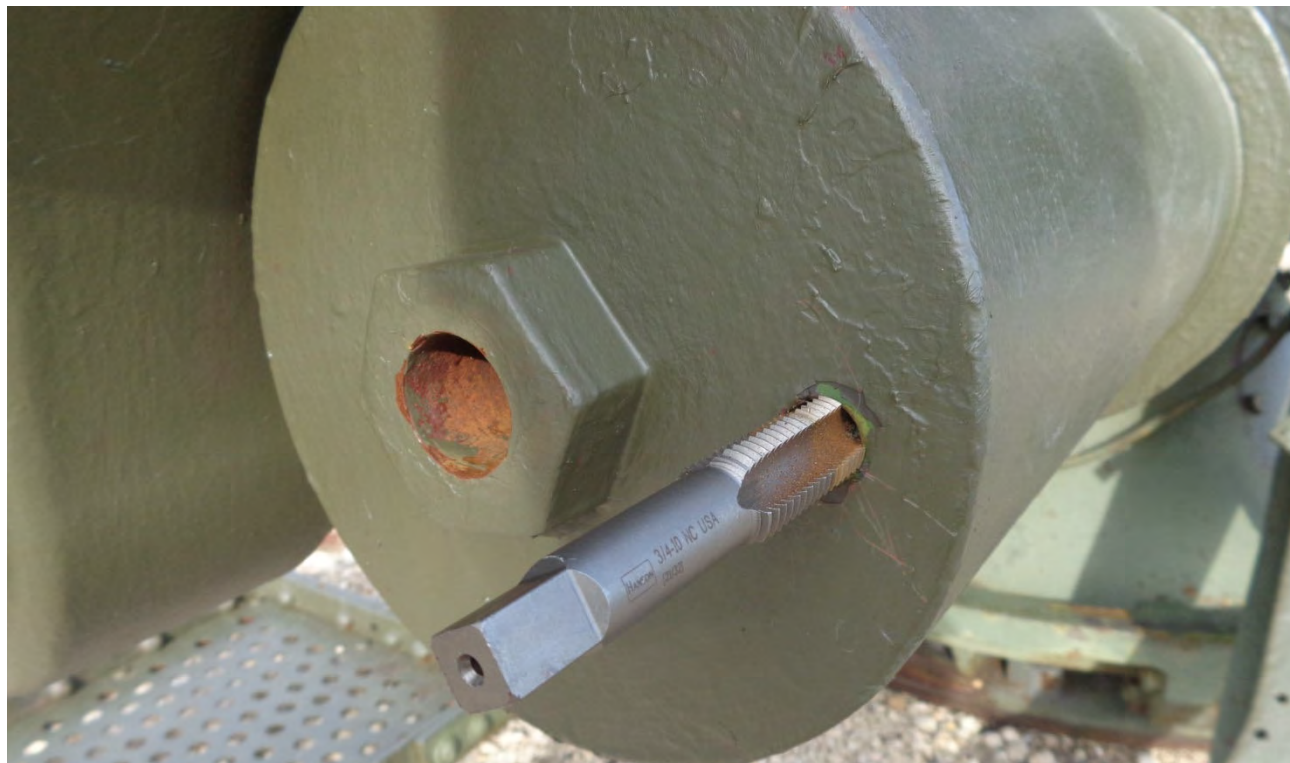
On January 8 2021, CPL Cusano and LTC Welch installed the two slugs on Gun #2. The first step was to clear out the threaded holes in the back of the recuperator cylinders. This was done with a 3/4-inch course thread tap as shown in the photo below.

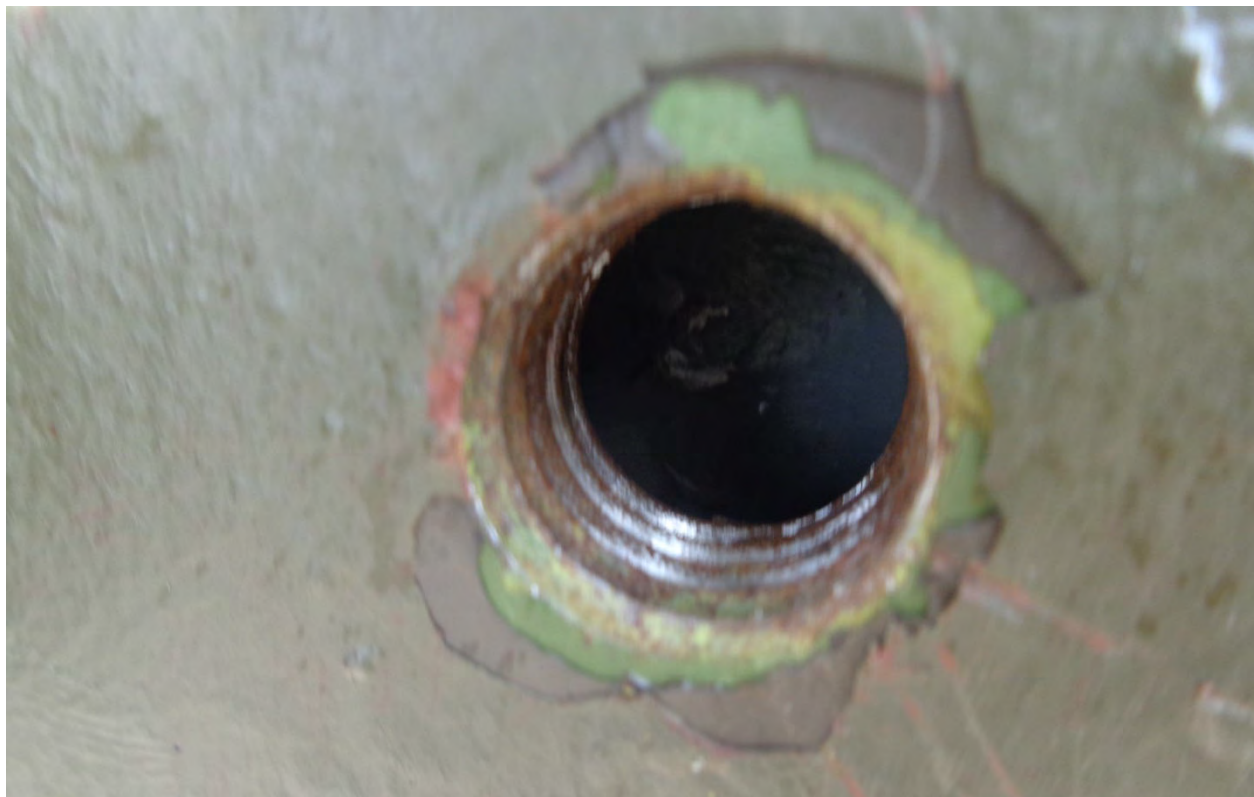
The photo below shows the threaded hole cleaned by the tap and ready for a bolt to hold the counterweight slug in place.

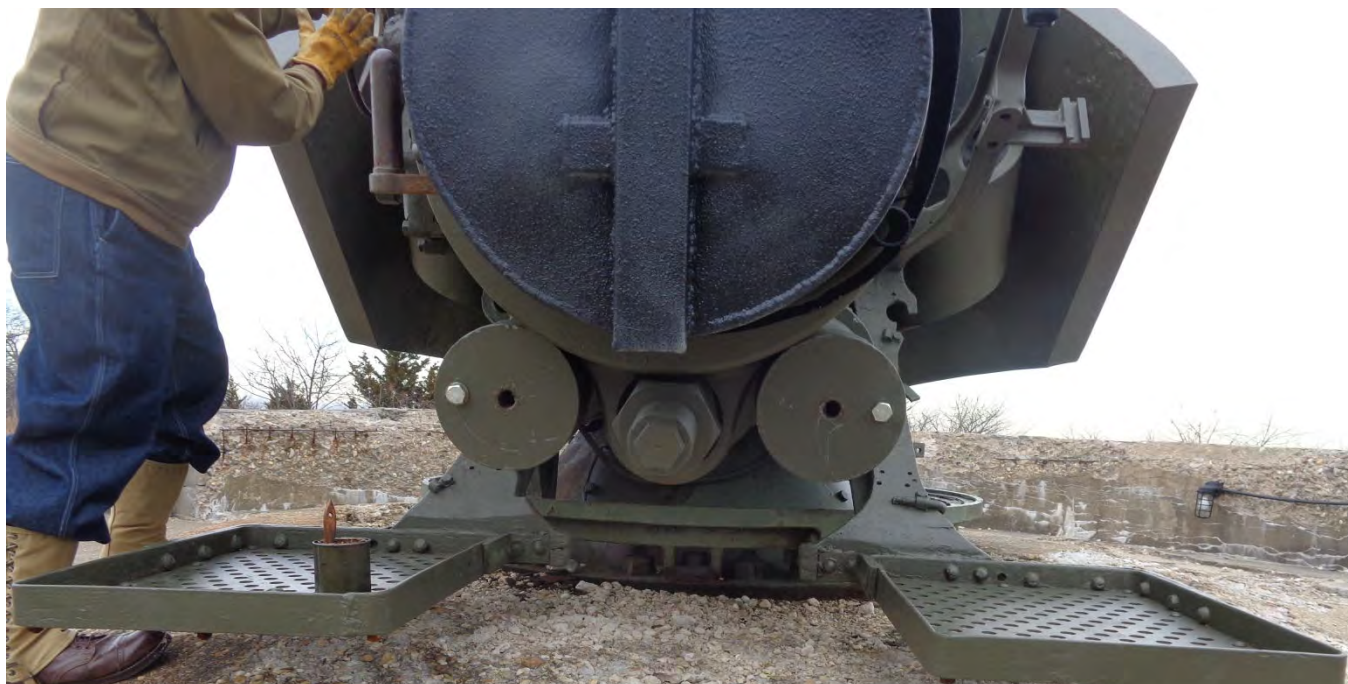
The photo below shows both 9-inch 76-pound counterweight slugs in place for Gun #2. All that remains for both guns are to cast the yokes, install them and the threaded recuperator rods into place.

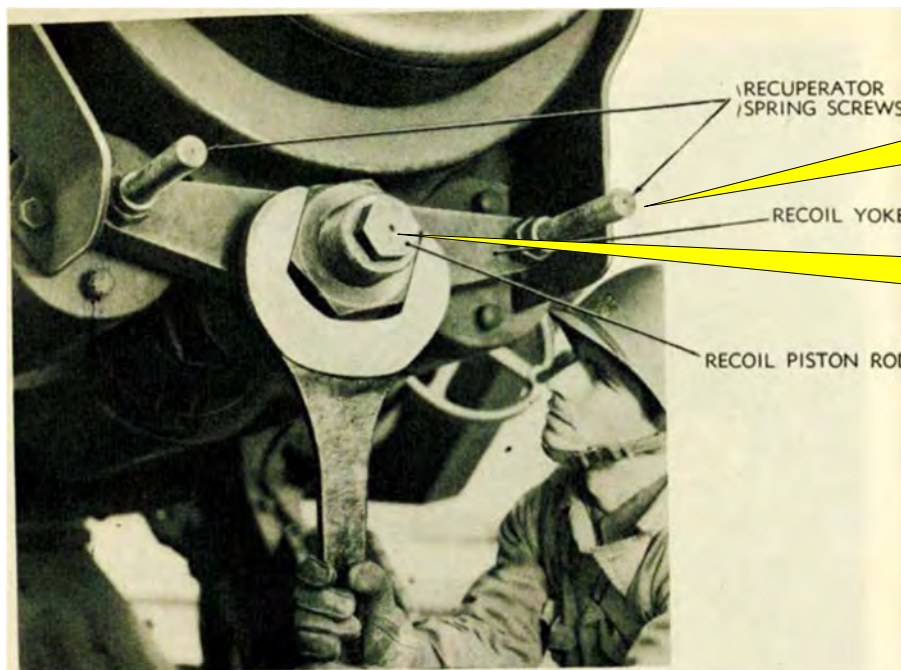
The photo below shows the recoil yoke, recoil piston rod and recuperator spring screws. This photo is from page 52 of TM 9-424 - 6-inch M1900 Seacoast Gun, Mar 1945.

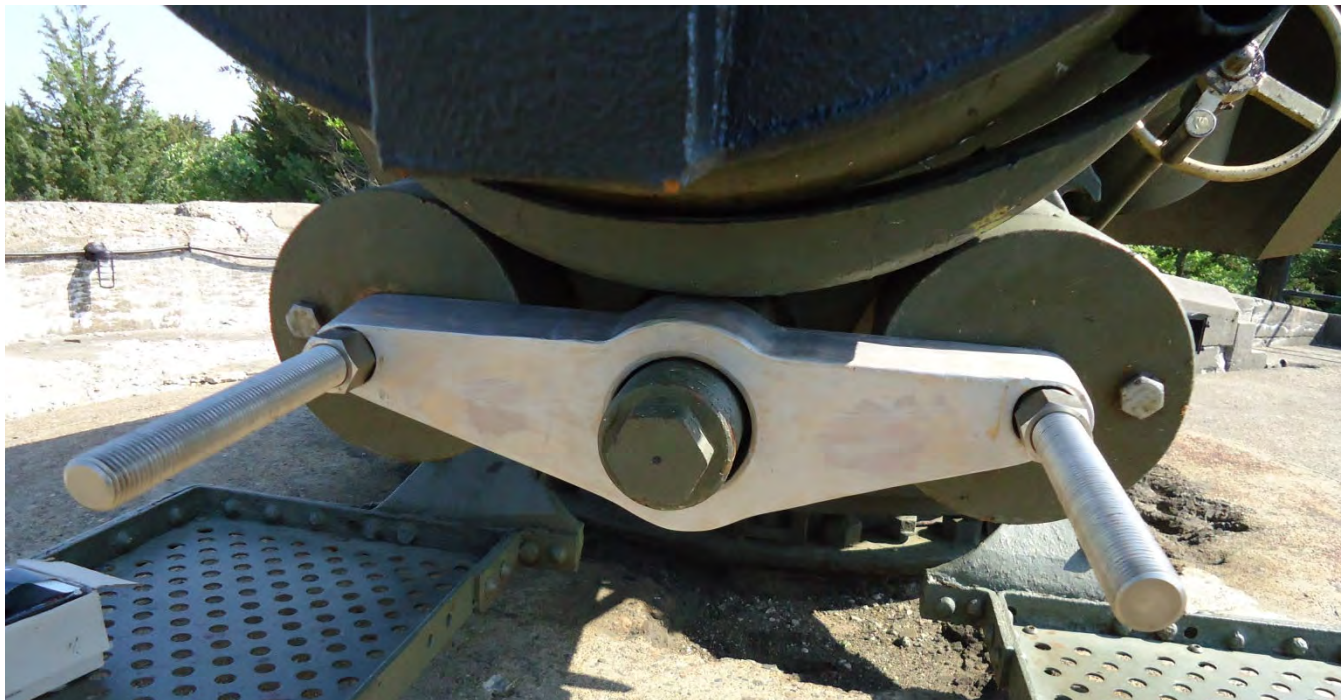
Gun #1 yoke pattern fits as designed. It requires no modification and is ready for casting. The only anomaly is the stainless steel (SS) bolt on the right of the photo is not perpendicular to the steel slug. It is on a diagonal to the left. In order to fit the yoke pattern, the right bolt must be installed after the yoke is placed on the left SS bolt and the center 3-inch diameter counter recoil bolt.

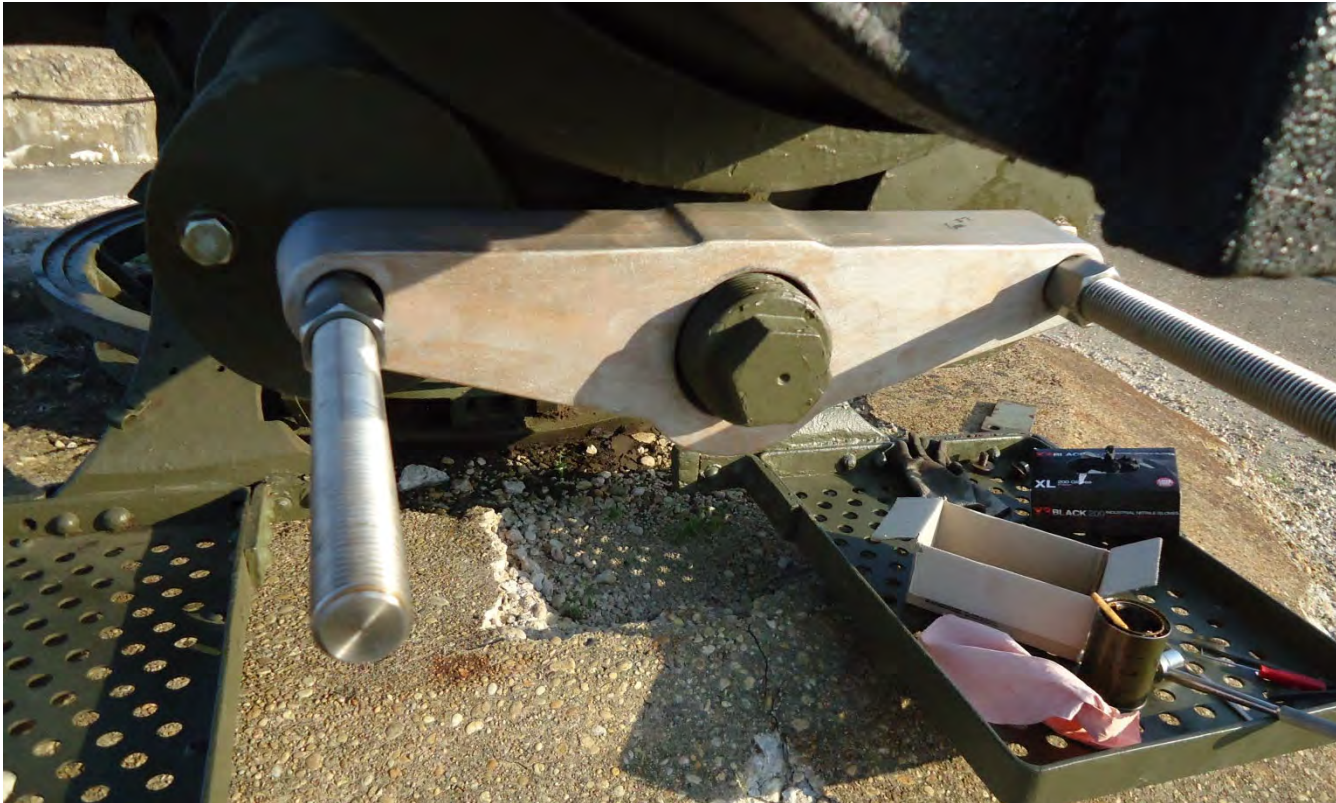
The yoke pattern for Gun #2 does fit but with significant problems. It is shown assembled below.

The Yoke Pattern #2 center hole for the large 3-inch counter recoil bolt is about $\frac{3}{8}$ of an inch below the level it should be in relationship to the two SS bolts. This can be seen in both pictures below. While the yoke can be installed, it requires the bolts to be attached after putting the yoke onto the large counter recoil bolt. The resulting "stress" on the two SS Bolts prevents tightening of the bolts adequately as designed.

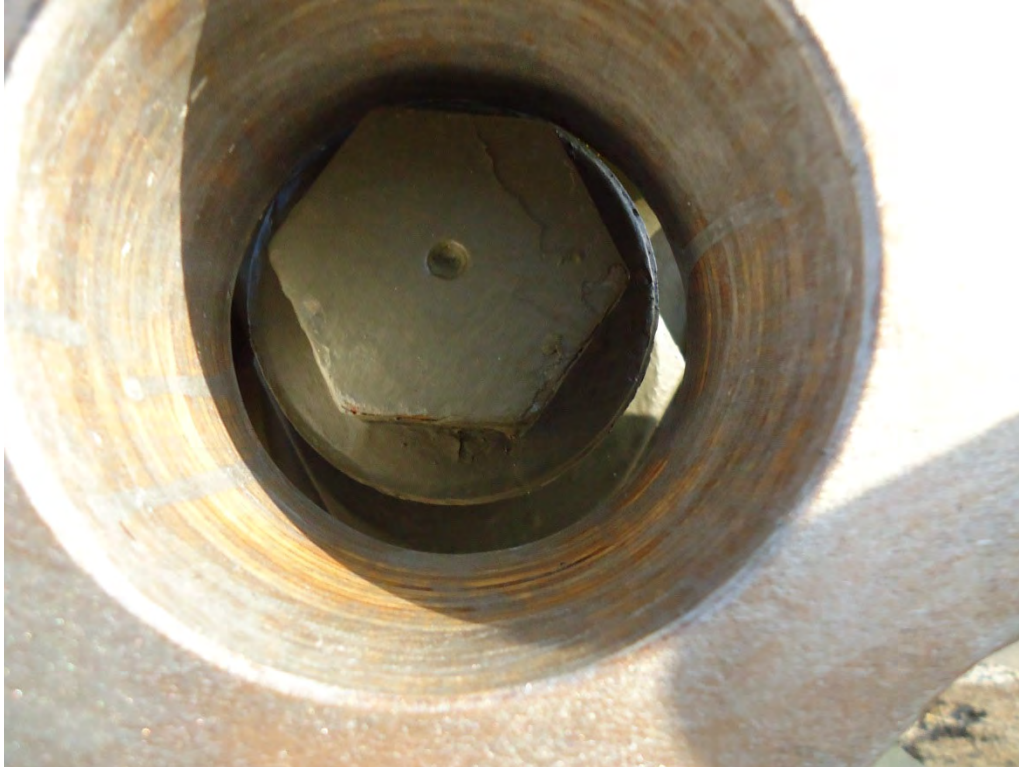
The photo below shows the offset nature of the 3/4-inch counter-recoil bolt to the top of the yoke pattern.

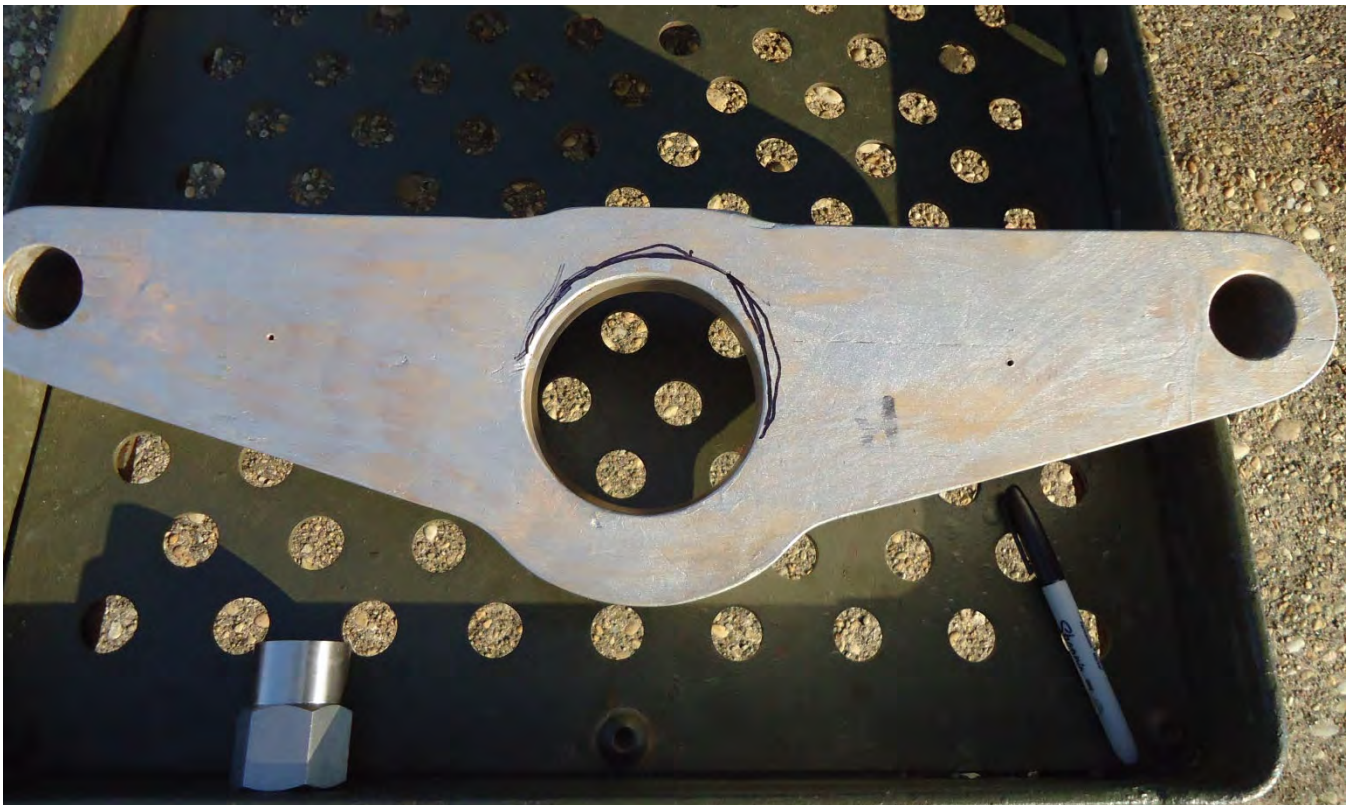
The photo below shows the yoke pattern with rough pen marking of the area of pattern that needs to be removed. The ideal solution would be relocating the hole about 3/8 of an inch up towards the top of the yoke pattern.

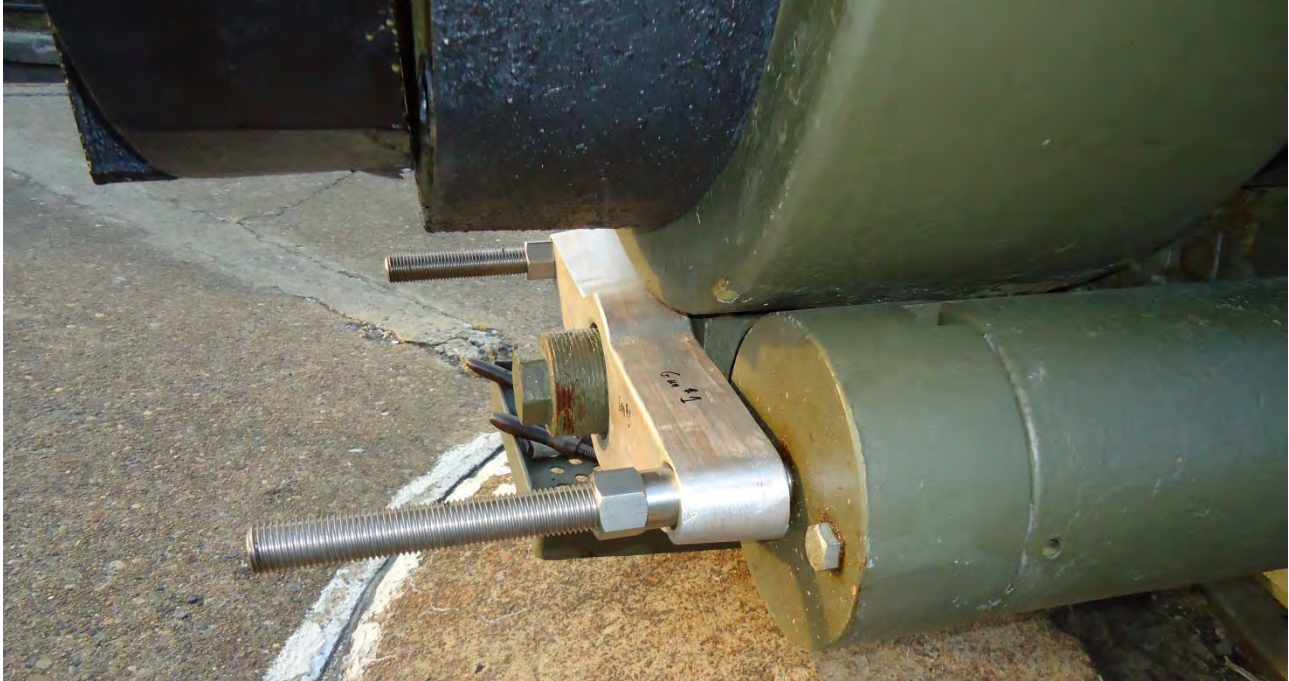
As discussed on Friday 21 May 2021 it appeared that about 5 inches of the SS Bolts needed to be removed to ensure the bolt did not protrude past the face of the breach block housing. During the test installation, it was determined that by slightly loosening the retaining bolt on the threaded steel slug, it was possible to insert the SS Bolt into the hole in the center of the counter-recoil cylinder. The photo of Gun #1 below shows the far SS bolt well inserted into the counter-recoil cylinder. The shortness of the far (left) SS Bolt shows this depth of penetration into the counter-recoil cylinder.

The photo below shows the depth the bolt was inserted into the counterweight and the counter-recoil cylinder. Unfortunately, this is too far in and is pushing the steel slugs inside the cylinder and stressing the retaining nut on the counter-recoil steel slug. The best option appears to be inserting the SS Bolt no deeper than the end of the counterweight slug. This requires at least five inches of the SS Bolt to be removed and refaced.

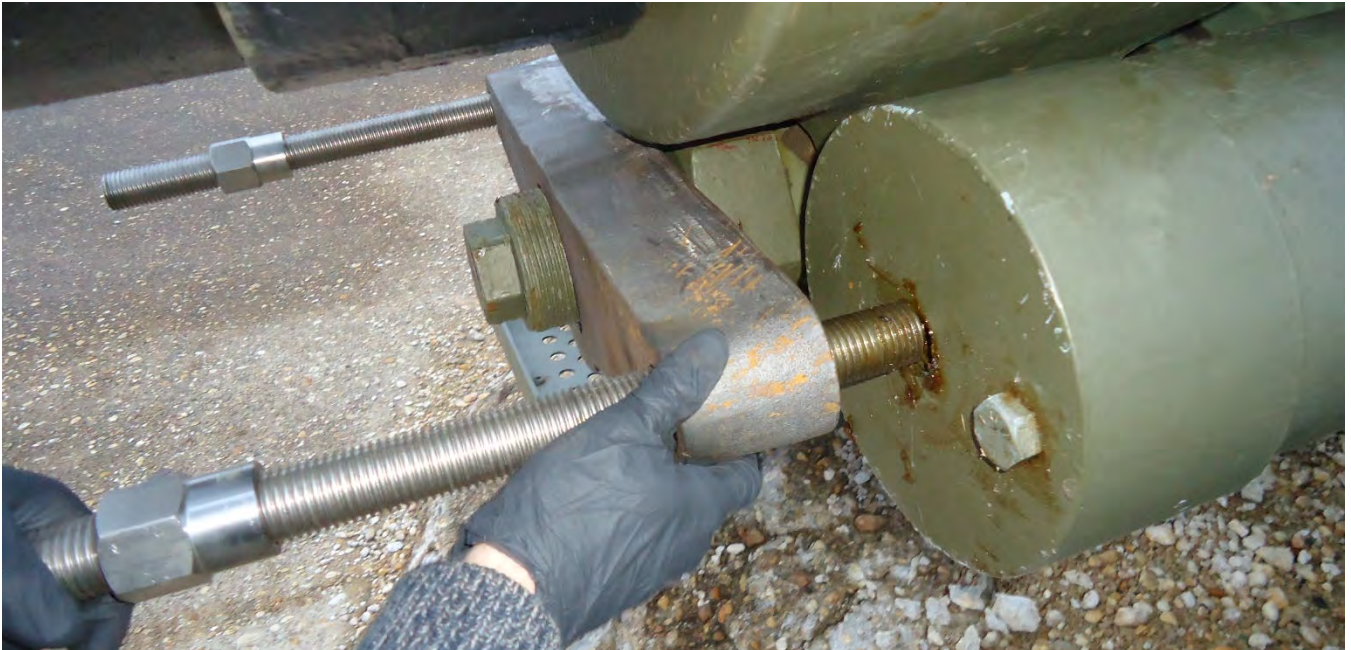
The cast-iron yoke for Gun #2 requires adjustment by removal of metal to ensure the SS bolt will fit without undue stress.

The photo above shows the misalignment of about 1/8 of an inch towards the left of the threaded hole in the external counterweight slug. This will require part of the yoke to be trimmed using an "end-mill" bit in the drill press. The yokes shrink in size during cooling after casting and do not fully match the size of the patterns. This was expected so the foundry compensated for that shrinkage. However, we knew there would still be a requirement for machining.

On 14 and 28 January 2022, trimming of the inside of the threaded rod holes on the yokes. The large drill press with an end-mill bit was used to shave the metal away from the side of the hole.

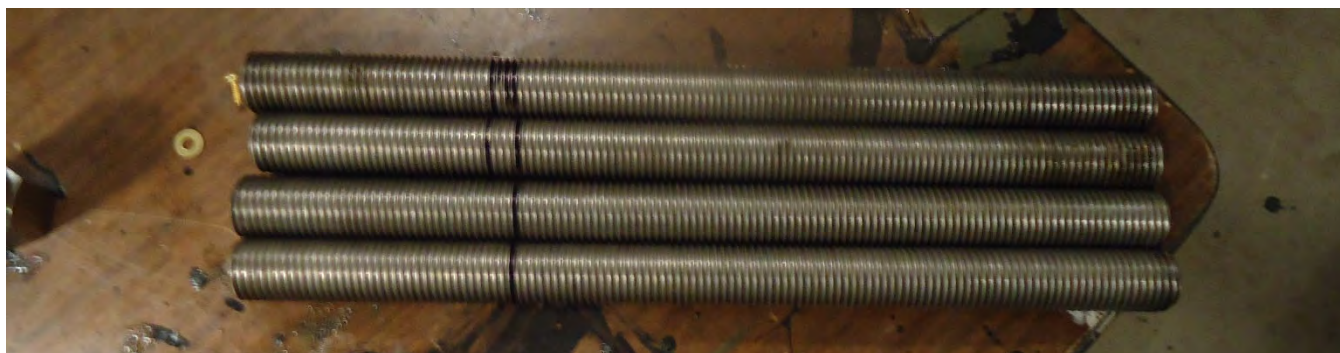
In late December 2021 we cut the threaded rods to the proper length. The black lines show the cut locations.

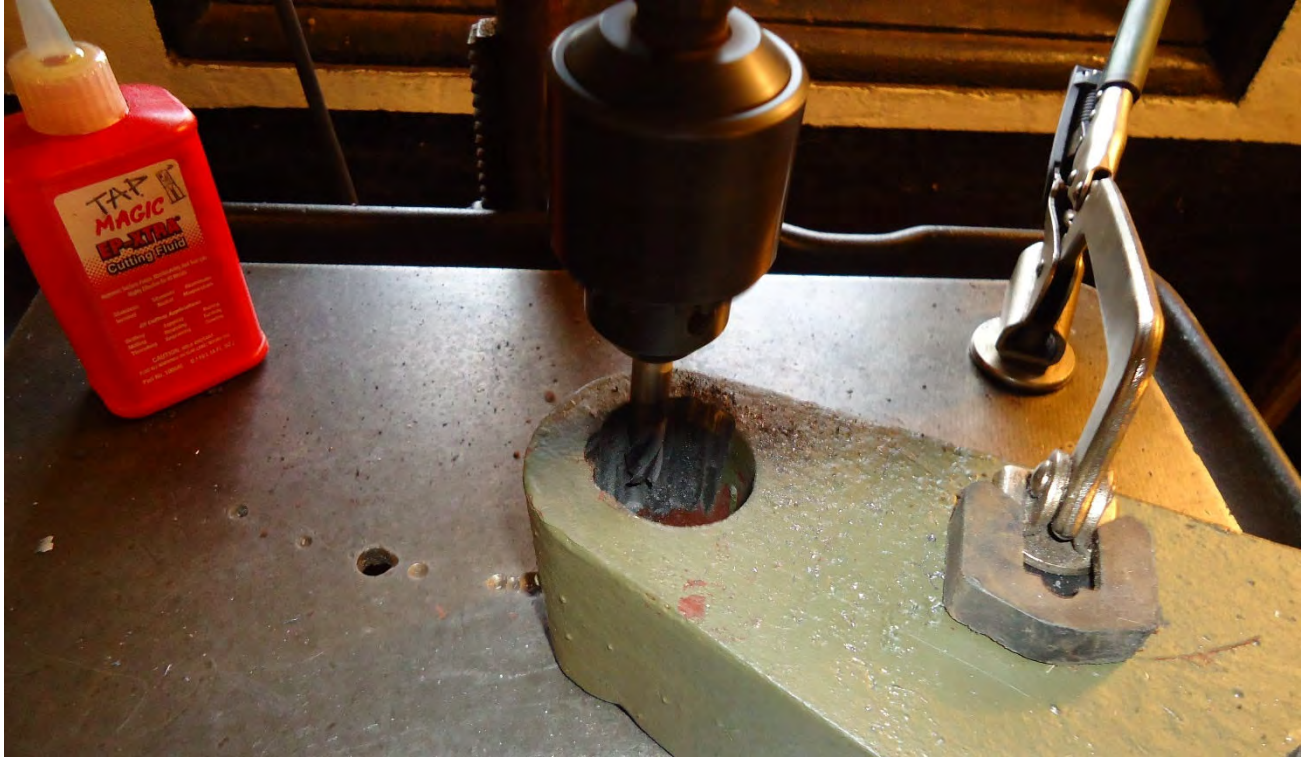
The photo below shows a more detailed view of the end mill bit and drill press being used to "shave" the steel out of the threaded rod hole.

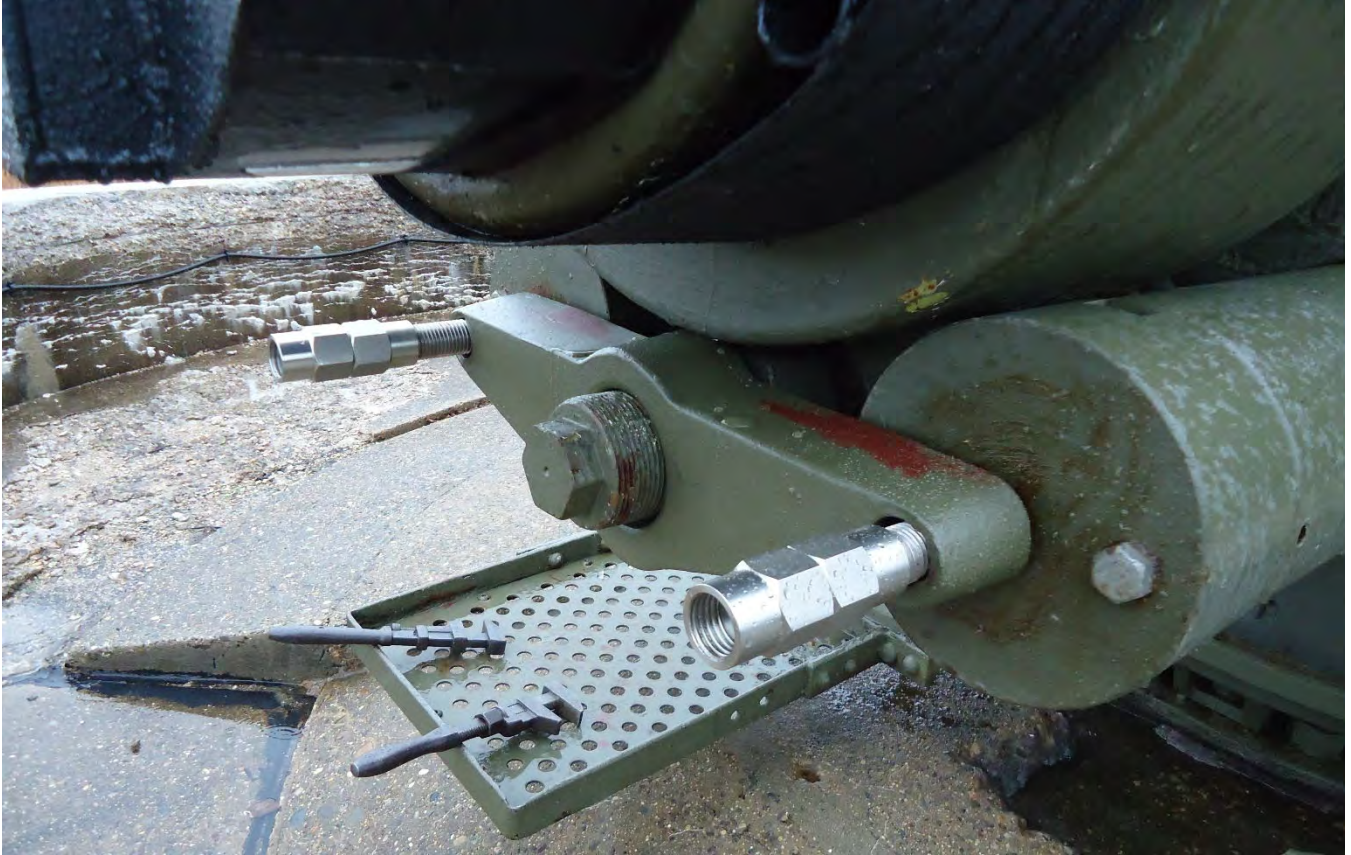
A significant issue was discovered as we mounted the external counterweights - Gun #1's cylinders are made of brass or bronze. These threads are weaker than steel threads and are susceptible to being stripped if subjected to excessive stress. Gun #2's cylinders are made of steel and the threads for the 5/8-inch bolts are much less susceptible to stripping under a load. This requires firm locking of the yoke to push the external counterweights firmly against the recuperator cylinders. The answer is a large 3-3/4-inch fine thread nut to lock the yoke onto place.

On 20 February 2022 we tested a 3-3/4-inch fine thread nut. The nut cost AGFA \$207 including shipping and weighed 19 pounds. The nut is large enough to be cut in half to make two nuts - one for each gun.

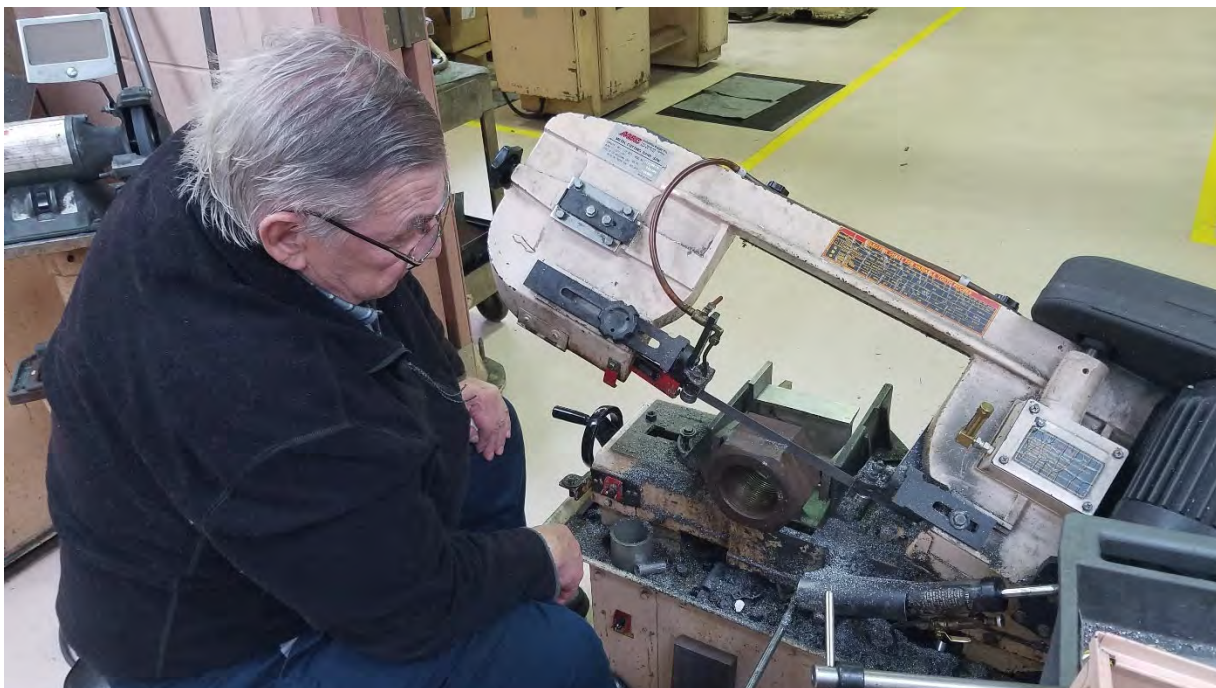
On 22 February 2022 Jim Wolf cut the nut. Jim is the Production Manager and expert machinist/toolmaker for Motion Systems Corp., Eatontown, NJ. Motion is the primary US producer of custom ball screw actuators. Jim has long experience with custom manufacturing for US Arsenals and defense contractors. Jim has been a huge help with major machining tasks. Below he uses a professional bandsaw to cut the nut. This took 20 minutes! He then faced the back half of the nut to look like the top of the original nut.

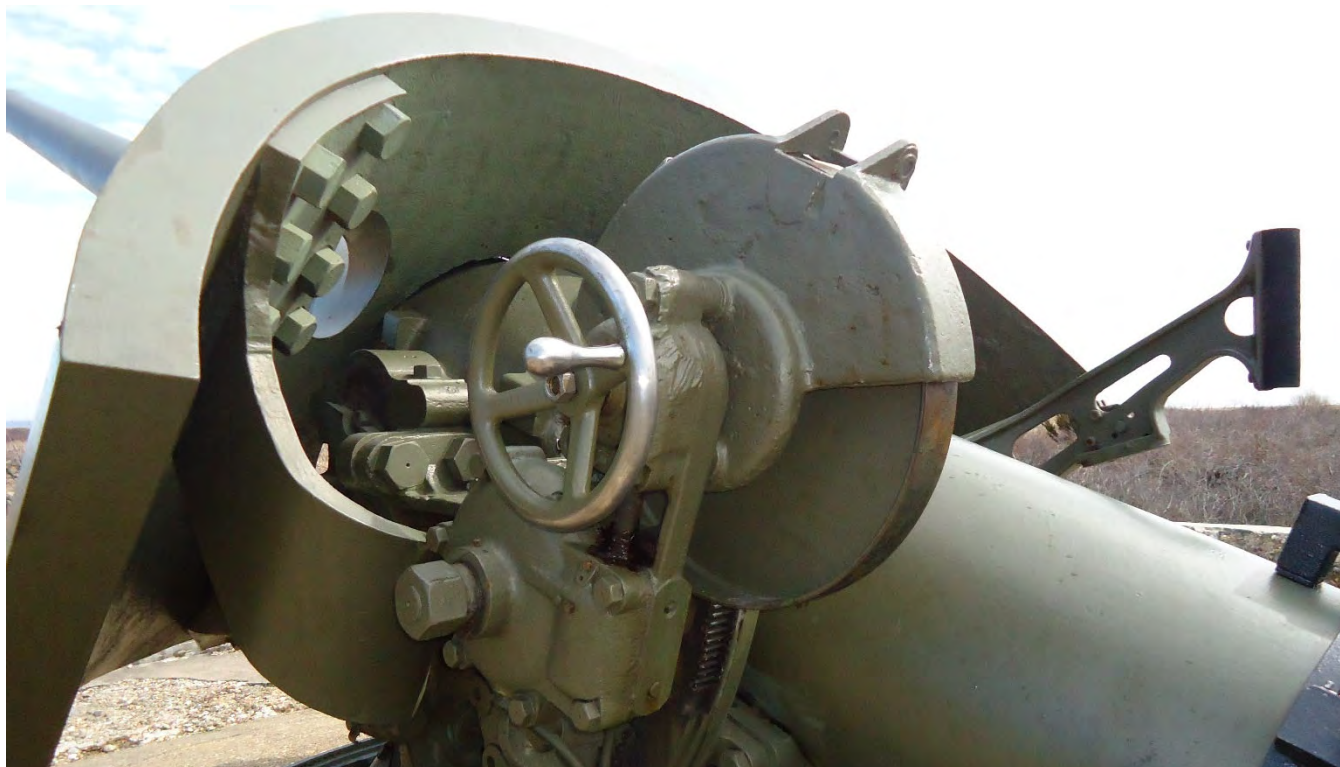
On 26 March 2022 we began final installation of the counterweight yokes on both guns. The photo below shows a new handwheel that looks very similar to the original handwheels supplied with the guns. Jim Wolf expertly fitted this handwheel to enable attachment to the existing shaft. This new handwheel has greatly improved elevation.

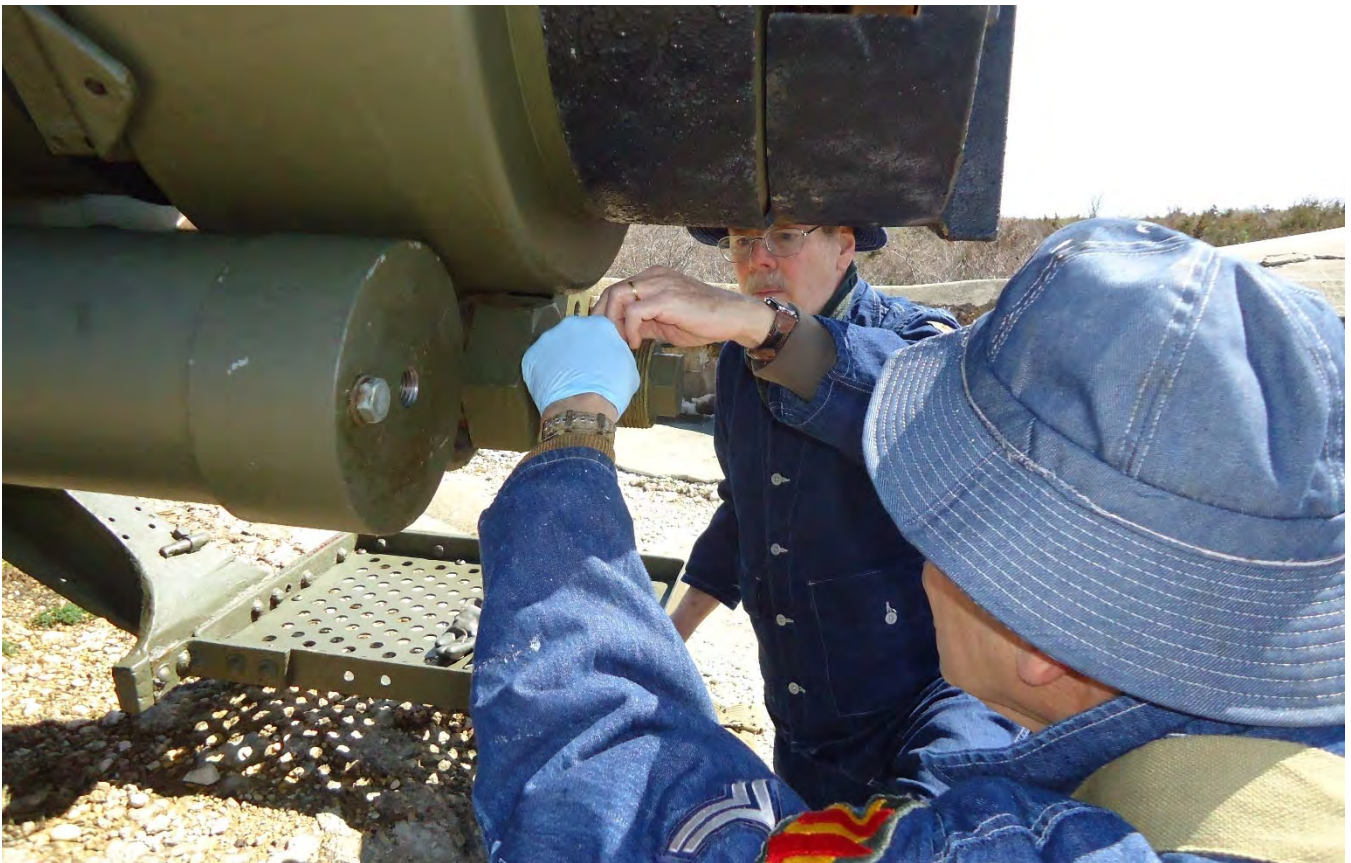
The 3-3/4-inch threaded counter-recoil shaft required significant cleaning to accept the new bolt. Below CPL Cusano and PVT Hill clean out the threads.

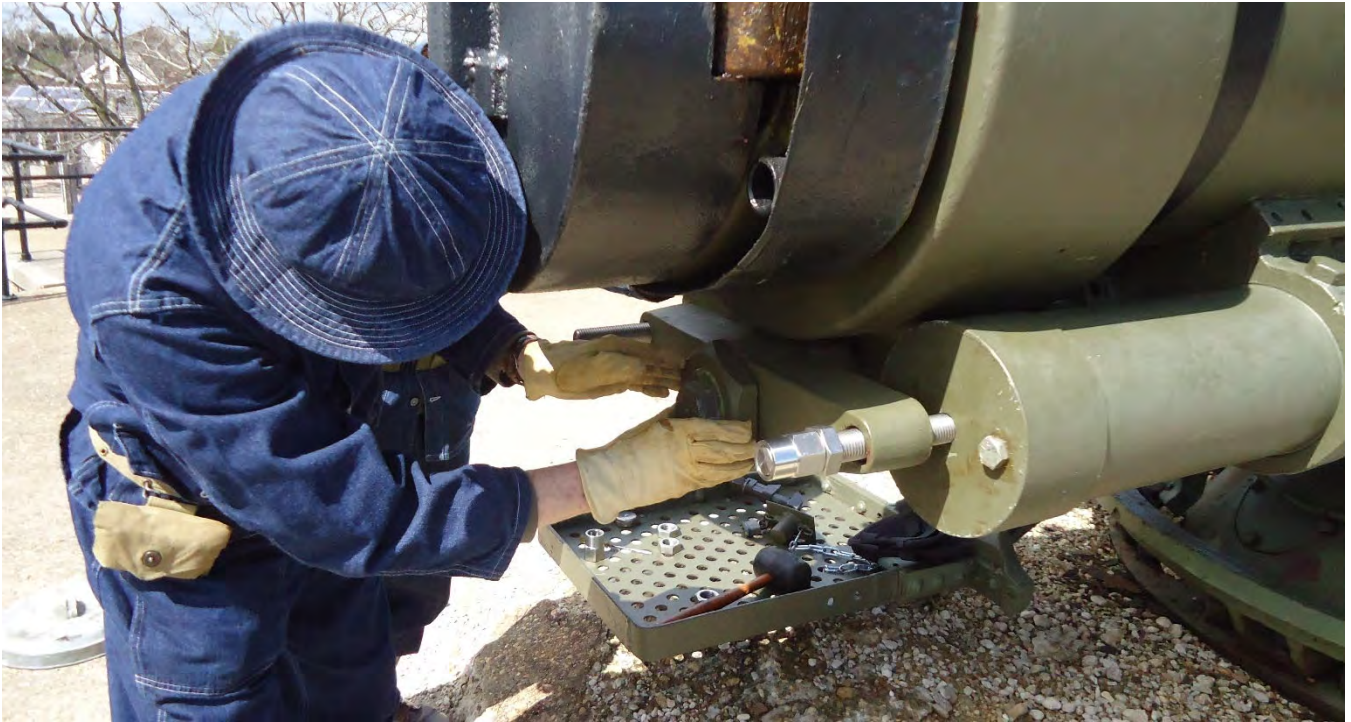
In the photo below PVT Hill test fits the large nut.

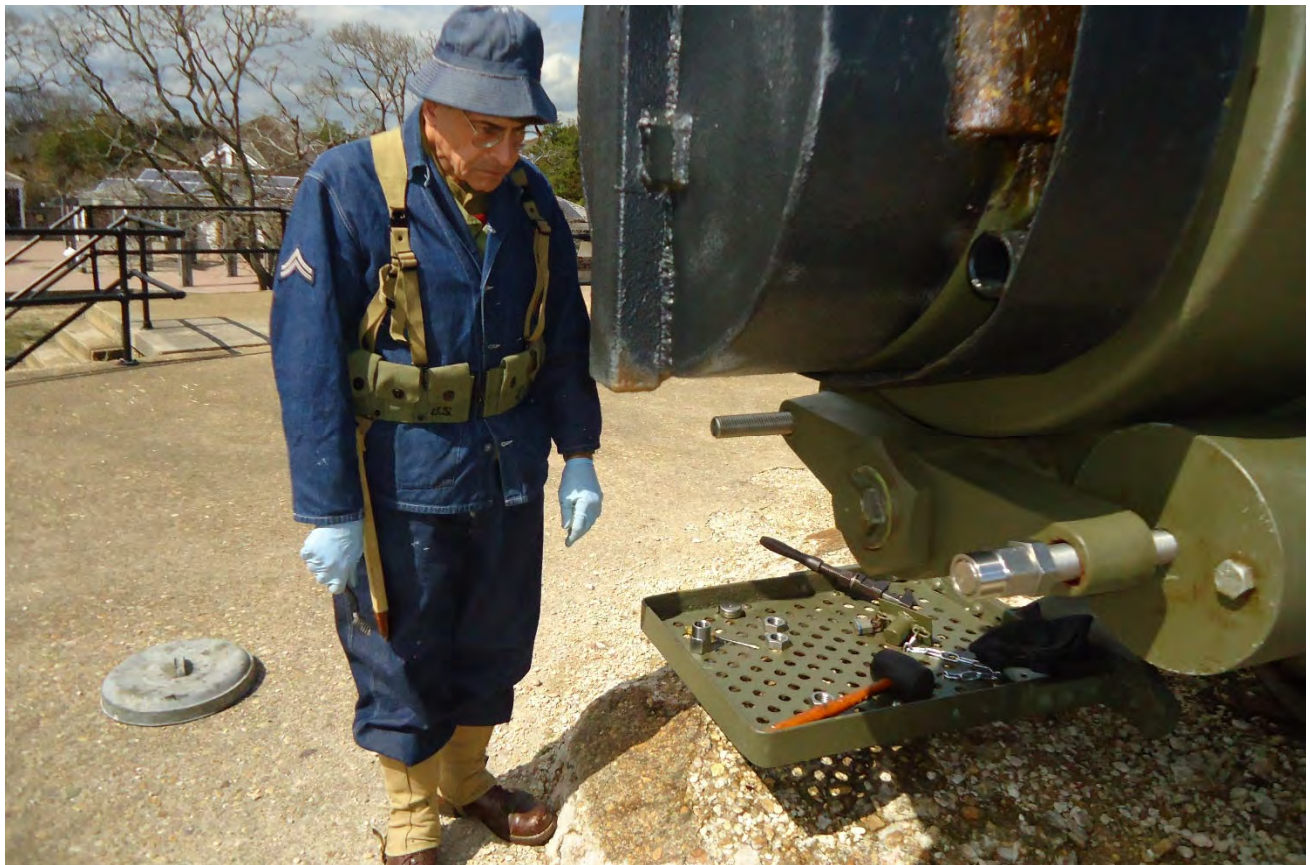
Below, CPL Cusano prepares to test fit the two stainless steel nuts on the stainless steel threaded rods. The large nut is already in place.

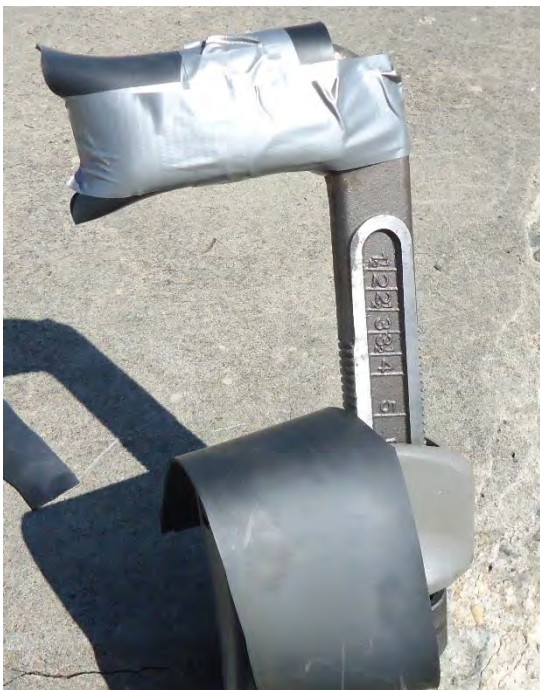
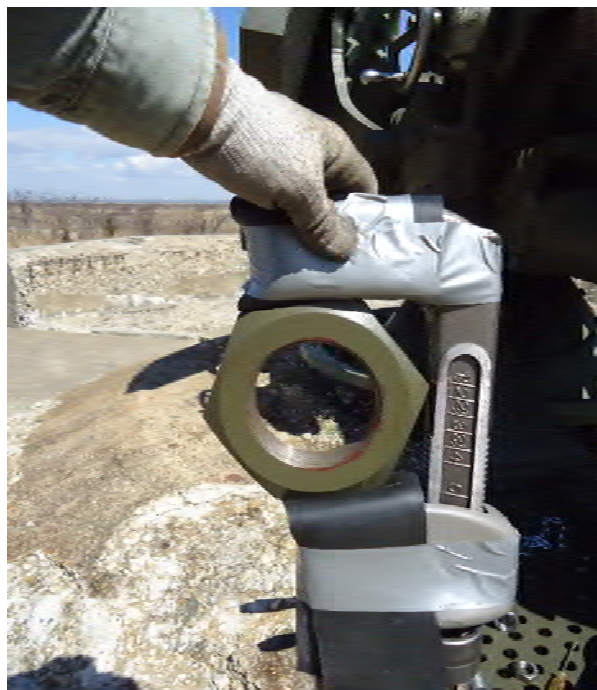
Once the yoke and stainless steel rods were in place, it became time to tighten the large nut. Lacking a 6-inch jaw wrench, we used a pipe wrench with thick rubber gasket material to protect the nut from the jaws of the wrench.

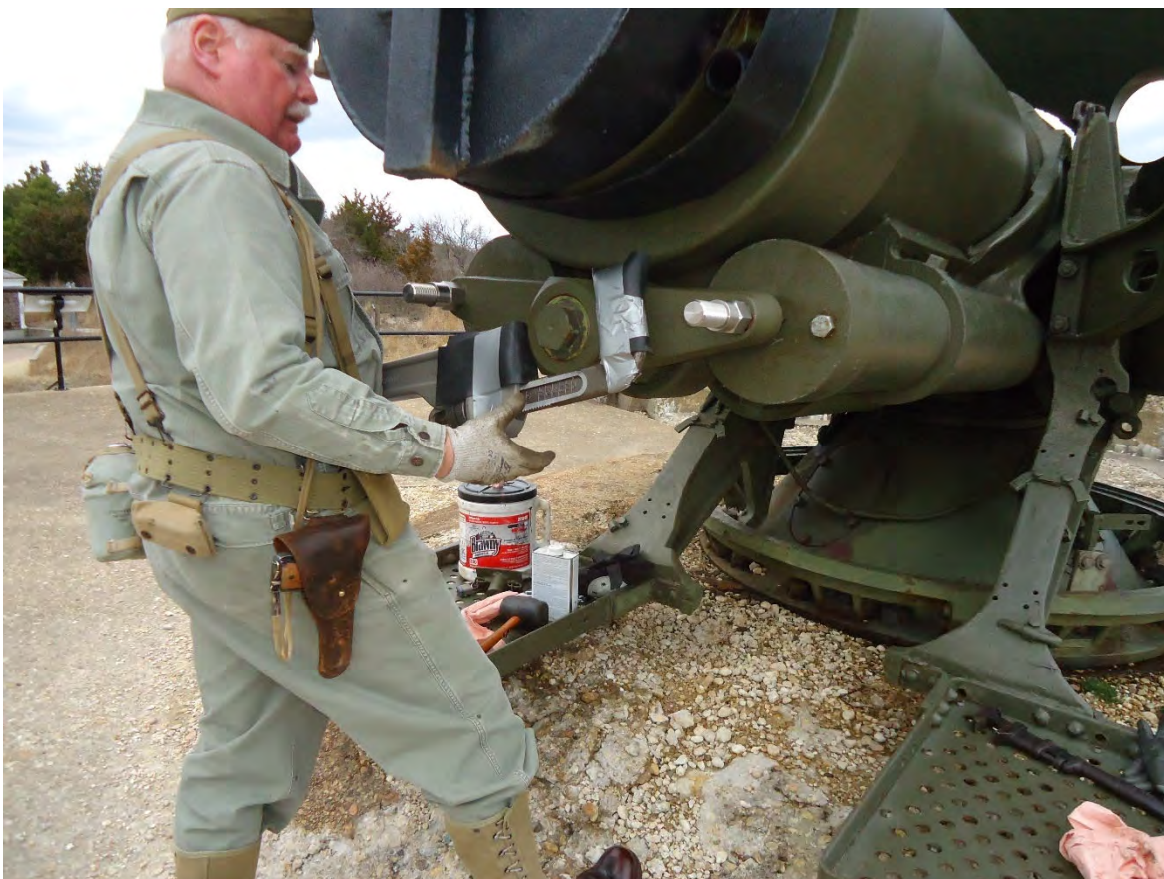
Below LTC Welch uses the wrench to tighten the large nut and lock the yoke and external counterweights against the back face of the recuperator cylinders. The wrench worked as intended and did not scar the nuts.
