6-inch M1900 Seacoast Gun Elevation Counterweight Project
Design, Fabrication and Installation
Ft. Hancock, New Jersey
(October 2019 to April 2022)

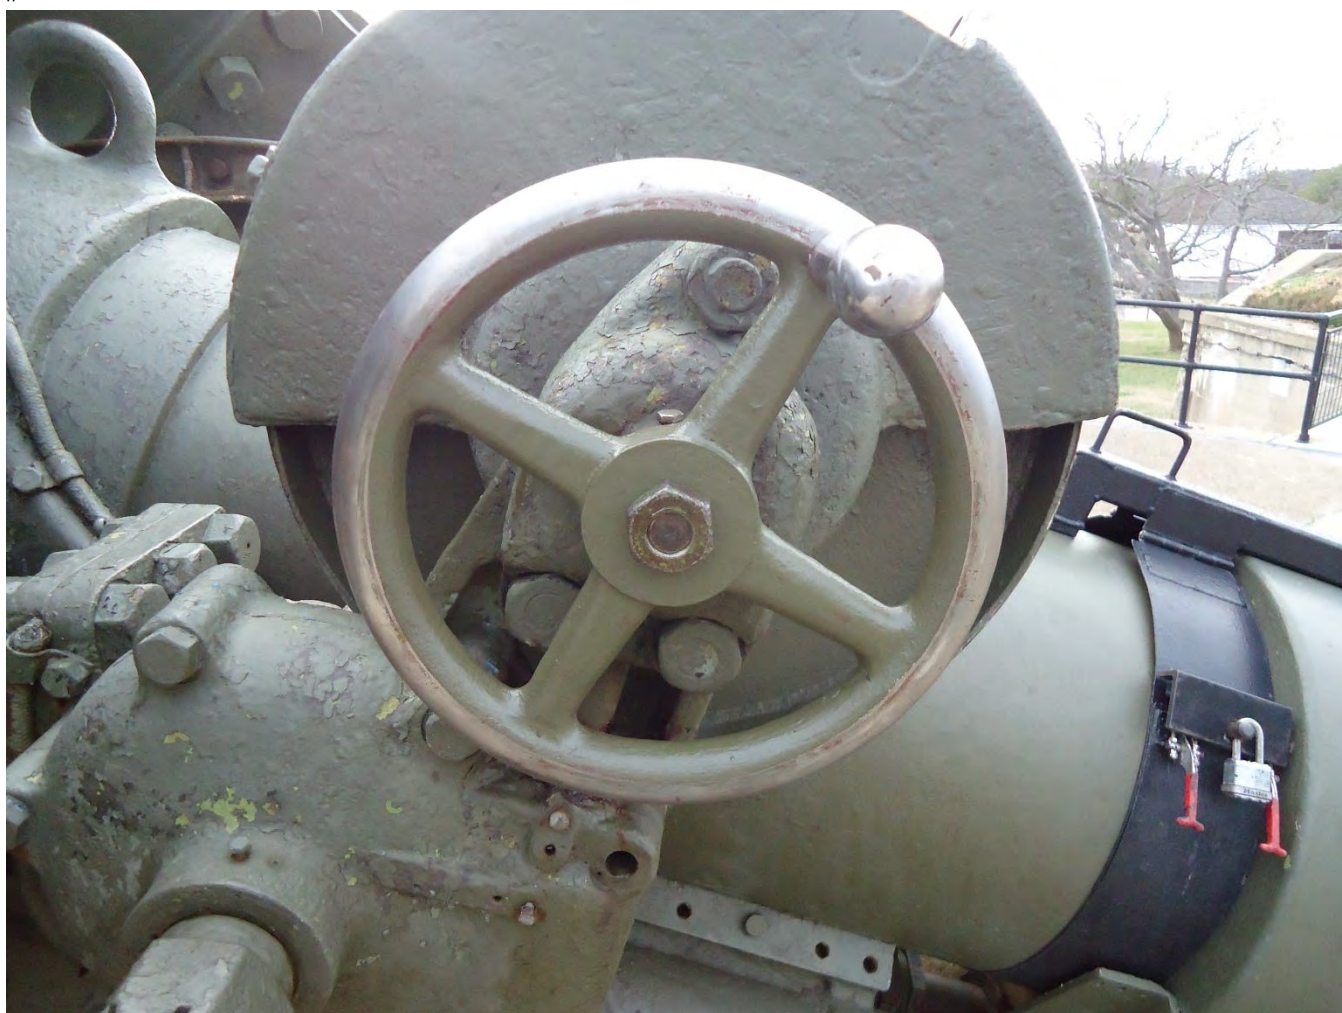
Similar to Gun #2, Gun #1 also received a new cast iron handwheel for elevation. The two handwheels are slightly different. Gun #1's wheel is "flat" where as Gun #2's wheel is concave.

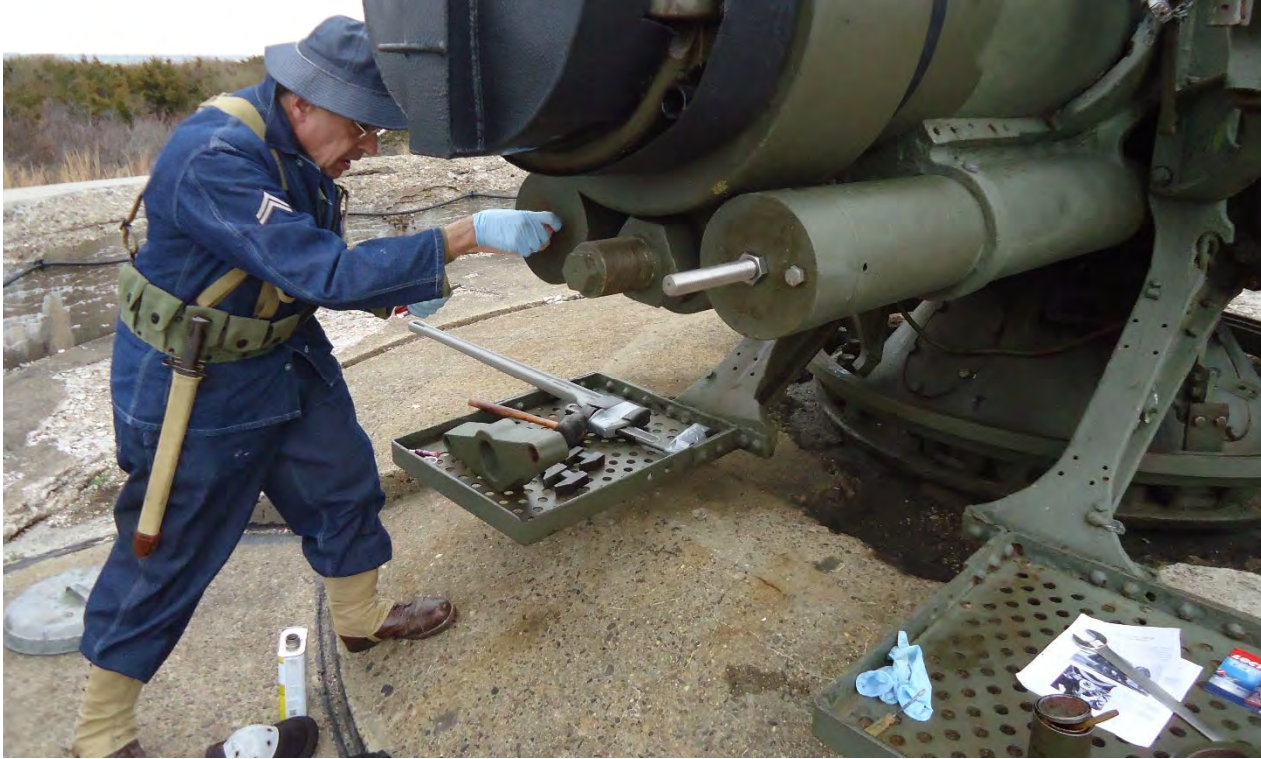
Below CPL Cusano begins the process of cleaning out the threads in the external counterweight slugs for the Stainless-Steel threaded rods.

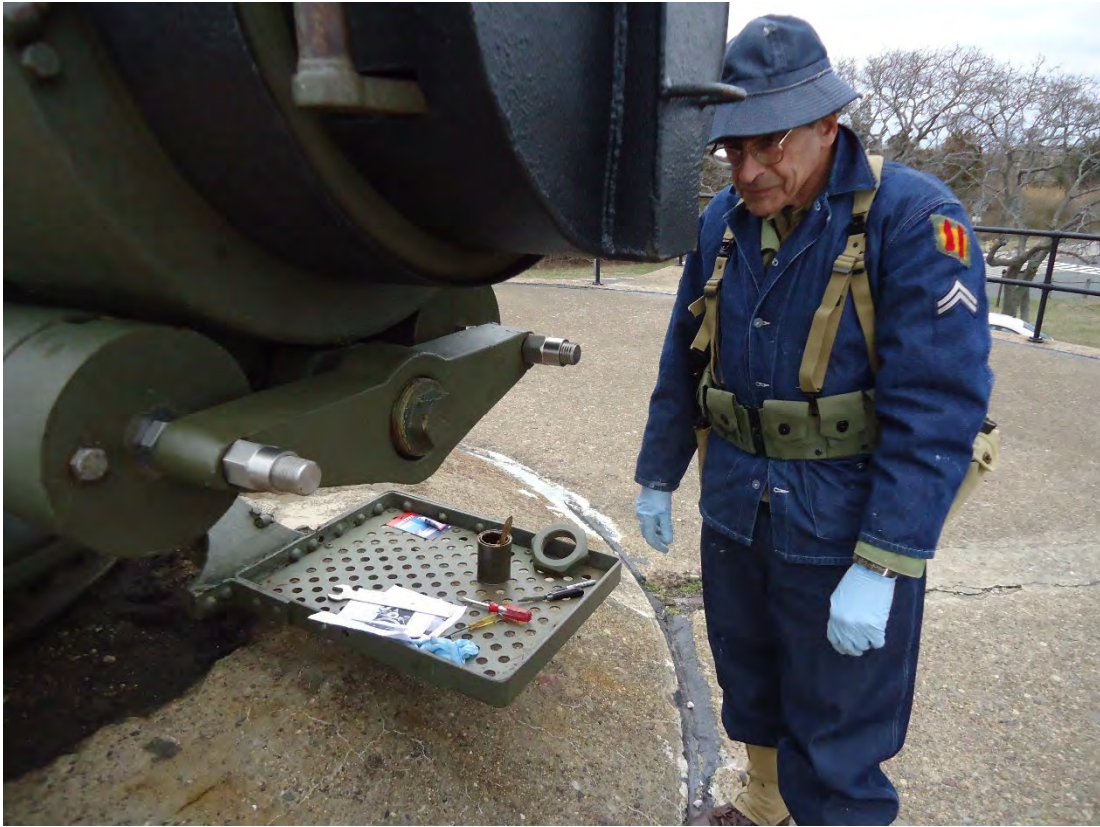
Below CPL Cusano surveys the test installation for Gun #1 with all stainless-steel bolts and nuts locked and aligned.

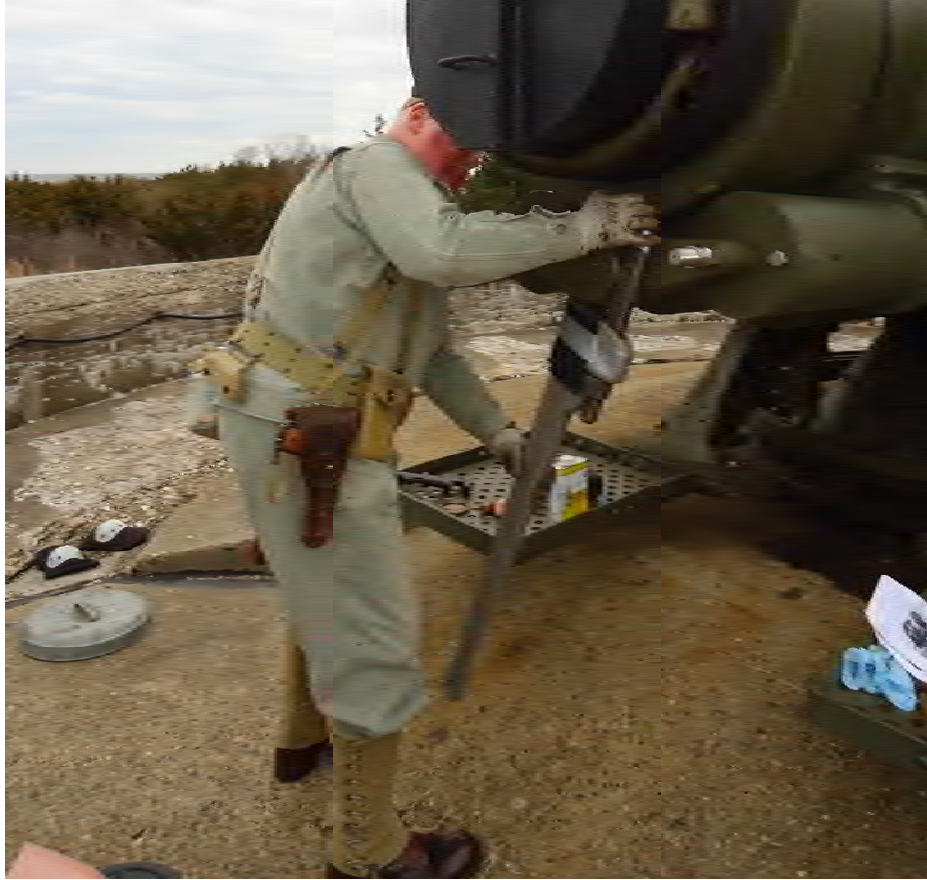
Once all the rods and nuts were confirmed in their locations, the large center 3-3/4 inch nut was secured using the pipe wrench. Below LTC Welch seats the nut.

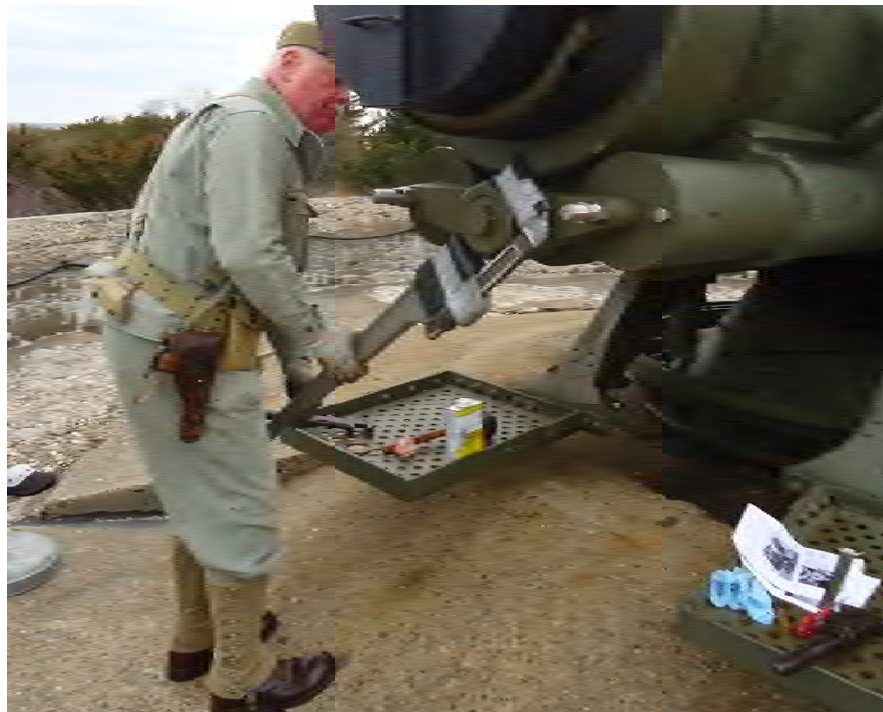
Below LTC Welch applies the final tightening of the large nut, locking the yoke and the two external counterweight slugs to the back face of the recuperator cylinders.

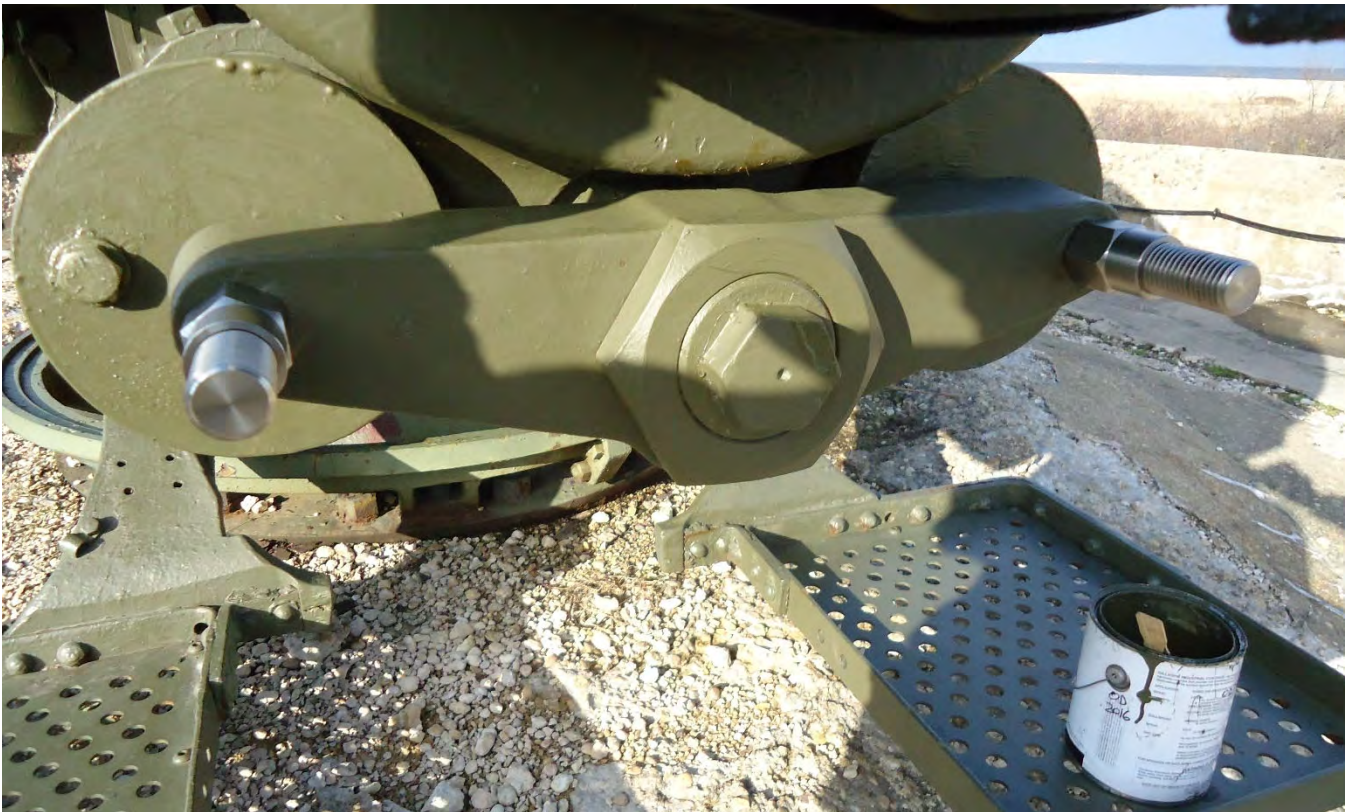
The photo below shows Gun #2 system in place and painted.

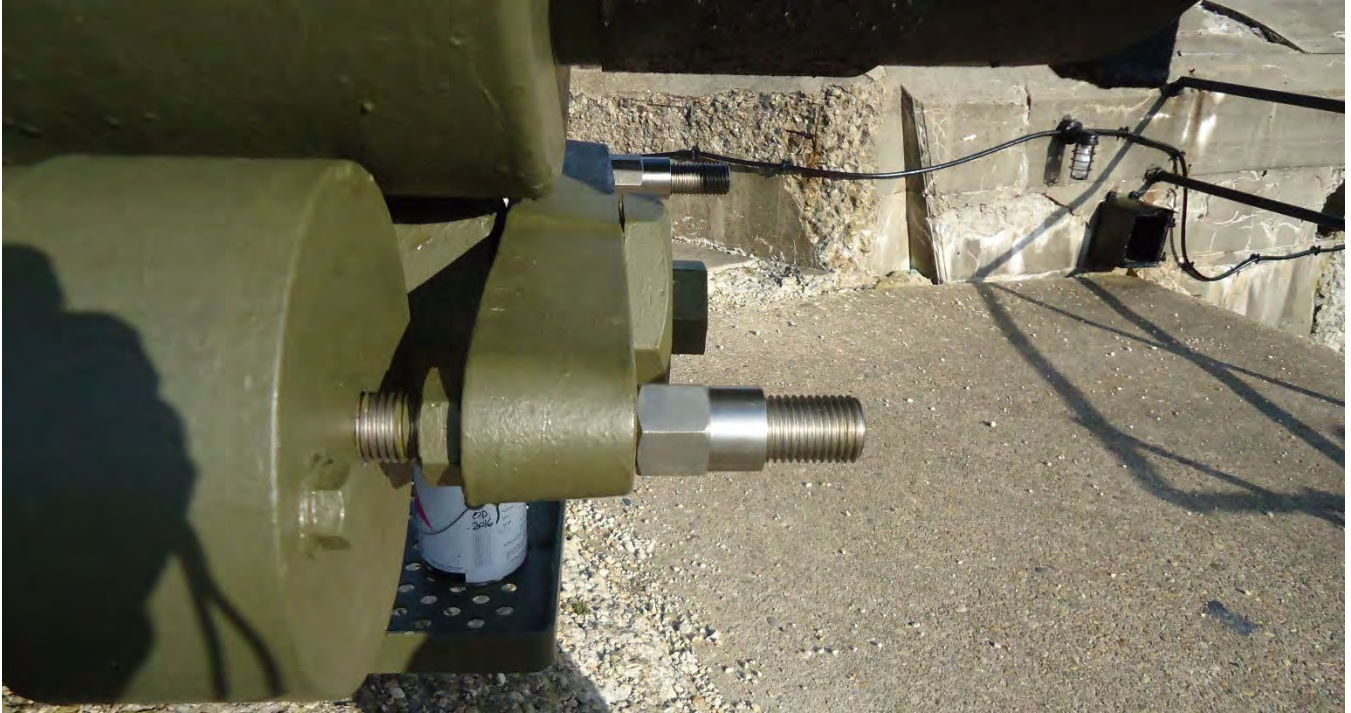
The photo of Gun #2 below shows the approximate 1-inch clearance between the face of the counterweight and the small half inch thick stainless-steel nut. This small nut allows the yoke to seat and push the external counterweight against the recuperator cylinder.

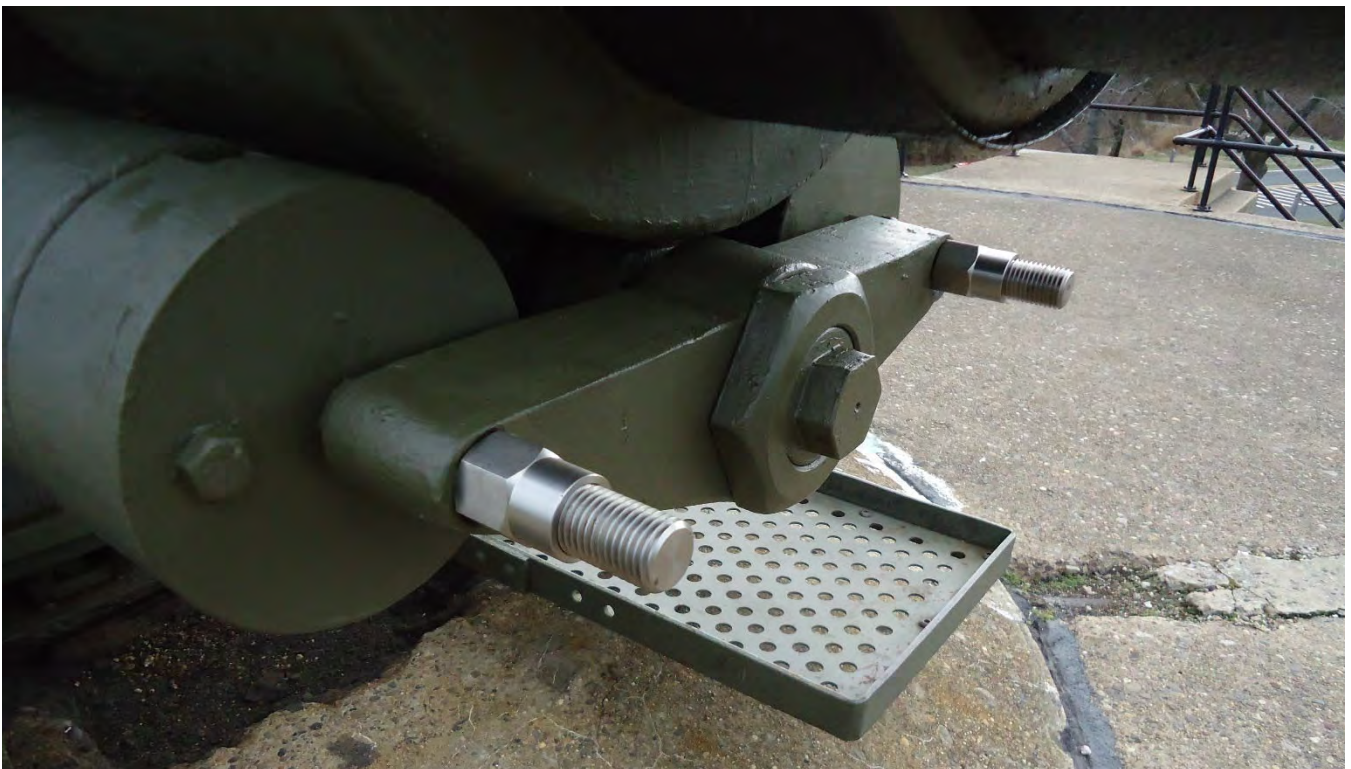
The photo below shows Gun #1 and the lack of a full inch space on the threaded rod. In this case the half-inch thick nut locks the stainless-steel threaded rod into the counterweight slug. The yoke then pushes against the half-inch nut, securing the counterweight to the back face of the recuperator cylinder.

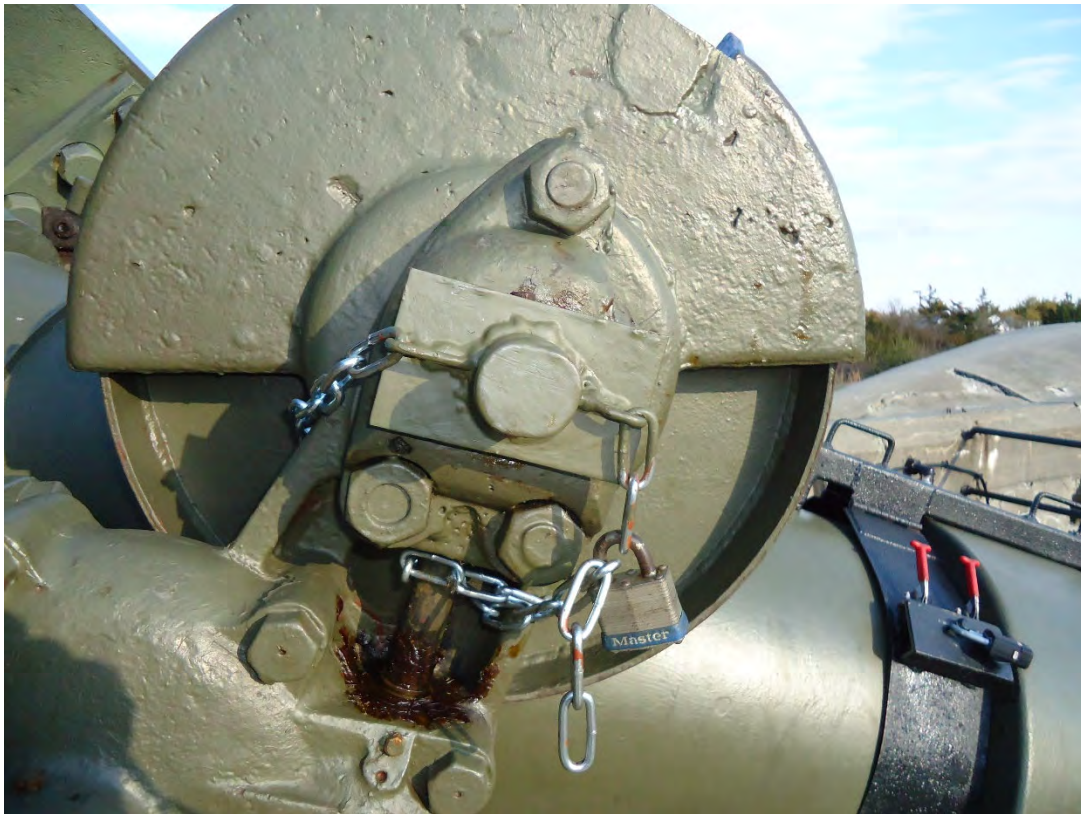
The next change is a locking mechanism for the elevation square where the handwheel connects. This ensures the gun cannot be elevated or depressed when otherwise not attended.

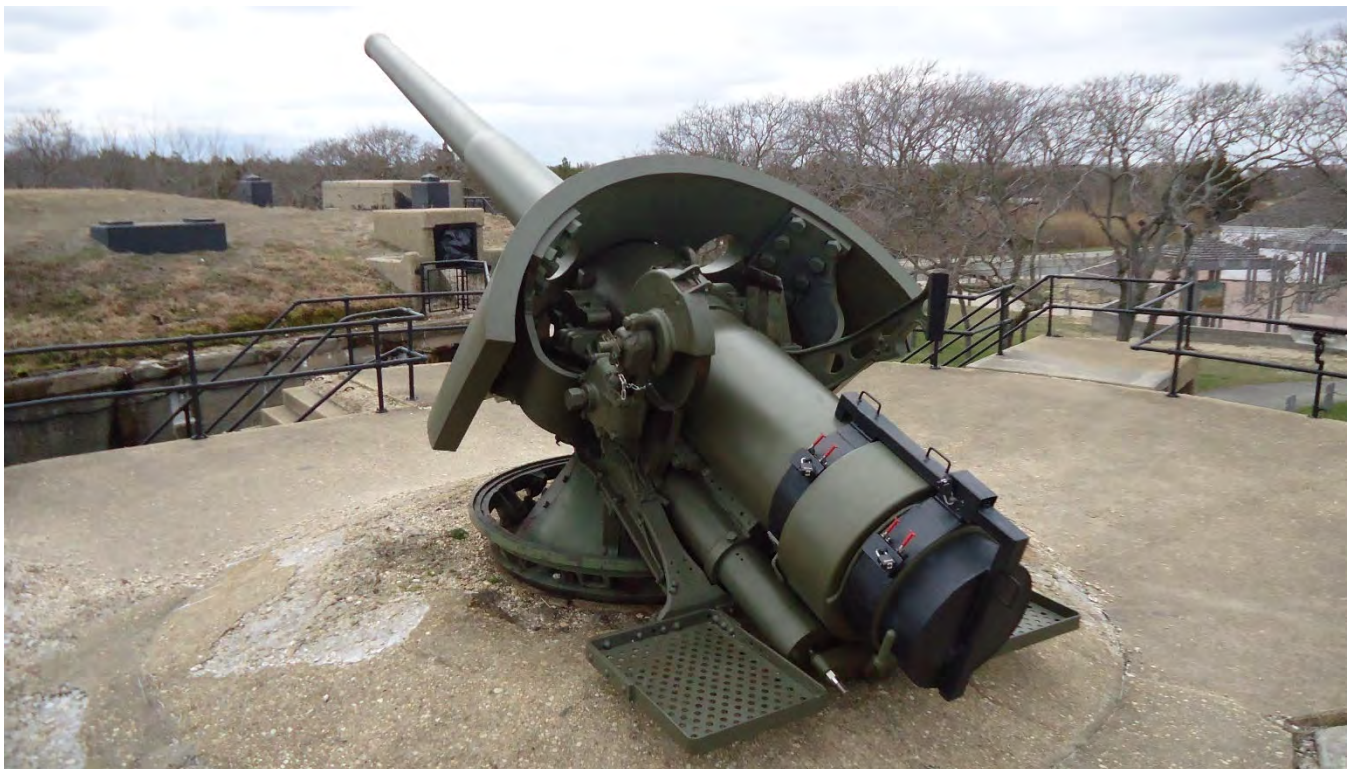
The photo below shows Gun #2 with elevation lock and yoke in place.

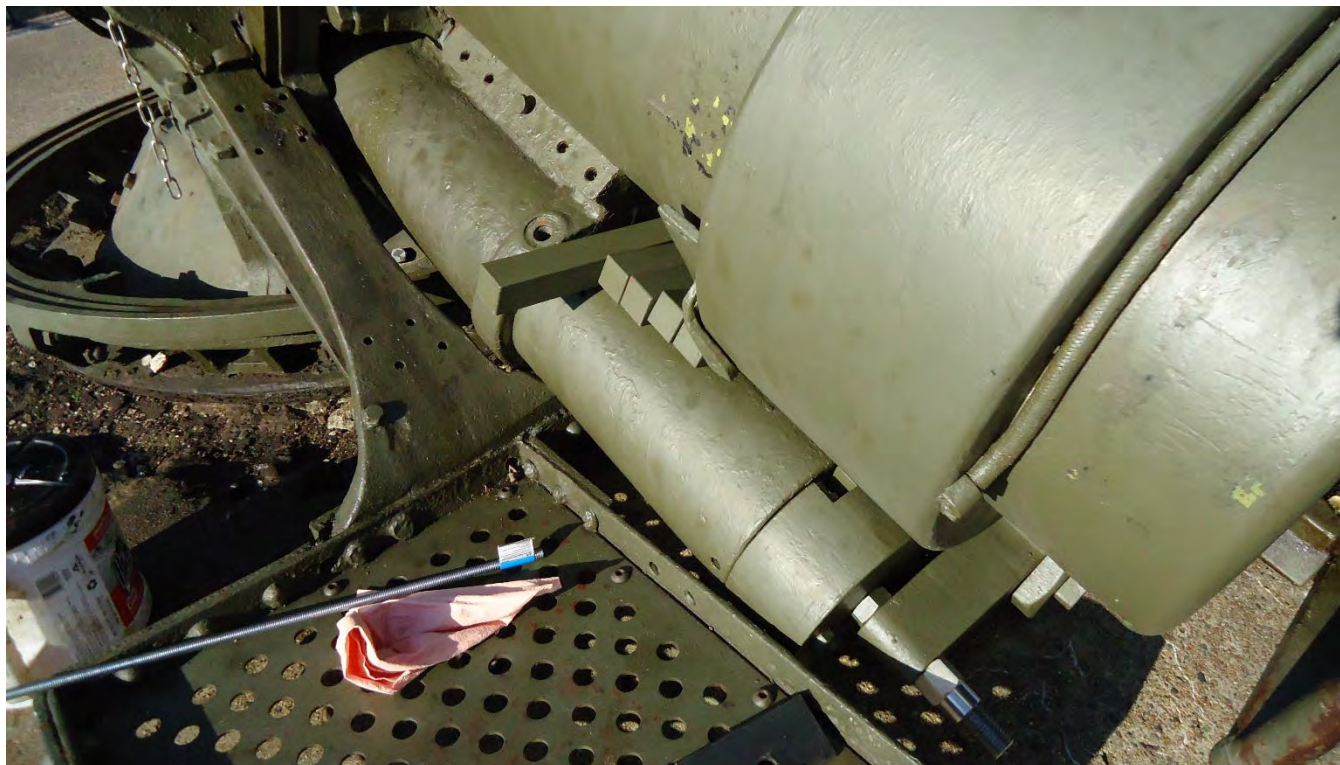
An initial test on 15 April 2022 demonstrated a very close balancing of Gun #1 with the breach cover removed. While four of the bars fit well on the left side (elevation setter's station), one extended from the placement area. That bar can be cut in half and the other half placed on the other side of the gun.

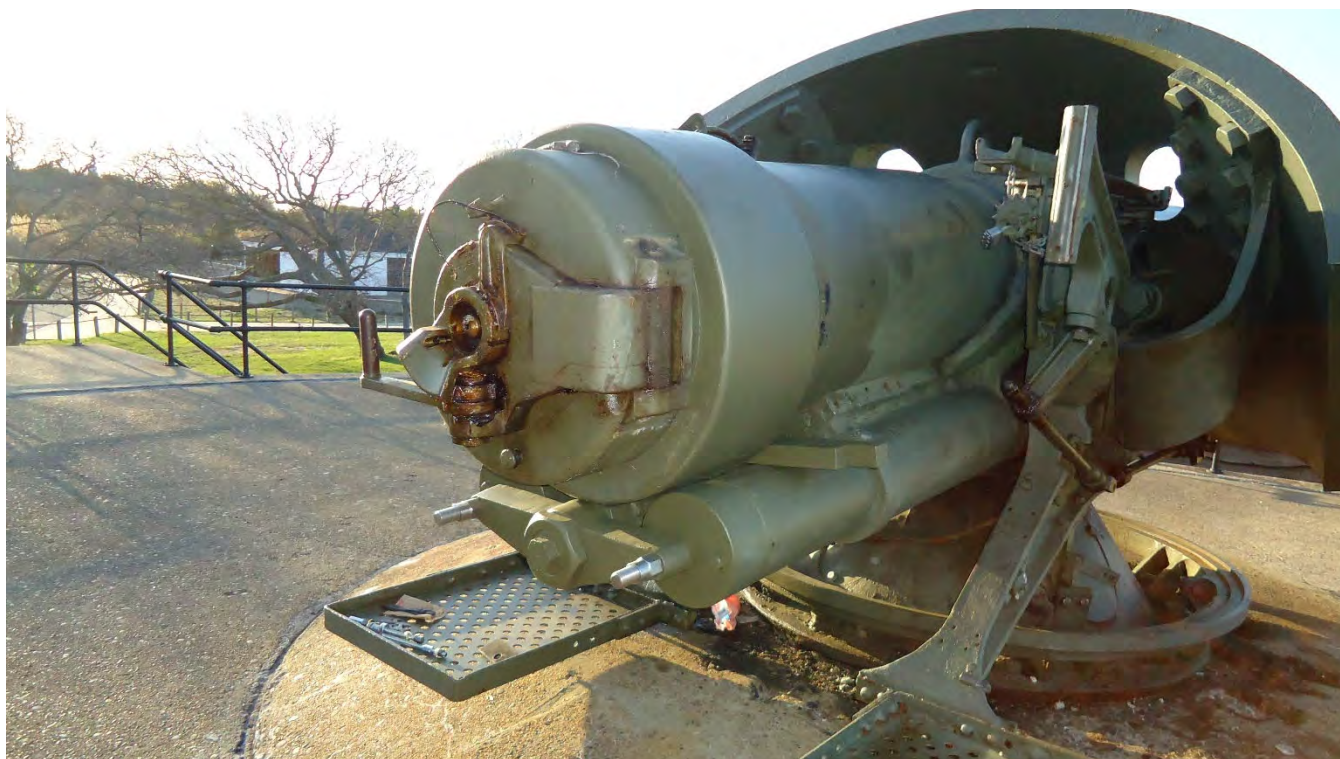
On the right (gun pointer's) side of the gun, two bars fit, but one should be cut and the two pieces will fit better. Notice the new yoke and recuperator "spring rods".

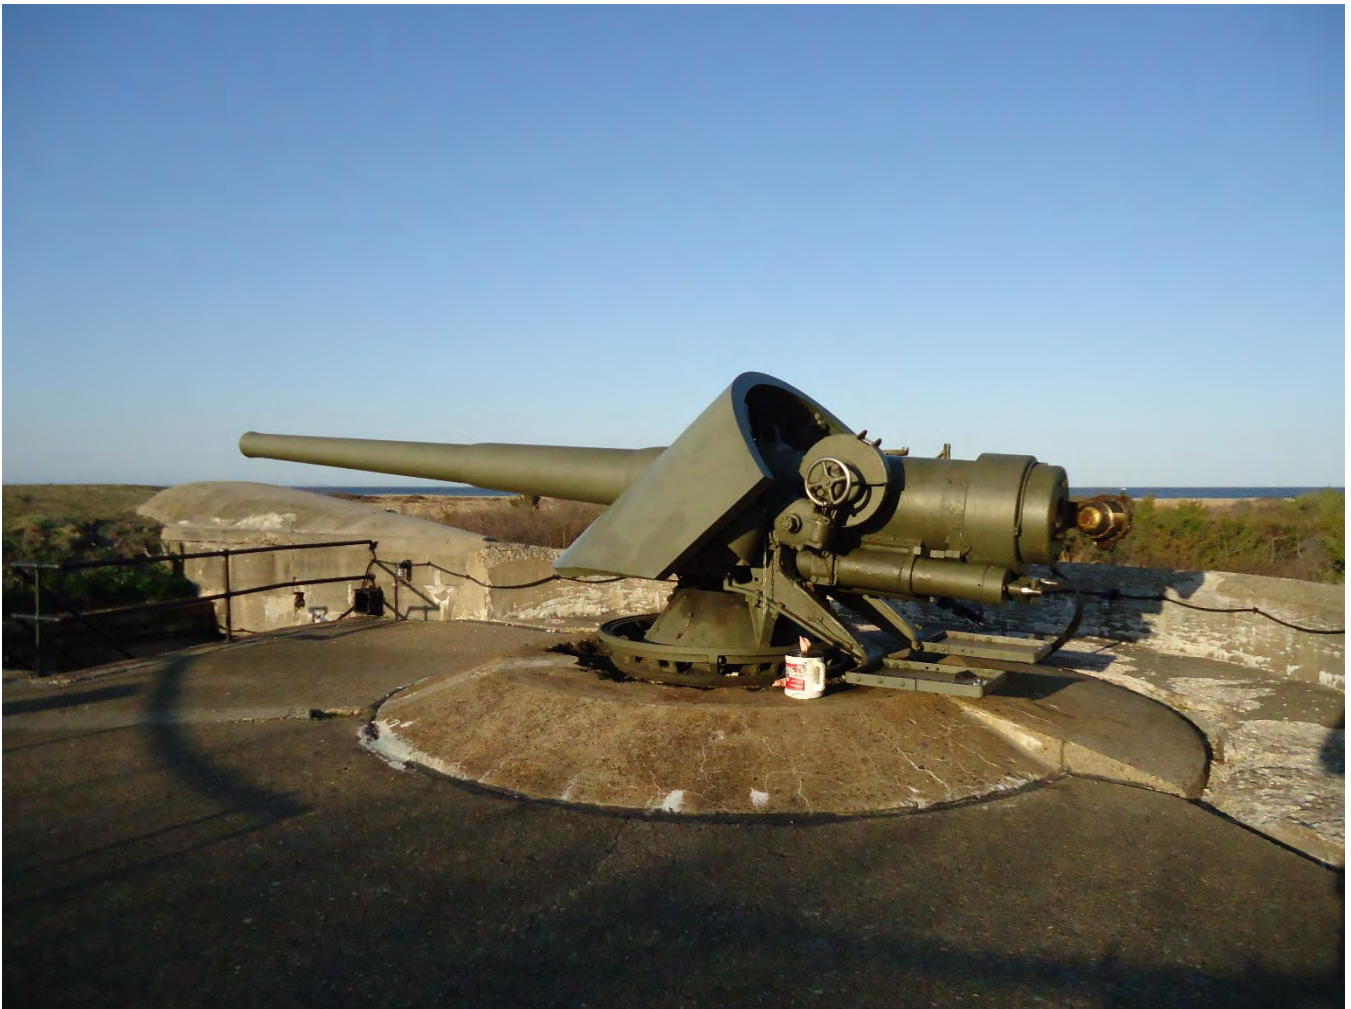
The photo below shows Gun #1 on the late afternoon of 15 April 2022. The counterweight system is essentially complete and the gun elevates and depresses as designed.
