ENVIRONMENTAL BASELINE SURVEY
For
Sixty-One Acres of Permit Terminated Lands
At
Fort Fisher, North Carolina

United States Air Force
Headquarters Air Combat Command

September 2000

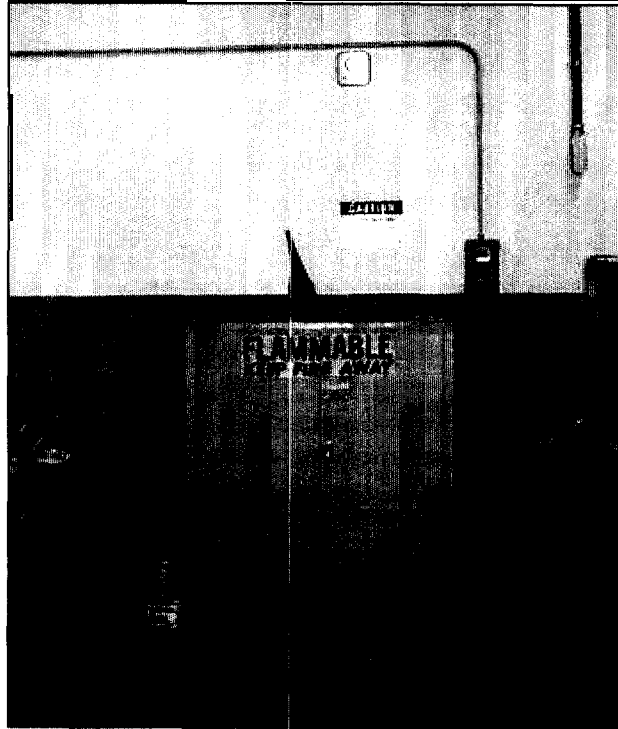
July 17, 2000. Flammables Cabinet (minimal storage of paint and paint thinner) inside Building 138, adjacent to Parcel E 1.

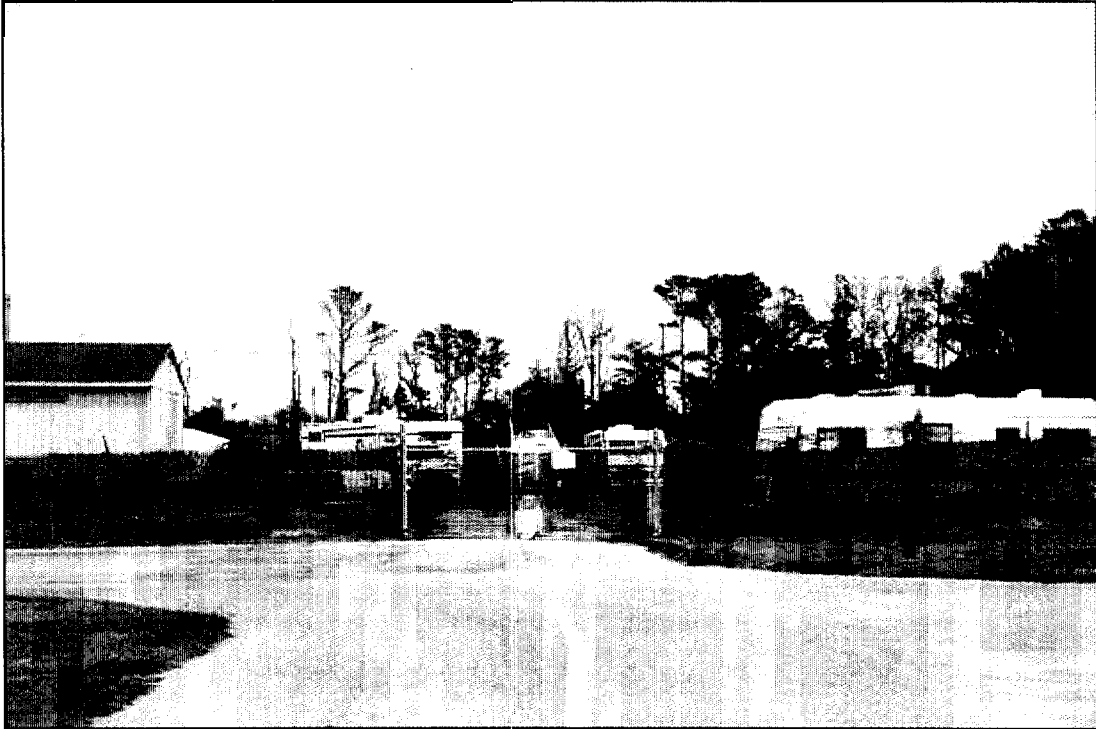
July 17, 2000. RV Storage Area. Photo taken facing southeast of Building 138 , adjacent to Parcel E 1.

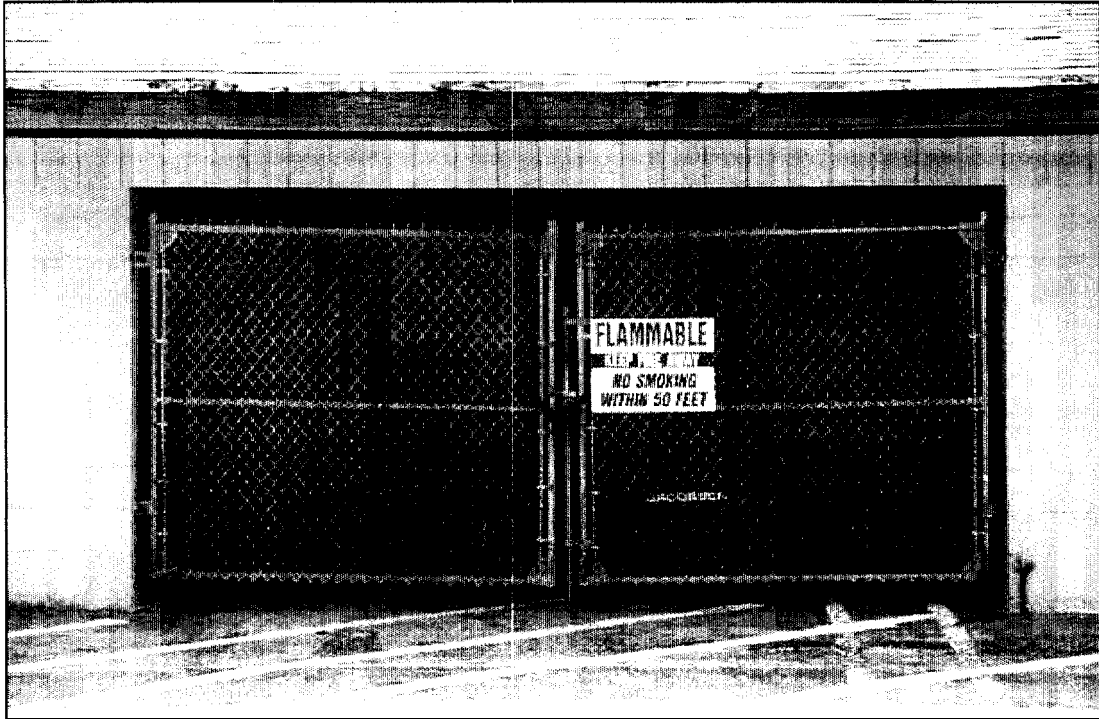
July 17, 2000. Inside view of lawn mower storage building. Building located northeast of Building 138 , adjacent to Parcel E1. Photo taken facing west.

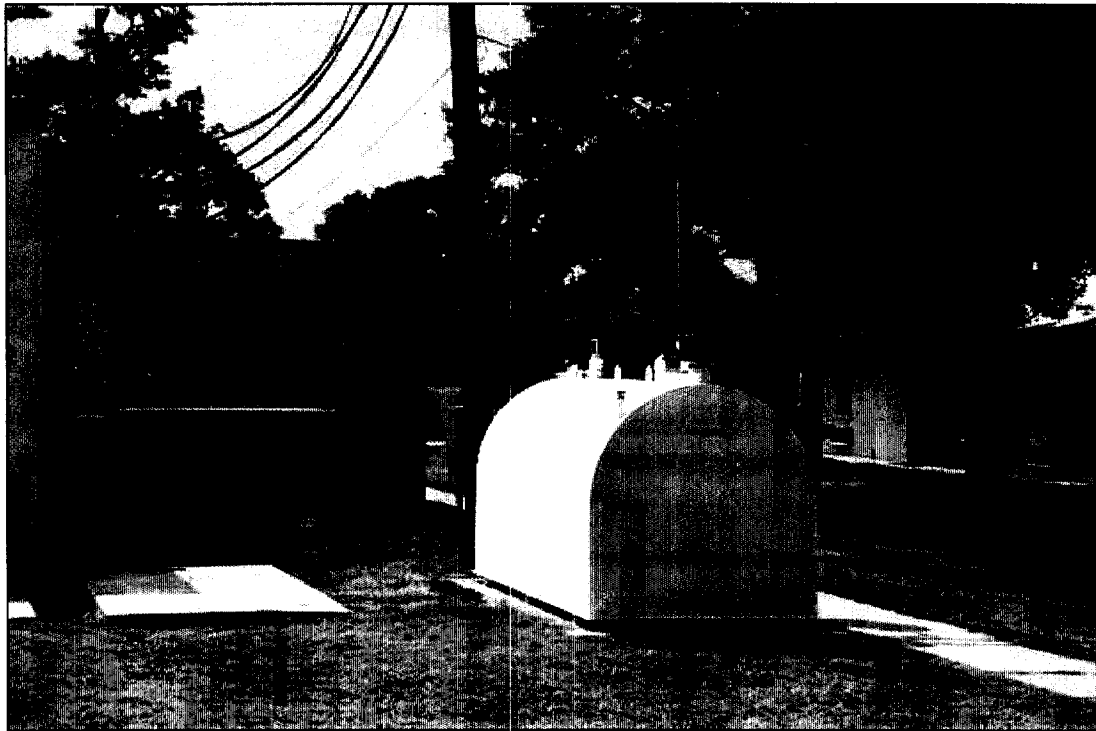
July 17, 2000. Heat. Pump east of Building 142 , adjacent to Parcel E1. Photo taken facing west.

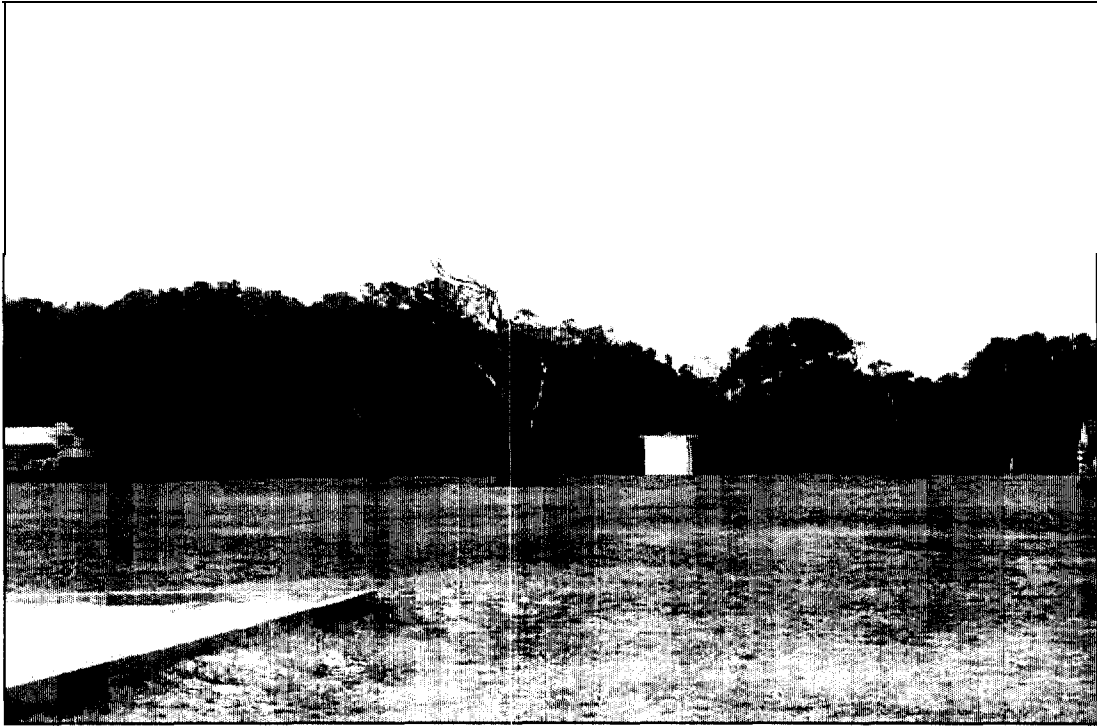
July 17, 2000. Parcel E2 bordered to the west by a trailer lot and to the east by vacation cottages. Well house located at rear of parcel. Photo taken facing northeast on Cape Fear Dr.

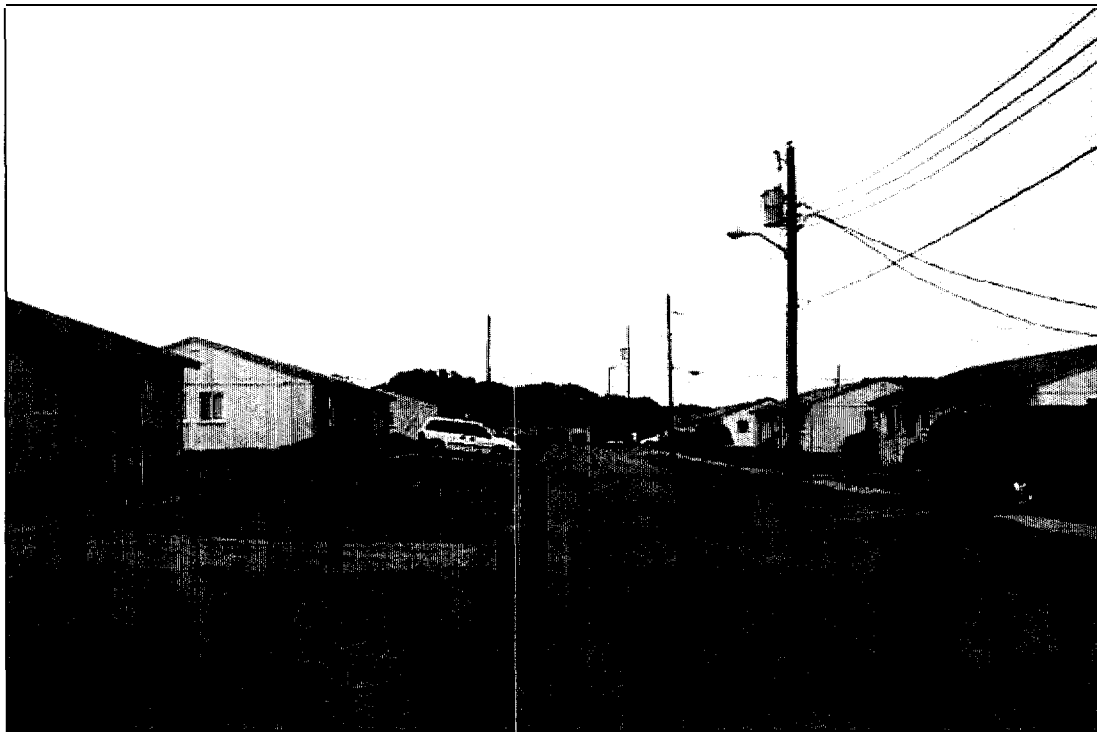
July 17, 2000. Vacation cottages, building 2 1 O-232 , adjacent to Parcel E2. Photo taken facing northeast at the intersection of Cape Fear Dr. and C St.

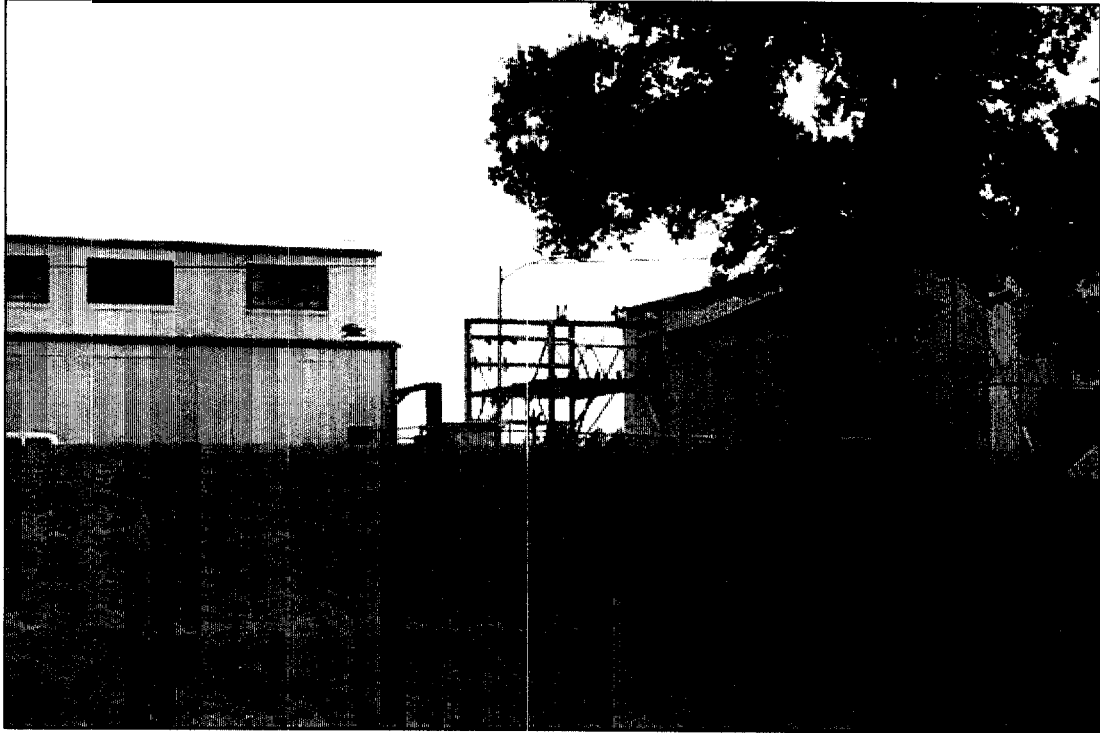
July 17, 2000. Site of sparging bioremediation activity , adjacent to Parcel E2. Photo taken northeast on B St.

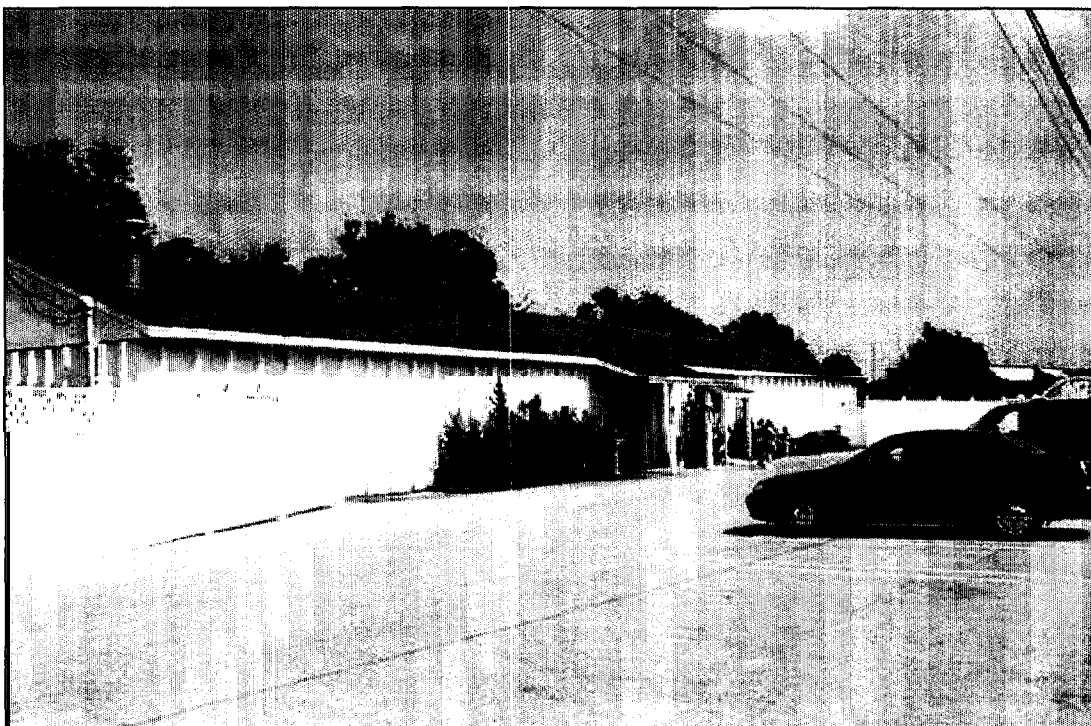
A lead based paint survey for the Recreation Area is not planned as of the date of this report. The potential for the presence of lead based paint is greater in buildings constructed prior to 1978, which includes Building 118. The visual inspection of the property indicated that all paint surfaces were in good condition.

July 17, 2000. Reception Center, Building 118, on Parcel E3. Photo taken facing southeast on 2nd St.

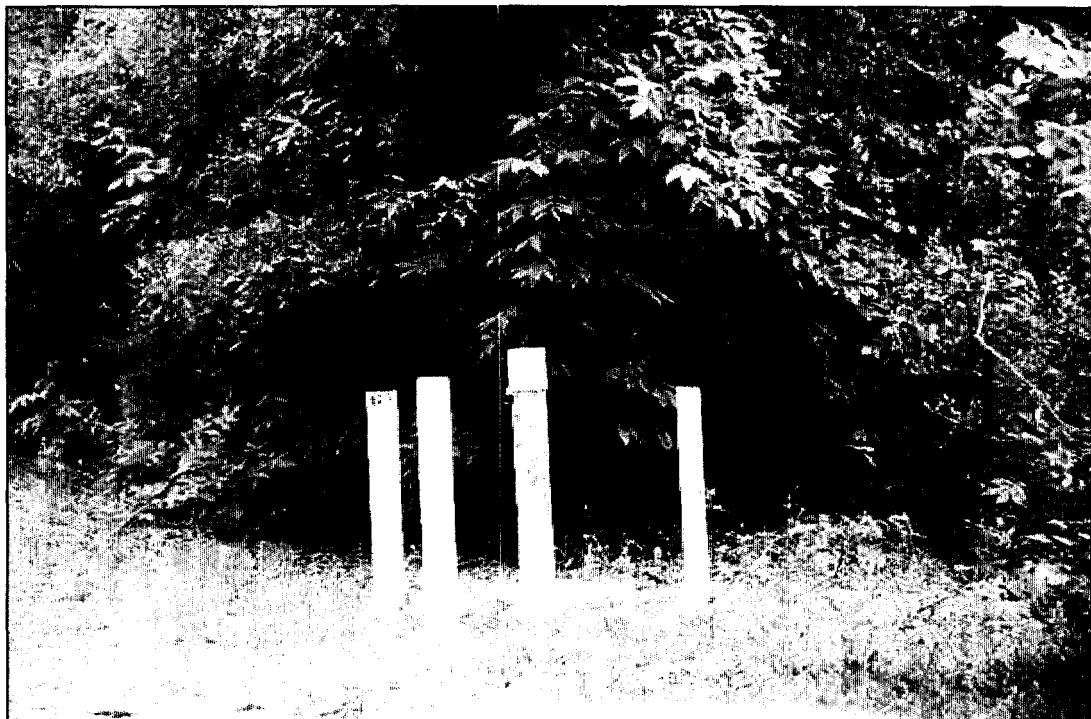
July 17, 2000. Monitoring Well Number 1 located on Parcel E 1, southwest of Building 138. Photo taken facing west on unmarked utility road.

water quality standards. The Air Force has scheduled the monitoring wells in Parcel E 1 to be closed in the future (Scott 2000).

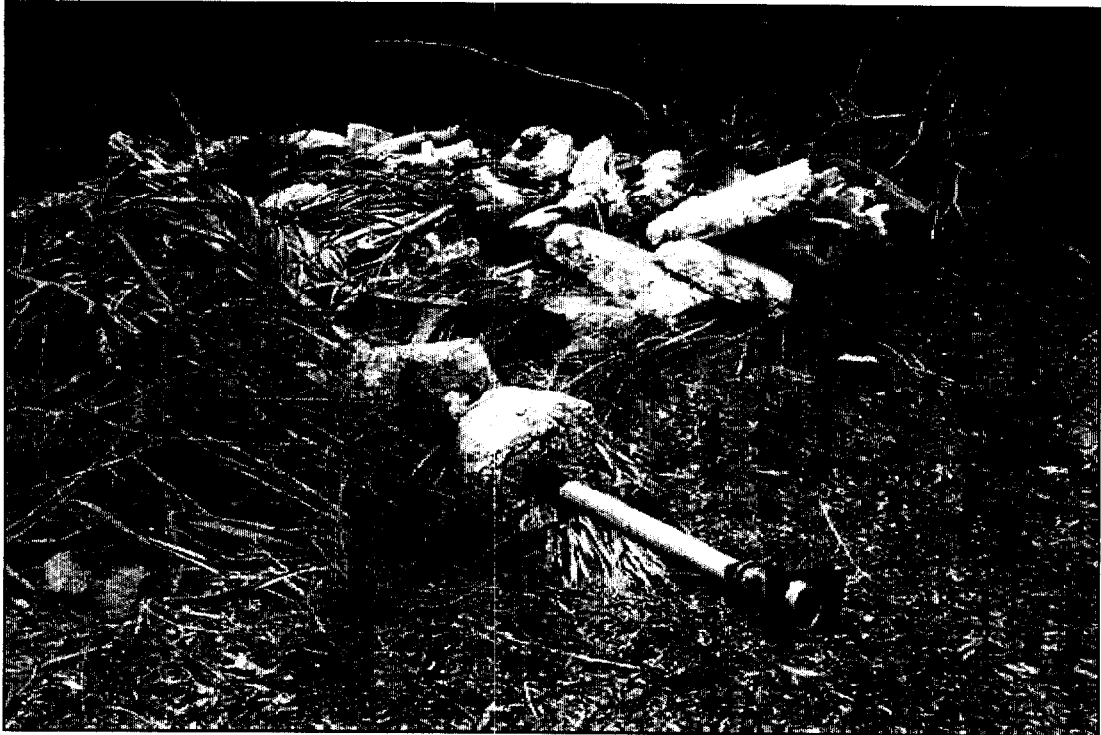
July 17, 2000. Landscaping Debris (vegetation trimmings, concrete from removed fence line:) found within wooded area on Parcel E1, southwest of Building 138. Photo taken facing south from unmarked utility road.

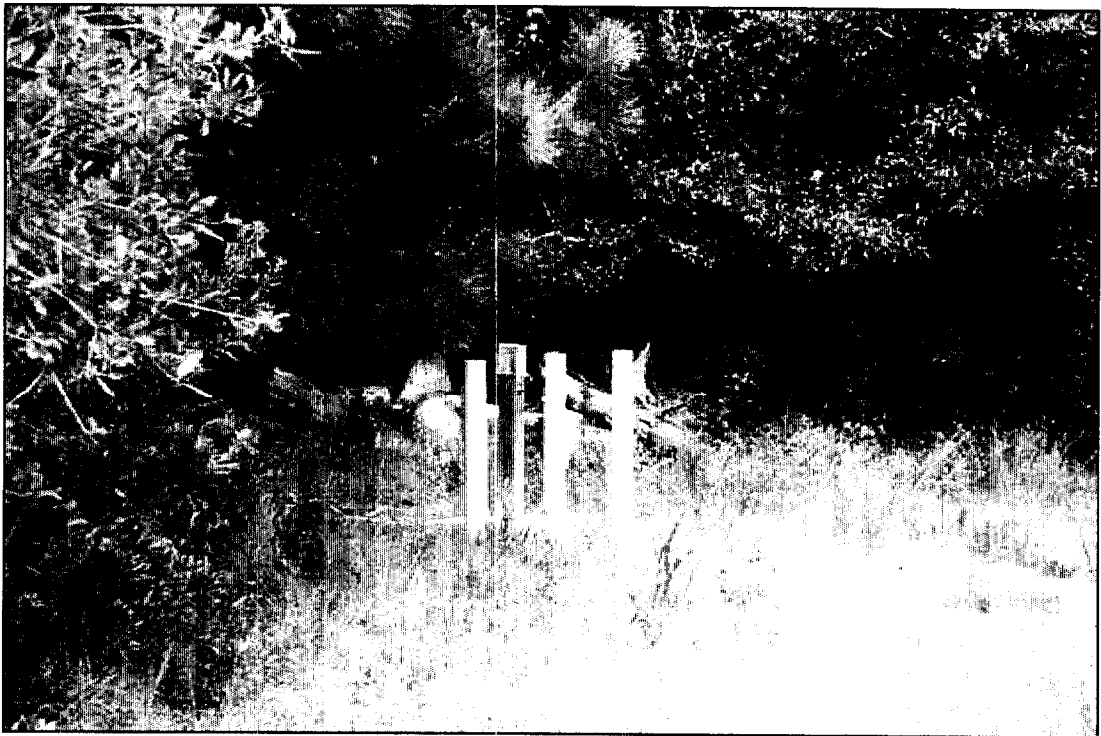
July 17, 2000. Monitoring Well Number Two located in wooded area on Parcel E1, southwest of Building 138. Photo taken facing southeast from unmarked utility road.
