2017 TRANSPORTATION SYSTEMS MONITORING PROGRAM REPORT

September 2017

Santa Clara Valley Transportation Authority

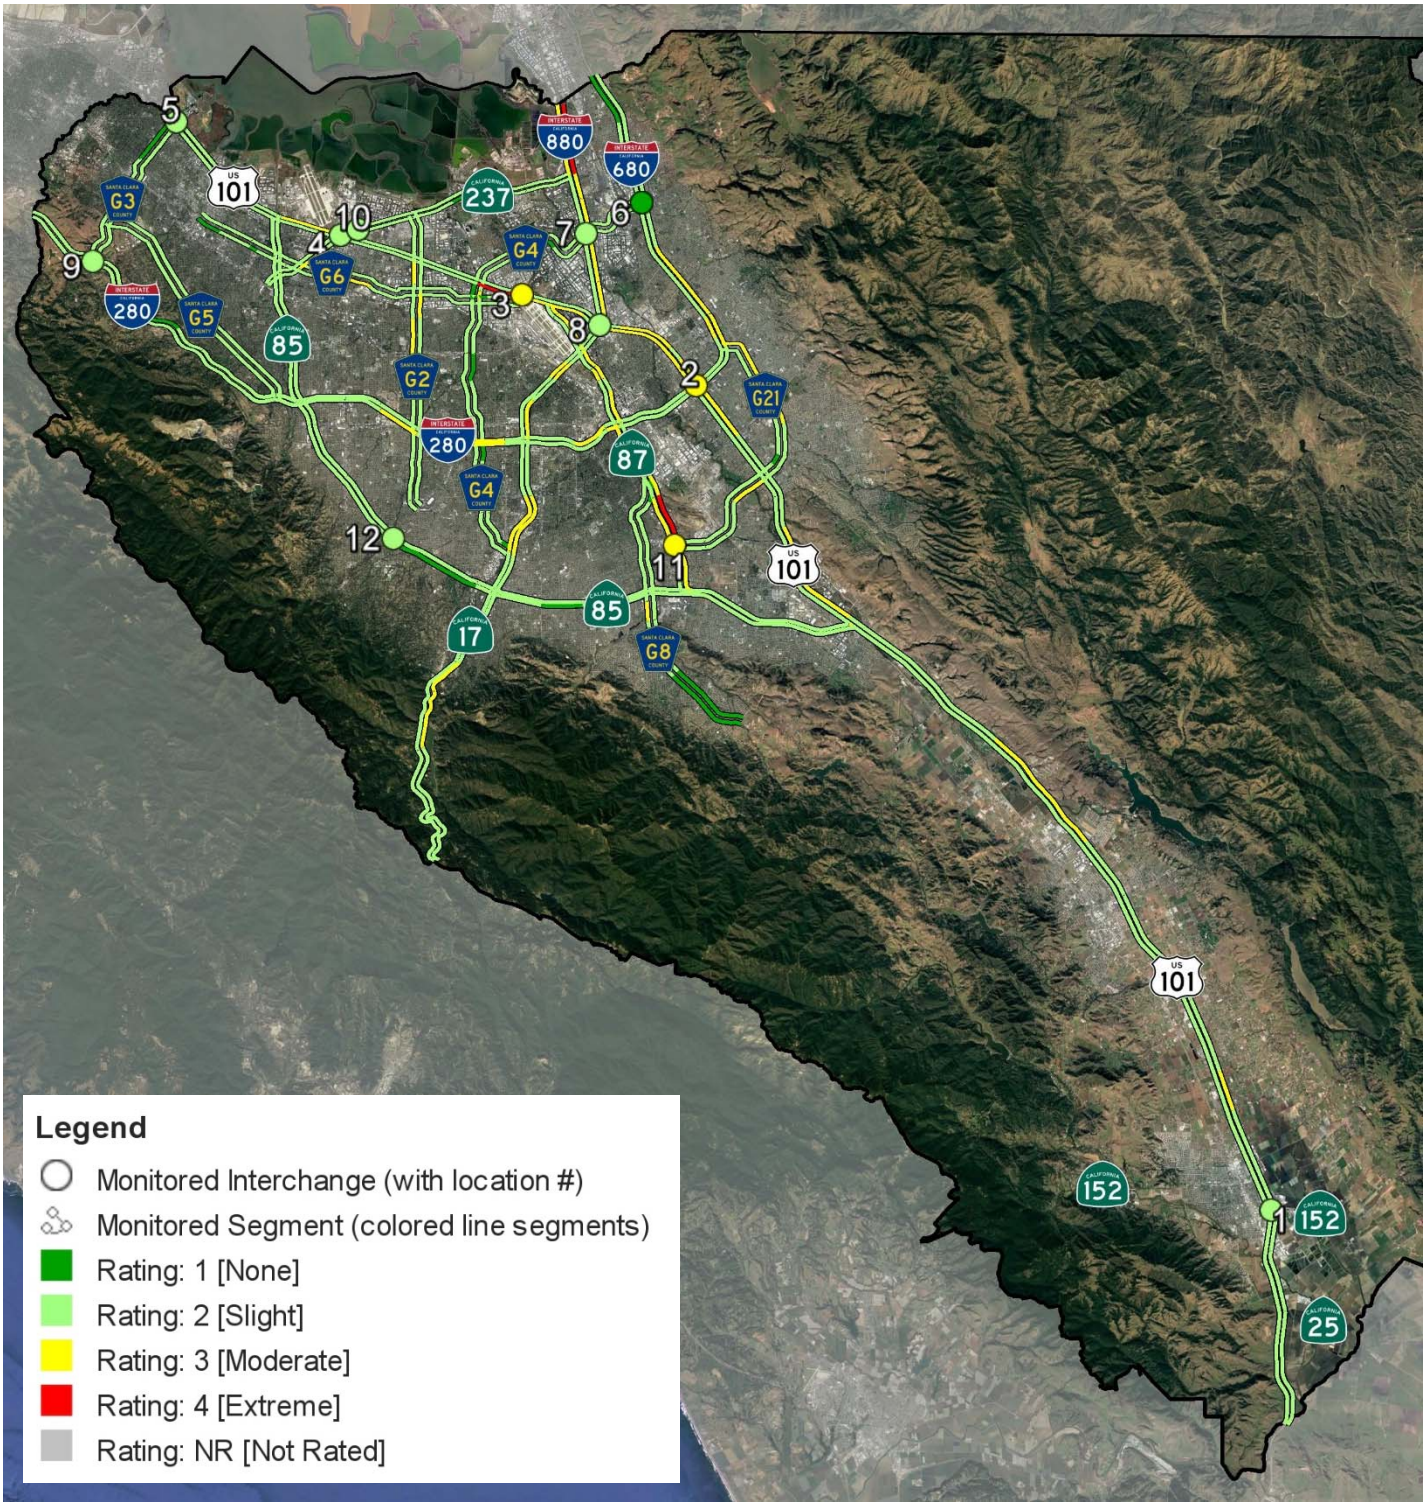
Figure 36. *Litter Conditions Assessment Map.*

RATING	LITTER (mi)	LANDSCAPE (mi)	GRAFFITI (mi)	LITTER (%)	LANDSCAPE (%)	GRAFFITI (%)
1	12.5	11.9	115.5	10.3%	9.9%	95.6%
2	98.5	73.9	1.9	81.5%	61.2%	1.6%
3	9.8	34.3	0.5	8.1%	28.4%	0.4%
4	0.0	0.7	2.9	0.0%	0.6%	2.4%
UC	0.0	0.0	0.0	0.0%	0.0%	0.0%
NR	0.0	0.0	0.0	0.0%	0.0%	0.0%
Total	**120.8**	**120.8**	**120.8**	**100.0%**	**100.0%**	**100.0%**

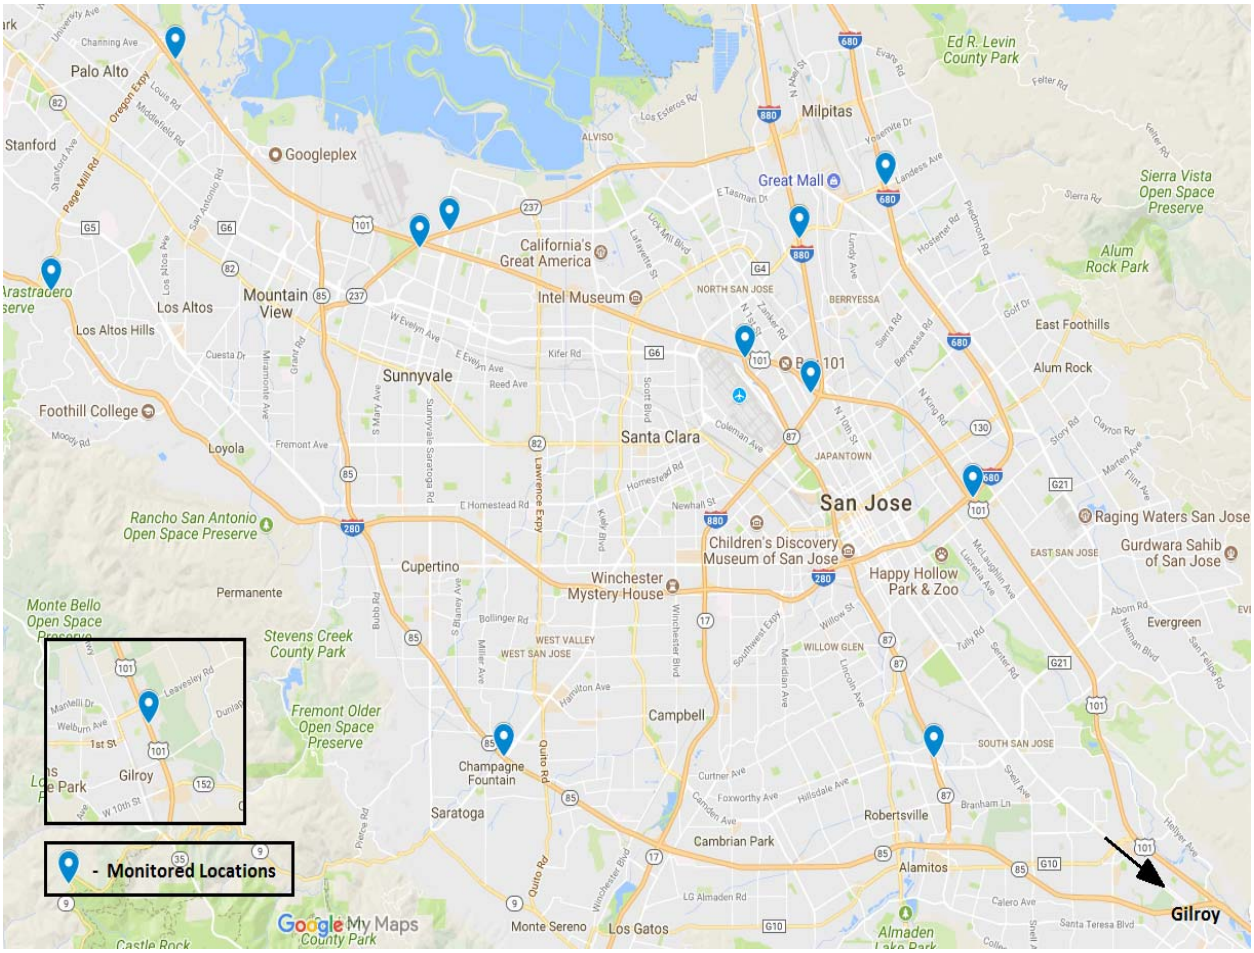
Figure 47. *Map of Interchange Monitoring Locations.*

NO	RTE	CROSSING	LITTER	LANDSCAPE	GRAFFITI
1	101	SR 152 East	2	2	1
2	101	Story Rd	3	3	1
3	101	Trimble Rd	3	2	1
4	101	SR 237	2	4	1
5	101	Oregon Expwy	2	2	1
6	680	Montague Expwy	1	1	1
7	880	Montague Expwy	2	4	1
8	880	US 101	2	2	1
9	280	Page Mill Rd	2	3	1
10	237	N Mathilda Ave	2	4	1
11	87	Capitol Expwy	3	3	1
12	85	Saratoga Ave	2	3	1
