PSY2 RETAIN TIPS
(as of 05/23/98 at 00:56:36 EDT)

RETAIN Technical Data

May 23, 1998

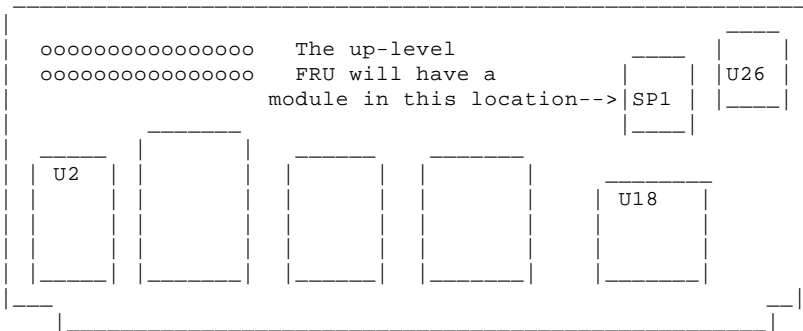
CURRENT LEVEL CARDS ARE IDENTIFIED WITH FRU P/N82G2484;
THESE CARDS ARE NOT AFFECTED, AND SHOULD NOT BE REPLACED.

NOTE: A SMALL QUANTITY OF NEW FRUS WERE PRODUCED WITHOUT THE FRU PART NUMBER BEING CHANGED ON THE BOARD. UP-LEVEL FRUS CAN BE IDENTIFIED BY CHECKING FOR A MODULE IN LOCATION SP1. IF THERE IS NO MODULE IN THIS LOCATION THE PART IS DOWN-LEVEL AND SHOULD BE REPLACED. REFER TO THE FOLLOWING DIAGRAM FOR THE LOCATION OF SP1:

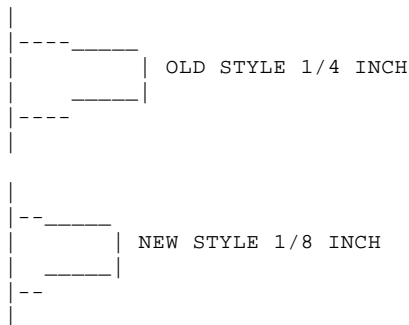
An alignment plug shoulder length of 1/8th inch indicates the new cover is installed. The plug fits into the AC Adapter port on the Thinkpad.

Cover Kit, FRU P/N66G9433, has been released to correct connection and fit conditions found on 3550 model 002 Docking Stations that meet the requirements in the Physical Check section.

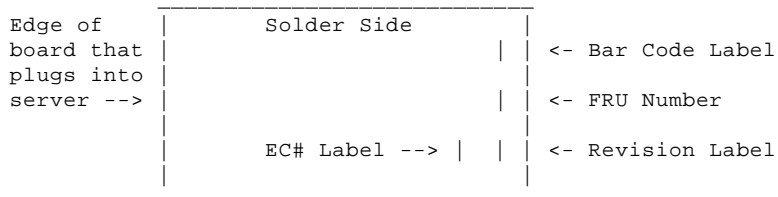
The EC level of the boards can be determined one of two ways, depending on the manufacturer of the board assembly:

1. Some boards will contain an EC# label on the solder side of the board, with the EC level (eg. D30616).
2. Other processor boards may not contain an EC# label, and the bar code label is different; the bar code label will state "50 MHZ CPU 308-0017-001." On these boards, the revision level of the board must be used to determine the EC level. The revision level is identified by the highest number colored-in on the revision label.

REVISION LEVEL 26 = EC LEVEL D30616
 REVISION LEVEL 27 = EC LEVEL D30640
 Other revisions may be encountered.

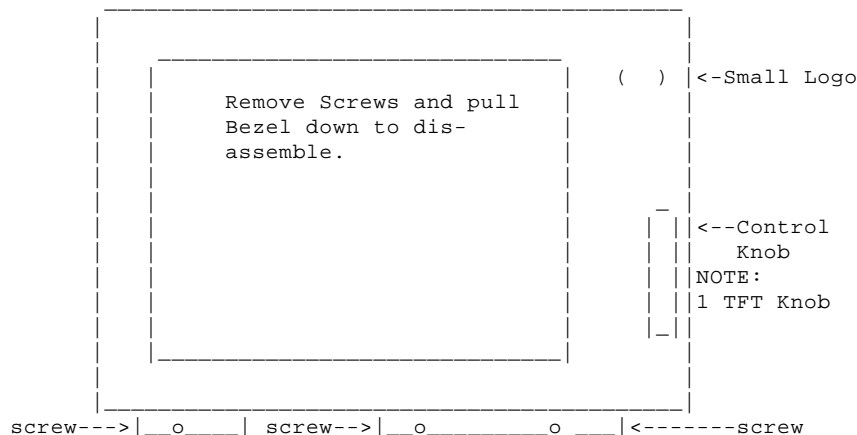
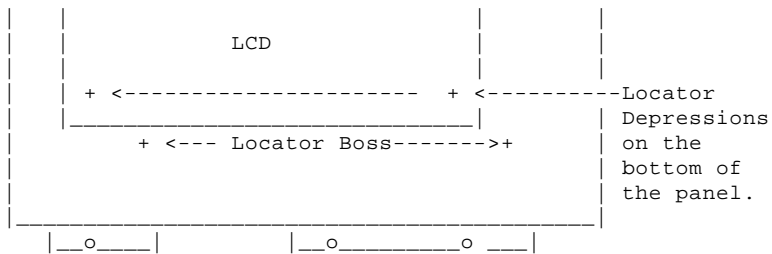
LCD Locator Boss Location and removal instructions:

The diagram below shows the LCD panel raised above the bosses

The complete HMM description is on page 169 of S84H-8101-00. The locator boss identified with a + in the above diagram can be removed with a pair of flush-cut diagonal cutting pliers. The panel can then be reinstalled in the reworked rear cover.

If the rework can not be done, order a new rear cover FRU P/N20H4264.

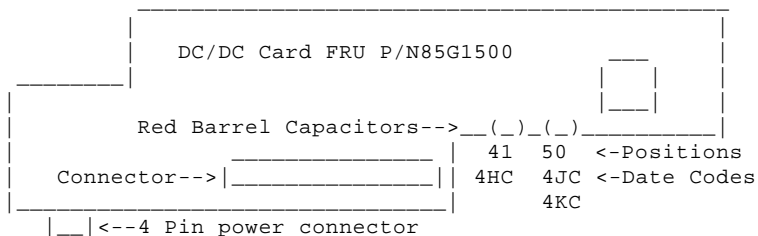
Use the DC/DC Adapter card diagram in Figure 1 to determine the position of the affected capacitors. If they are present, replace the card. All DC/DC Adapter card FRU stock of P/N85G1500 contains the correct level capacitors.

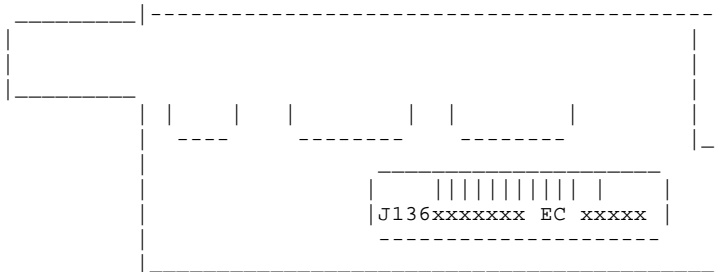
- 2. Model number listed in the FEATURES Section of this ECA.
- 3. A Keyboard Card Assembly FRU P/N69H7913 that contains the following information on its bar code:

The bar code information is located on the keyboard card and can be seen below the keyboard connectors when the top cover is removed. x = any number or letter.

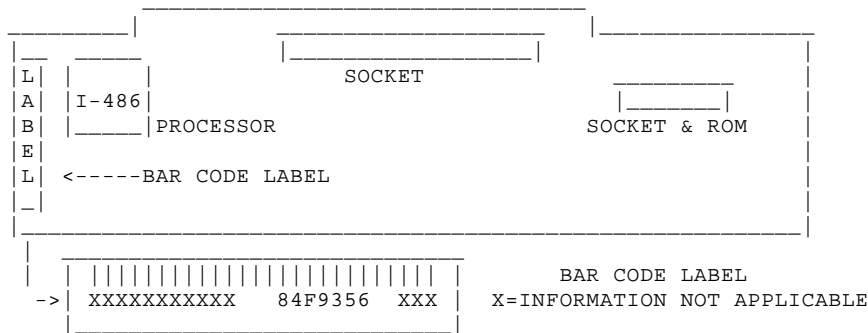
ONLY the bar code part number should be used to determine if the processor board is affected.

THE BAR CODE LABEL IS LOCATED ON THE EDGE OF THE BOARD AS ILLUSTRATED BELOW:

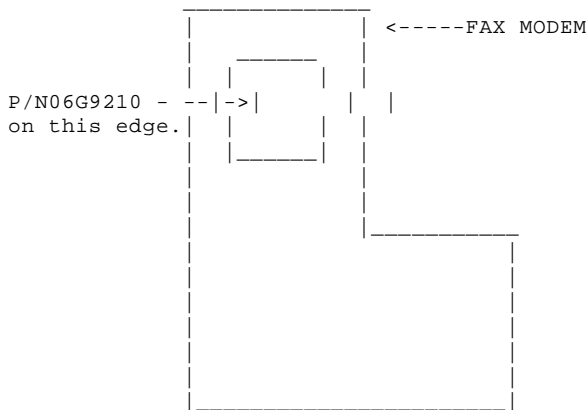
To be affected, the Internal Data Fax Modem must:

1. Pass FAX diagnostics
AND
2. Fail when running fax programs.
AND
3. NOT have P/N06G9210 written on the edge of the module
in the drawing below.

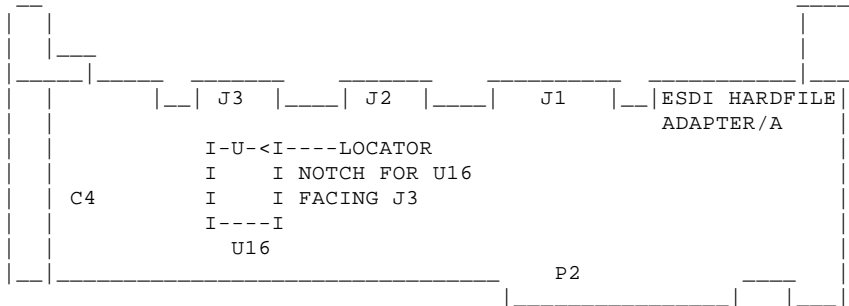
INSPECT THE MODULE IN LOCATION U16 FOR P/N04G3759 PRINTED ON THE TOP SURFACE. IF PRESENT, THIS EPROM HAS ALREADY BEEN INSTALLED. MODULES WITH ANY OTHER P/N SHOULD BE REPLACED BY THE CURRENT VERSION.

THE MODULE LOCATION, U16, IS NOTED BELOW:

INSTALL THE NEW EPROM WITH THE LOCATOR NOTCH TOWARD EDGE CONNECTOR J3.

ON SOME ESDI ADAPTERS, U16 MAY BE MOUNTED HORIZONTALLY. IN THIS CASE, THE LOCATOR WILL FACE THE LEFT SIDE OF THE CARD (THE NOTCH WILL FACE COMPONENT C4).

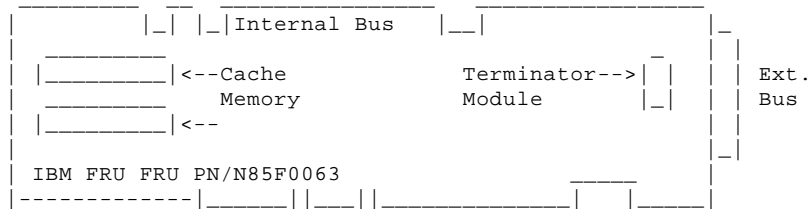
1. THE TERMINATION SCHEME HAS CHANGED AND IS NOW THE SAME AS USED ON THE SCSI ADAPTER WITHOUT CACHE MEMORY. THERE IS A 20 - PIN TERMINATOR MODULE INSTALLED IN A SOCKET NEAR THE EXTERNAL SCSI BUS CONNECTOR (REFER TO DIAGRAM BELOW). THE EXTERNAL TERMINATOR (FRU P/N33F8464) IS NO LONGER REQUIRED, AND IS NOT SUPPLIED WITH THIS OPTION, OR WITH PRODUCTS WHICH USE THIS ADAPTER AS A STANDARD FEATURE. TERMINATION OF THIS ADAPTER IS ACCOMPLISHED WHEN THE 20 PIN T-RES MODULE IS INSERTED IN ITS SOCKET. (THIS MODULE IS USUALLY ORANGE IN COLOR) THE T-RES MODULE IS TO BE REMOVED FROM THE ADAPTER IF BOTH INTERNAL AND EXTERNAL DEVICES ARE ATTACHED TO THE ADAPTER. IN THIS SITUATION, THE SCSI BUS IS TERMINATED AT THE LAST DEVICE ON THE INTERNAL CABLE AND THE LAST DEVICE ON THE EXTERNAL CABLE. THE TERMINATOR MODULE SHOULD BE LEFT IN PLACE IF EITHER THE INTERNAL OR EXTERNAL SCSI BUS IS UNUSED.

NOTE: THE TERMINATOR MODULE MAY BE REMOVED AND THE "OLD STYLE" EXTERNAL TERMINATOR USED, IF AVAILABLE AND REQUIRED BY A CUSTOMER THAT "MIGRATES" EXTERNAL SCSI DEVICES BETWEEN SYSTEMS. THE "OLD STYLE" TERMINATOR MUST NOT BE USED IF THE T-RES MODULE IS INSERTED IN ITS SOCKET AND THERE ARE DEVICES ATTACHED TO THE INTERNAL SCSI BUS, AS THIS CAUSES "DOUBLE TERMINATION" AND PROBABLE SYSTEM FAILURES.

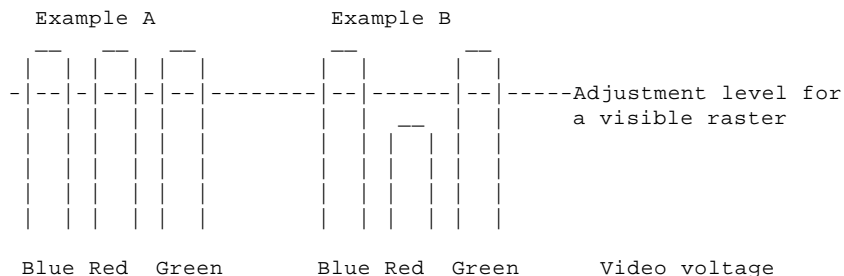
If the self test raster does not appear "white", it is most likely due to a mal-adjustment of one or more of the video level or cutoff voltages. Refer to page 8-20 of the Display Hardware Maintenance Manual and perform these adjustments prior to doing the Geometry adjustments.

Note: In example A, a white self test raster is visible because RED, BLUE and GREEN video gains are in close balance, therefore the human eye actually perceives "White". Without this balance, a color other than white will be seen.

In example B, a non-white raster is visible because the Red video gain is too low for proper "white balance." In extreme cases of mal-adjustment, the Self-Test raster may not be visible. Adjusting one of the video gains "up" may provide a visible raster, which by following the adjustment procedure on page 8-20, can be adjusted to meet all functional criteria without FRU parts replacement.

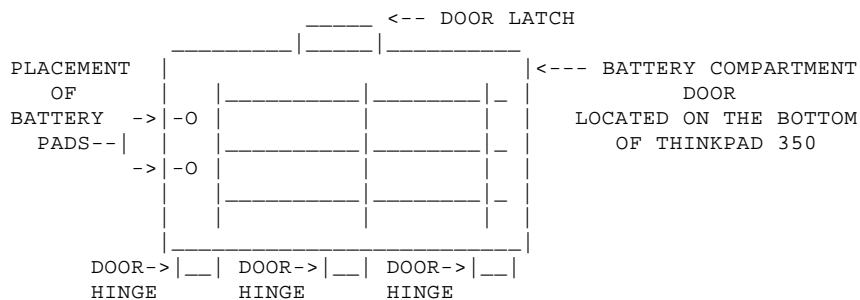
BATTERY PADS CAN BE USED TO INSURE A GOOD CONTACT BETWEEN THE BATTERY AND SYSTEM BOARD CONTACTS. PADS SHOULD BE ADDED TO THE BATTERY COMPARTMENT DOOR AS SHOWN BELOW.

NOTE: IN SOME CASES IT MAY BE NECESSARY TO ADD AN ADDITIONAL PAD TO THE NON-CONTACT END OF THE BATTERY, TO PROVIDE BETTER CONTACT TENSION. HOWEVER, IF YOUR EXISTING BATTERY PACK FITS TIGHTLY OR IS HARD TO REMOVE, THE ADDITIONAL PAD IS NOT REQUIRED.

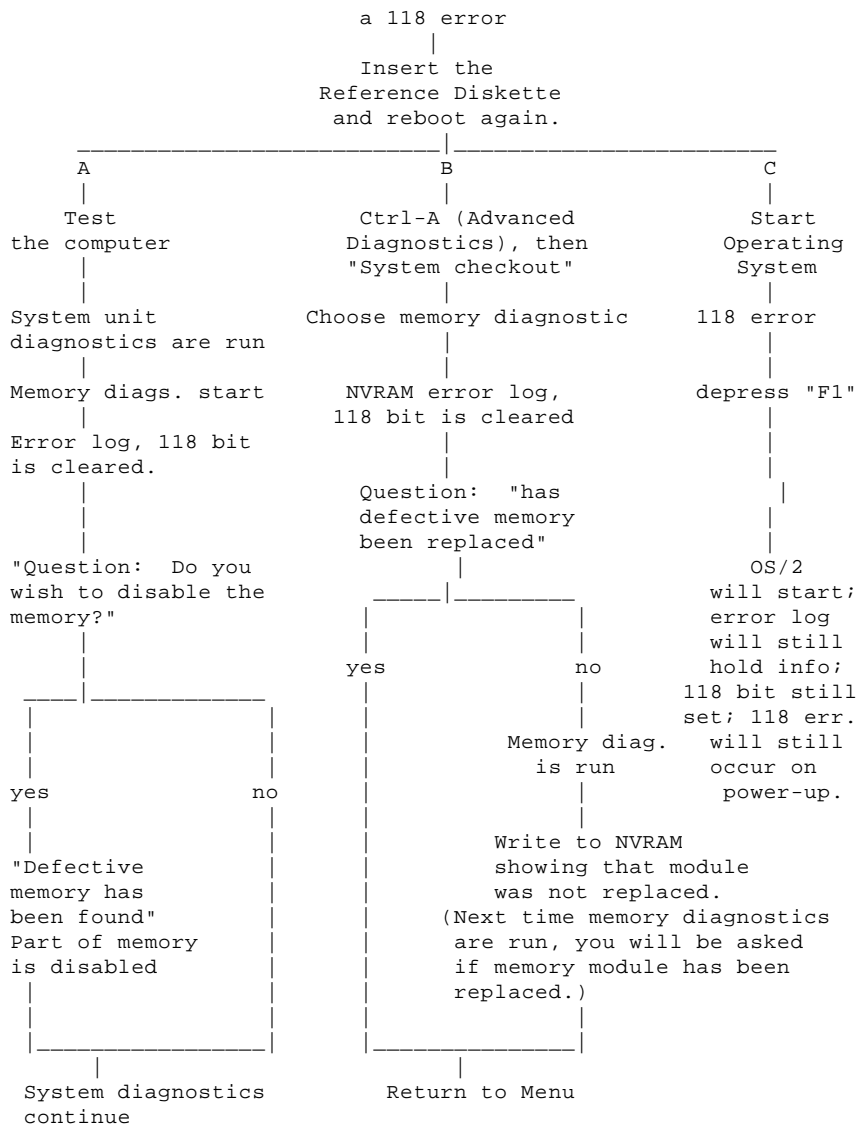
118 ERRORS DURING POST ON 8590 AND 8595 SYSTEMS

THE FOLLOWING CHART PROVIDES ADDITIONAL INFORMATION USEFUL IN CHOOSING THE CORRECT ACTION TO TAKE IN RESOLVING MEMORY PARITY AND 118 POST ERROR EVENTS.

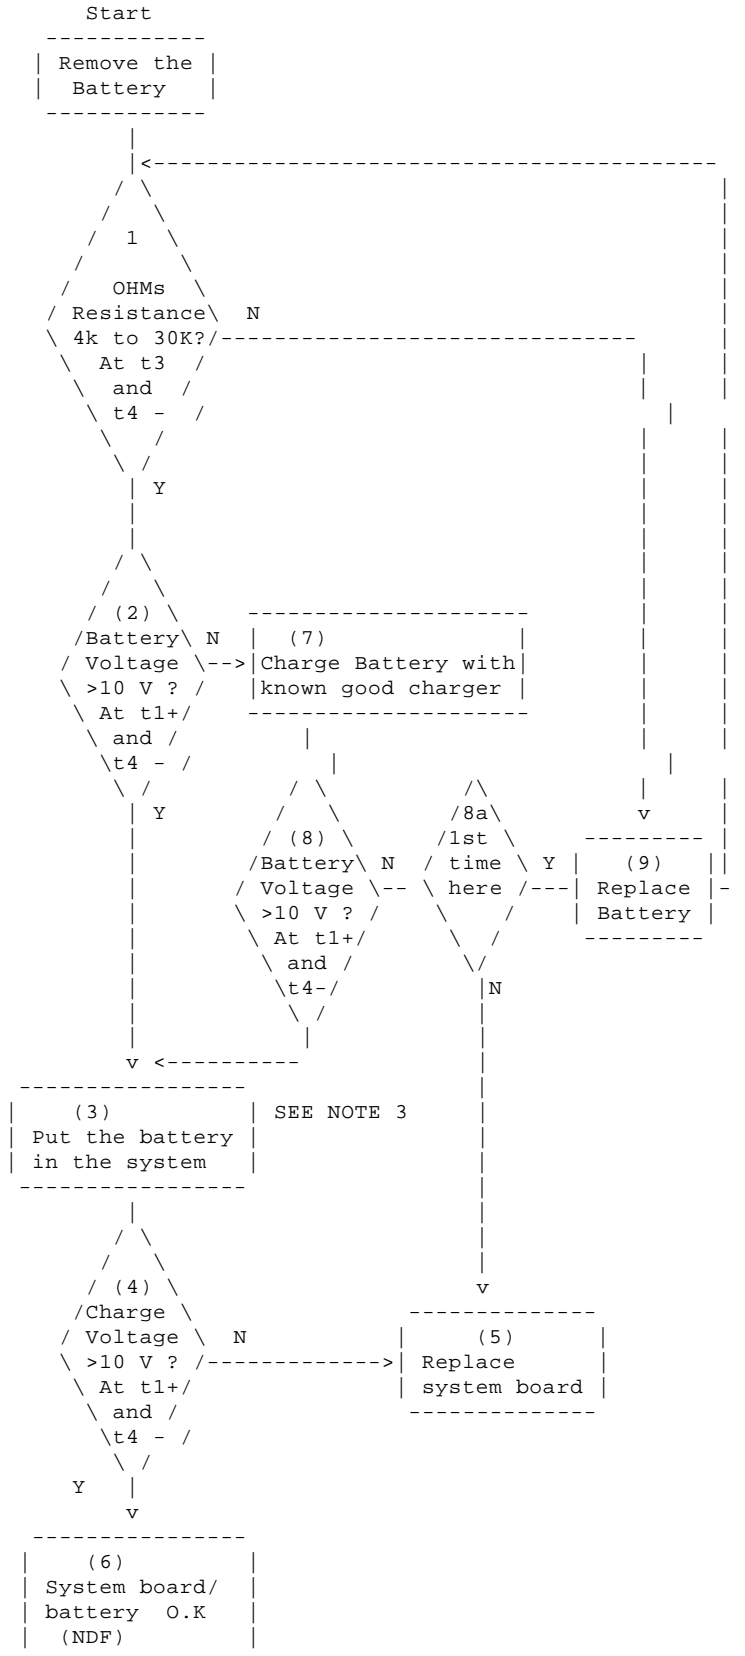
The section of 'Checking the Battery Pack' should be changed to the following procedure.

The following MAP steps replace the current HMM information on page 30 of IBM Mobile Systems HMM form number S82G-1502-03.

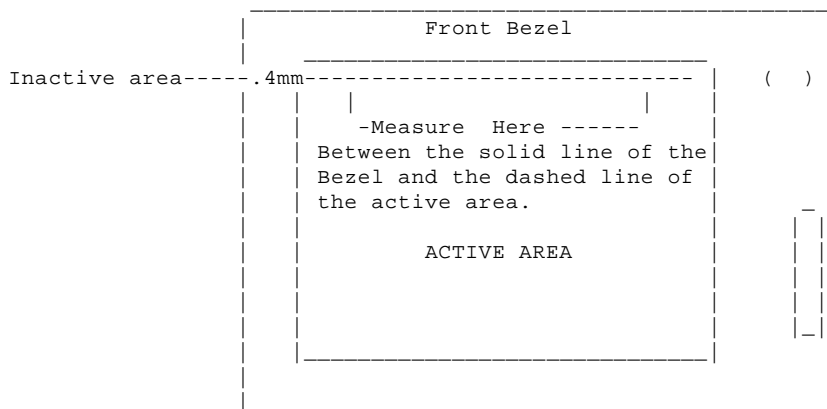
NOTE: There are two types of rear covers for the ThinkPad 560 TFT LCD unit. Make sure which type you have before installing the replacement LCD panel.

1. If the rear cover has two alignment bosses ensure they are inserted into the LCD indentations. If this is not done the panel could crack.
2. If the cover has no alignment bosses snug the LCD panel screws and completely reassemble the system. Loosely place the Front Bezel on the panel and power on the system. The inactive area on a full white or color screen should measure 0.4mm as the following figure shows. When the space between the bezel and active area is within specifications tighten the panel screws and complete the installation of the Bezel and screw covers.

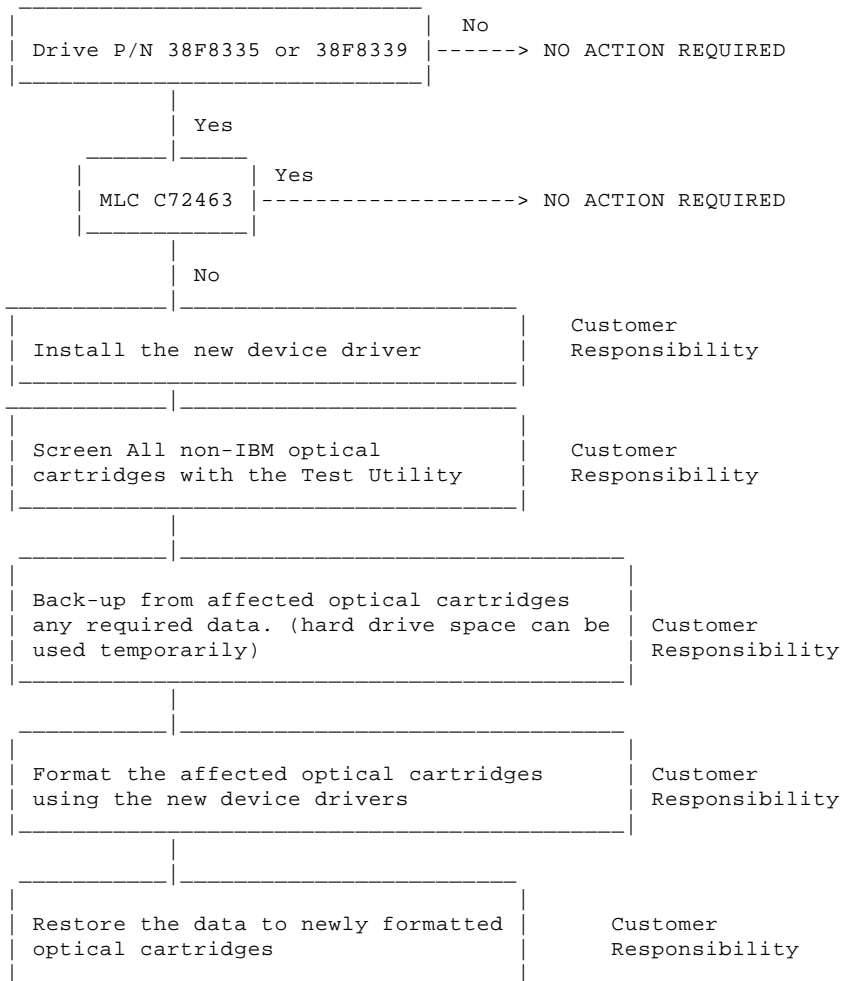
Use the following MAP to determine appropriate action.

1. All Optical cartridges formatted with the new device drivers on drives with the current microcode module are usable and no exposure to the problem will exist.
2. Current production Optical drives contain the new microcode module (MLC C72463).
3. Operating systems which do not use the DOS or OS/2 device

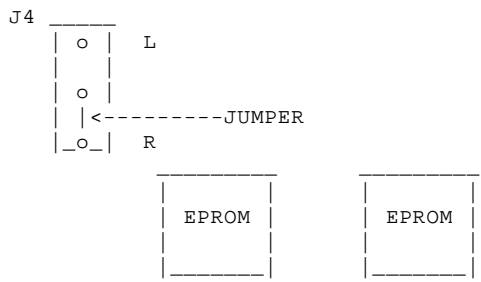
THIS JUMPER SHOULD NOT BE REMOVED OR REPOSITIONED.

In case the jumper is missing or incorrectly positioned, it must be replaced between the center pin and R, as shown below:

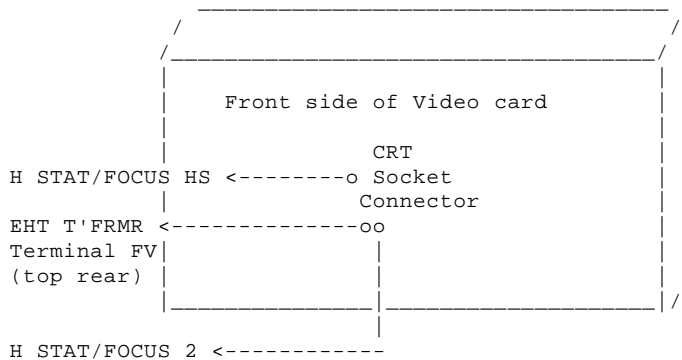
1. A PAIR OF BLACK WIRES CAN BE SEEN BELOW THE ITC CONNECTION ON THE VIDEO CARD.
 - A) FROM THAT PAIR, THE LEFT LEAD SHOULD BE CONNECTED TO THE "FV" CONNECTOR ON THE EXTRA HIGH TENSION (EHT) TRANSFORMER.
 - B) THE RIGHT LEAD SHOULD BE CONNECTED TO POSITION NUMBER "2" ON THE HSTAT/FOCUS ASSEMBLY.
2. THE BLACK WIRE DIRECTLY ABOVE THE PAIR OF WIRES MENTIONED IN STEP 1, SHOULD BE CONNECTED TO THE "HS" CONNECTOR ON THE HSTAT/FOCUS ASSEMBLY.
3. THE ONLY RED LEAD INVOLVED SHOULD BE CONNECTED BETWEEN POSITION "1" ON THE HSTAT/FOCUS ASSEMBLY AND THE "MV" POSITION ON THE EHT TRANSFORMER.

Note: The numbers referred to above are imprinted on top of the 4 corners of the H-STAT/FOCUS pot assembly, but are small and difficult to see.

IT IS NECESSARY TO PERFORM ALL ADJUSTMENTS DETAILED IN THE 8517 9517 COLOR DISPLAY HMS AFTER REPLACEMENT OF THE ANALOG CARD OR VIDEO CARD ASSEMBLY. REFER TO 9517 MONITOR ALIGNMENT SERVICE AID, RETAIN RECORD # H124719, WHICH SUPPLEMENTS THE ALIGNMENT PROCEDURE IN THE DISPLAY HARDWARE MAINTENANCE MANUAL (HMM), VOL. 1, SECTION 8, FORM NUMBER SA38-0053-00. THE SERVICE AID PROVIDES ADDITIONAL DETAILED ALIGNMENT INFORMATION NOT FOUND IN THE HMM. RETAIN RECORD # H12816 PROVIDES ESSENTIAL BACKGROUND INFORMATION ON MONITOR OPERATIONAL THEORY..

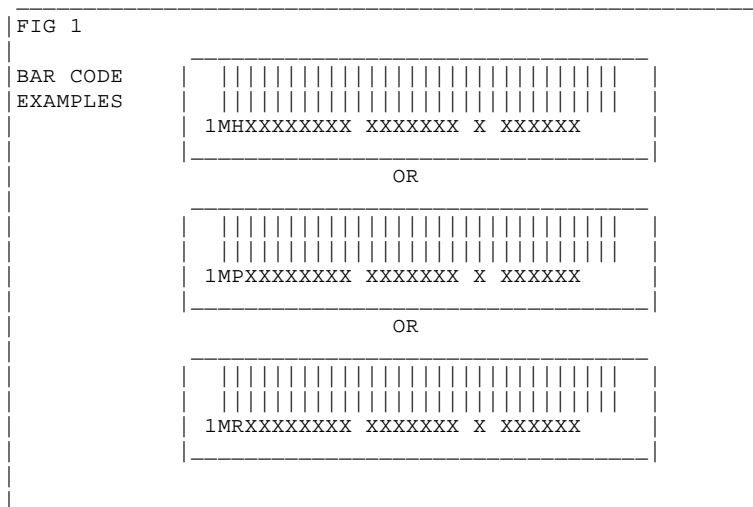
The bar code is located below the option in the ULTRA BAY. Lift the keyboard and remove the option to see the Bar code. The X in the figure represents any letter or number and is not relevant.

When ordering a replacement system board for one of the above 760 models check the bar code of the failing board. If the bar code contains 1MH, 1MP or 1MR, the system board is at the early level and the CPU level should be checked before it is swapped from the old system board to the new level system board. If the CPU that was ordered is not used return it. (Check FIG 4 for CPU FRU numbers.)

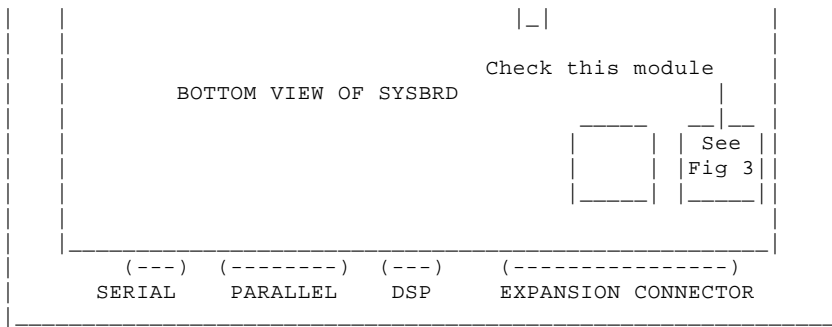
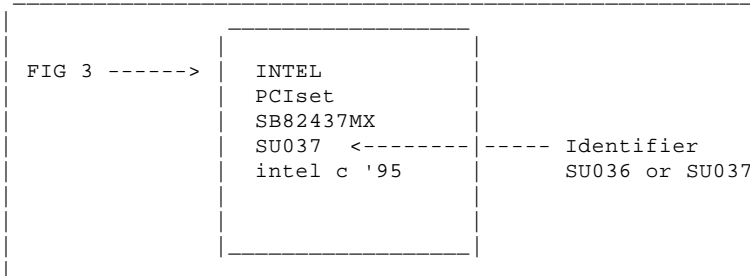
SYSTEM BOARD IDENTIFICATION METHOD 2. (FIG 2)

Alternative method to identify older level system boards if the bar code is damaged: This can only be done after the system board is removed from the computer.

If the sysbrd module identified in Fig 2 and 3 has SU036 or SU037 on it the system board is at the older level.
 If the CPU that was ordered is not used return it.

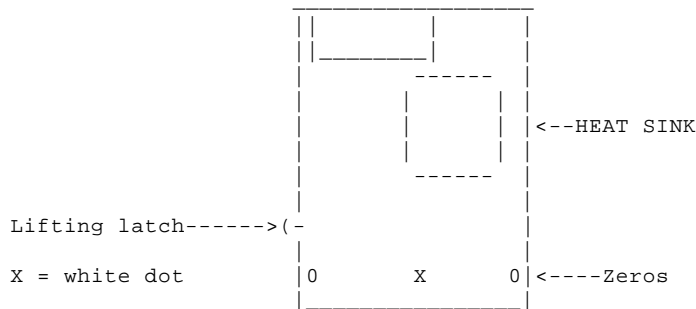
Figure 1.
 The Zeros and the white silk screened dot indicate where to press during installation.

The CPU card pins must all seat simultaneously during installation. To do this place the card over the socket. Then position your fingers at the two corners and on the white silk screened spot at the center of card over the connector. Press down with even pressure until the connector clicks into the socket.

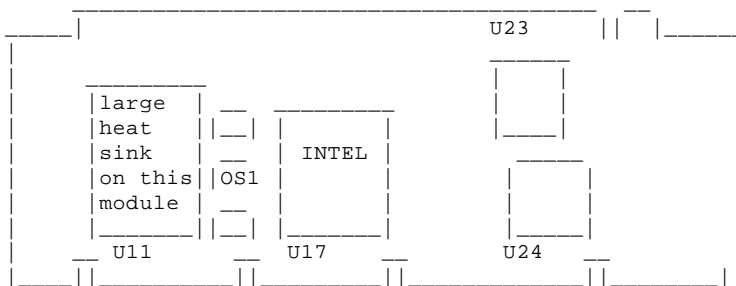
Physical confirmation of the Pentium processor board speed may be done by inspecting the small module (oscillator chip) at location OS1. OS1 is the center module between U11 and U17. A 66MHZ processor will have "66.0000 MHZ" printed on top of the module. Refer to the diagram below:

The FRU part number of the 66 MHZ Pentium Processor board is: P/N92F0120.

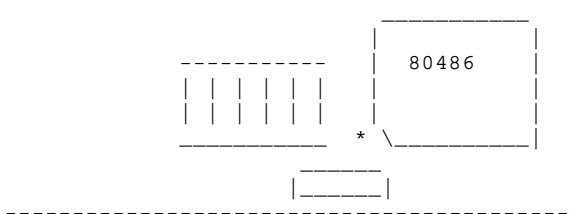
***** Warning *****
 * If the 486DX4 is installed without the voltage regulator *
 * and the system board DX4 voltage regulator connector is*
 * jumpered for 5 volts, as the system board FRU is normally *
 * jumpered, the 486DX4 will be destroyed when the system *
 * is powered on! *
 * *
 * If the processor is not positioned correctly, the system *
 * board or the processor may be damaged *

Install all 486DX4 processors with the bevelled corner located at the front-left corner of the processor socket.

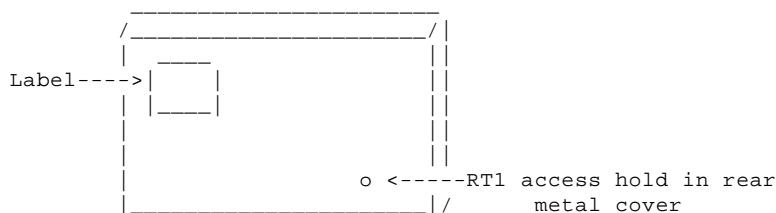
There is a coarse horizontal convergence control (RT1) on the rear of the monitor, which is not referenced in the service documentation. Refer to the diagram below for the location:

View from the rear of the 9527 Monitor video card (attached to the neck of the ITC and part of the Card Tray Assembly).

There are two versions of the RT1 potentiometer in the field. They are identified by the color of the plastic part where the adjustment tool is inserted (the "wiper") in the potentiometer. Note of the color of this part. Note: The color of the other parts of the control does not matter and should be ignored. Removal of the video the sheet metal RFI shield on the back of the video board may be required to examine the RT1 control.

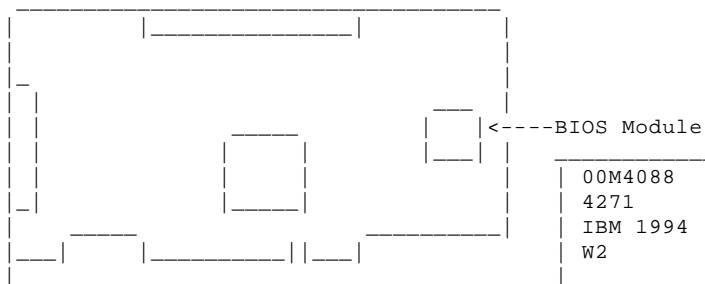
IBM SCSI-2 FAST PCI ADAPTER FRU P/N 53G0382

The BIOS module is located on the Adapter, as referenced below, in a socket and may be easily changed by the customer.

The earlier level of BIOS module may be identified by the markings on top of the module, also noted below.

Requests for this free BIOS upgrade should be escalated to Engineering through the Hardware Service Support Structure With the customer's name, required quantity and shipping address. Engineering will ship the newer modules direct to the customer at no charge.

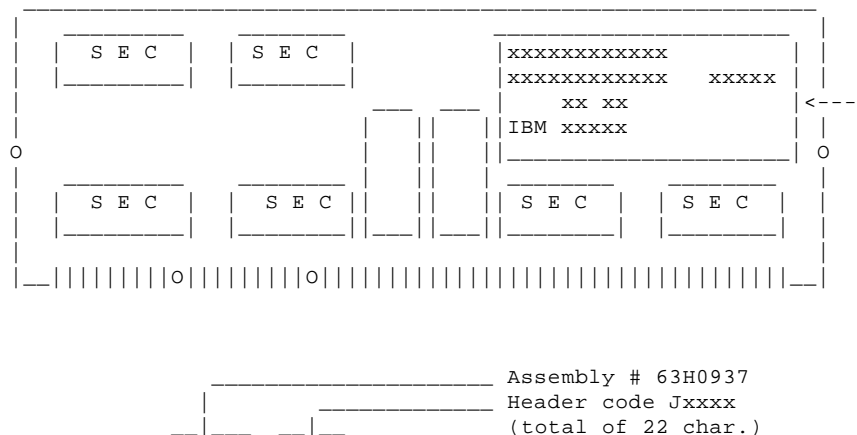
Diagram A: SAMPLE 128 MB MEMORY DIMM with IBM Label:

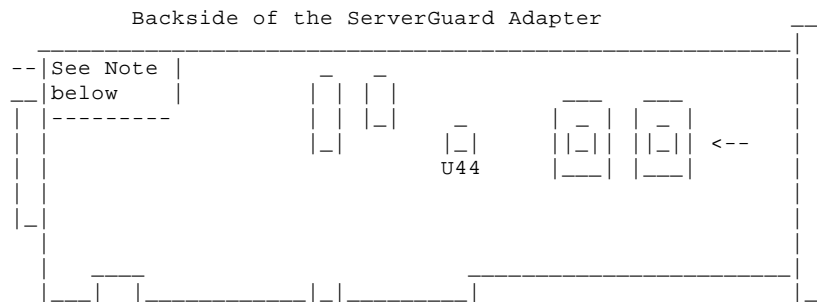
Inspect the ServerGuard card for a component (chip) at location U44. If this module is missing, the adapter is NOT exposed to this problem. The location of U44 is printed on the card, but the lettering is very small. Refer to the following diagram for the location of U44:

This problem is being corrected in current production. A new version of the ServerGuard adapter is available under FRU P/N06H8091.

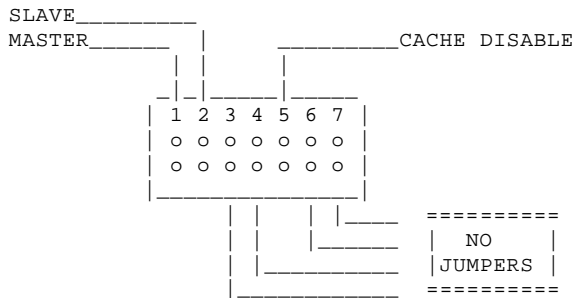
Systems currently being manufactured with a 1GB hardfile are being configured to prevent the failure from occurring. The jumper is installed in the #5 position located on the file control card to disable write caching. This change has little or no effect on operating system performance.

HARDFILES IN FRU STOCK DO NOT HAVE A JUMPER LOCATED ON POSITION 5. REMOVE JUMPERS AS REQUIRED FROM THE FAILING DRIVE, TO USE ON THE FRU REPLACEMENT.

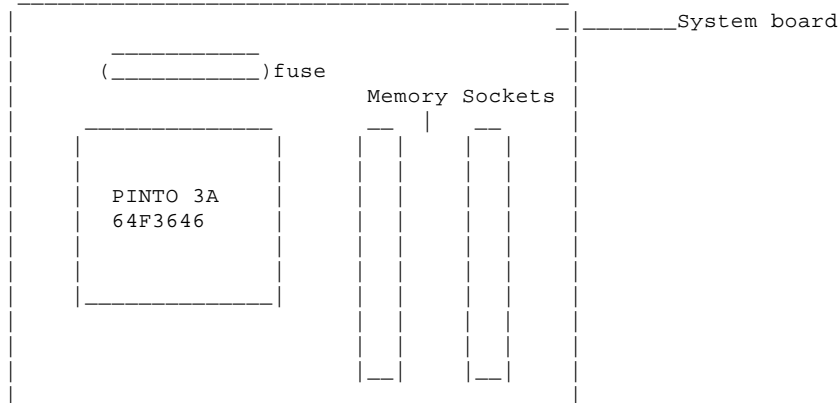
A limited number of PS/2 8555SX system boards contain a module located to the left of the memory simm sockets labelled "Pinto 3A #64F3646." This chip may conflict with the bus timings of the 486SLC Processor upgrade which results in a reduction in processor performance. The "Pinto 3A" chip only affects IBM option P/N13H6694, FRU P/N13H6697, card assembly P/N78G2521.

Customers or servicers that are experiencing this failure should contact the IBM PC Company HelpCenter for additional assistance in determining if the system is affected prior to replacing the processor card/board.

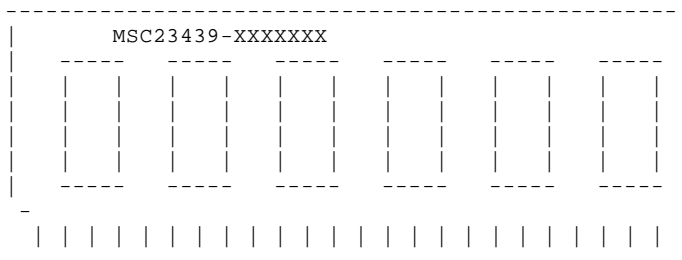
If 16MB ECC memory SIMMs are installed, check for the presence of manufacturing part number MSC23439.

Refer to the following diagram for the location of the SIMM Part number:

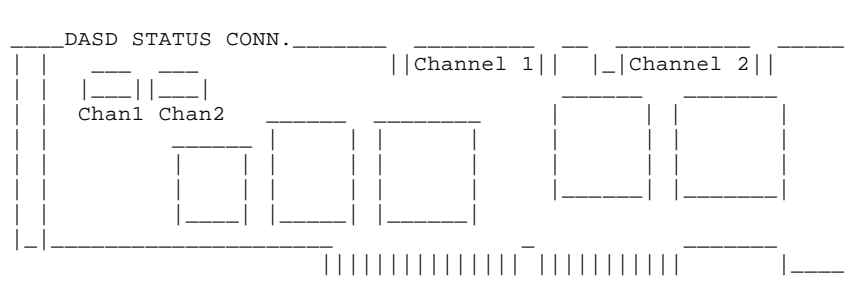
SCSI-2 Fast/Wide Streaming RAID Controller, FRU P/N06H3059

In systems which have more than one DASD Backplane installed, make certain that the RAID Channel 1 (SCSI) signal cable and the RAID Channel 1 Status cable are both attached to the same Backplane (are not crossed).

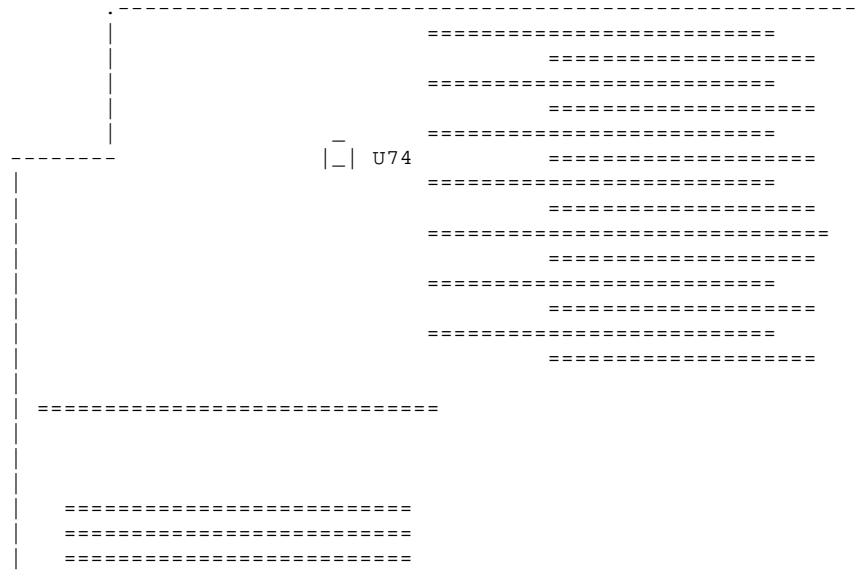
Locate the small chip at U74 and look for a tiny blue dot the size of a period (.). If this chip has a blue dot, the system board is good and can be installed. In the unlikely event that the tiny blue dot is missing and the Server 720 does not boot properly, order another system board FRU p/n 06H1810.

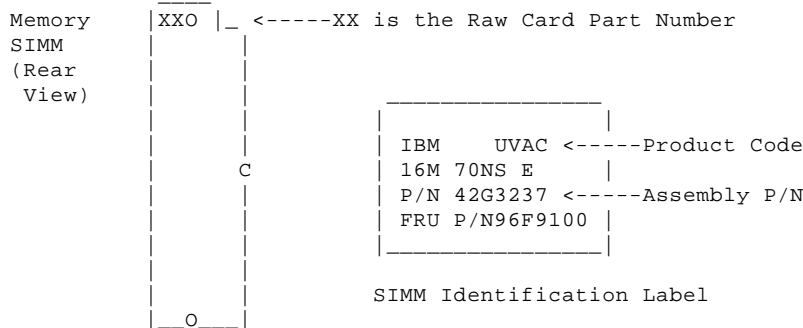
1. The system is exhibiting the failure symptoms.
2. The memory installed is IBM 16MB ECC 70ns, FRU P/N96F9100, Option 92G7209,
3. It must be assembly P/N 42G3237.
4. The raw card part number must be 32G8299-01. This number is located on the back side, above the notch of the card.
5. A product code 'UVAC' on the small white identification label on top one of the modules.

If NMI error symptoms are being experienced, only the memory SIMMs which meet the criteria described above should be replaced. If none of the SIMMs meet the description, normal problem resolution procedures should be performed.

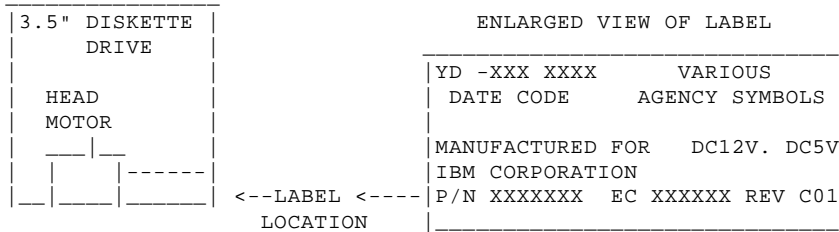
TOP VIEW OF DISKETTE DRIVE ASSEMBLY

THE AFFECTED DRIVES MAY BE IDENTIFIED BY REFERRING TO THE LAST NUMBER IN THE BOTTOM LINE OF PRINT OF THE LABEL IDENTIFIED IN THE FOLLOWING DIAGRAM:

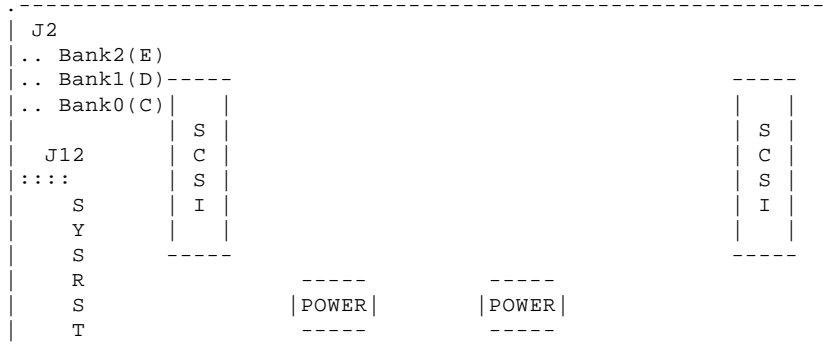
Note: 3518 Enclosures manufactured before 10/1/96 (MFG Date: 610 and earlier on the rear serial number label) shipped with a jumper incorrectly installed on J12. This jumper MUST be removed for proper operation.

1. Shutdown the operating system on the Server.
2. Power off the Server and the 3518 enclosure.
3. Unplug the 3518 for at least five(5) seconds. This action will ensure a full reset of the bus.
4. Verify the Backplane Jumper configuration for J2 and J12 on the 3518. Refer to pages 439-440 of the March 1996 PC Server HMM (publication number S30H-2501-01) and the diagram below.
 - a. J2 (Backplane Address jumper): Jumper MUST be installed on the pins for Bank0 for a single backplane system. If additional backplanes are installed, each backplane MUST have a jumper on the appropriate pins to ensure proper operation.
 - b. J12 (Backplane SCSI ID jumper): No jumpers should be present on pins 7-8 (labeled SYSRST).
5. Reconnect the power cord and power on the 3518.

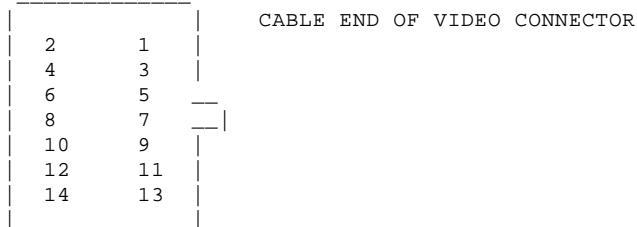
- 3) LOCATE PIN 9 (HORIZONTAL SYNC) AND PIN 11 (VERTICAL SYNC) ON THE CABLE END OF THE VIDEO CONNECTOR (J4).

- 4) WITH A DIGITAL VOLTMETER, MEASURE THE VOLTAGE BETWEEN PIN 9 AND GROUND, AND THEN BETWEEN PIN 11 AND GROUND (PINS 7 AND 8 ARE GROUND) AND RECORD VOLTAGES.
- 5) THE VOLTAGE MEASUREMENTS SHOULD BE BETWEEN 4.9 AND 5.2 VOLTS DC, BUT MORE IMPORTANTLY, BOTH SHOULD BE THE SAME VALUE (WITHIN .1 VOLT OF EACH OTHER).
- 6) IF THE VOLTAGES MEASUREMENTS ARE WITHIN TOLERANCE, THE SYSTEM BOARD SHOULD BE REPLACED.
- 7) IF THE VOLTAGE MEASUREMENTS ARE NOT WITHIN TOLERANCE, THE DISPLAY SHOULD BE REPLACED. IF THE SCREEN CONTINUES TO ROLL AFTER REPLACING THE DISPLAY, THEN THE SYSTEM BOARD HAS BEEN DAMAGED AND SHOULD ALSO BE REPLACED.

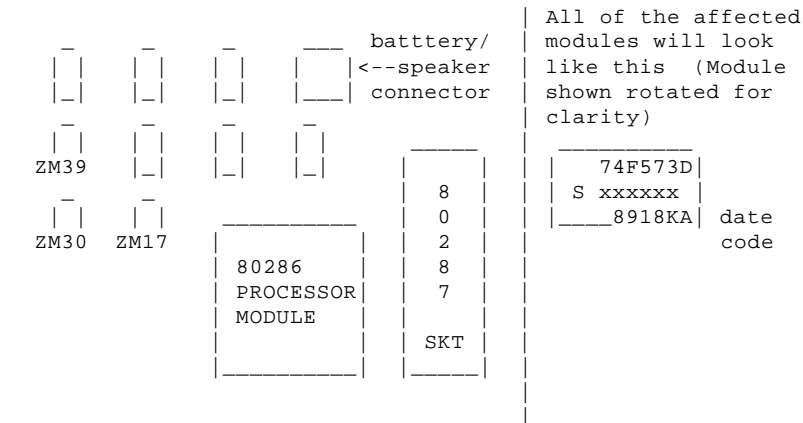
- A. The system functioned normally prior to the upgrade.
- B. If the upgrade is removed, the system will function normally and the diagnostics will run error-free.
- C. The modules at system board locations ZM17, ZM30 and ZM39 must have a large "S" on the left side of the module. Refer to the following diagram for the locations of the affected these modules:
- D. The module identified above, also has a six character date code such as, 8918KA. If the sixth character position of this code is either an "A" or is blank, the module is affected. If any other Alphanumeric character is in this position the system board is NOT AFFECTED.

Refer to the following diagram for the locations of these modules:

If this problem is encountered during the installation of the processor upgrade:

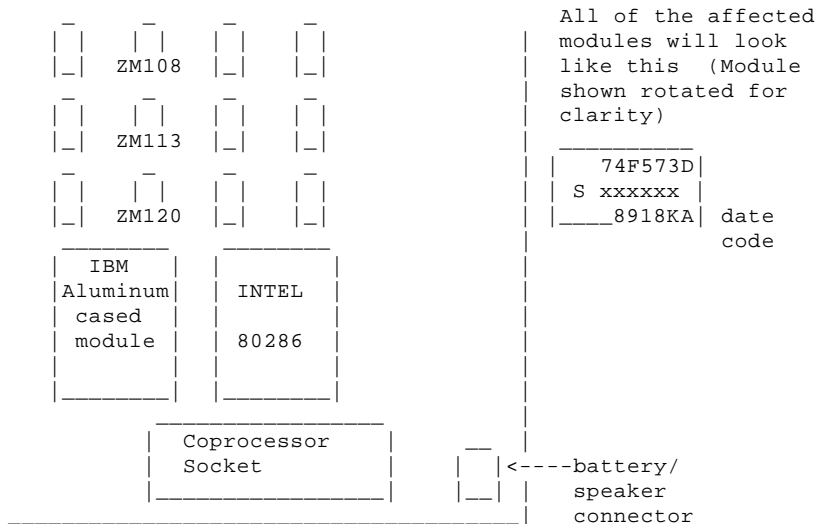
- A. The system functioned normally prior to the upgrade.
- B. If the upgrade is removed, the system will function normally and the diagnostics will run error-free.
- C. The modules at system board locations ZM120, ZM113 and ZM108 have a large "S" on the left side of the module.
- D. The module identified above, also has a six character date code such as, 8918KA. If the sixth character position of this code is either an "A" or is blank, the module is affected. If any other Alphanumeric character is in this position the system board is NOT AFFECTED.

Refer to the following diagram for the locations of these modules:

If this problem is encountered during the installation of the processor upgrade:
