Lake Sarah (Hennepin County)
Eurasian Watermilfoil Survey &
Curlyleaf Pondweed Post-Treatment Inspection
May 23, 2017

Prepared for the Lake Sarah Improvement Association

Report Date: May 25, 2017

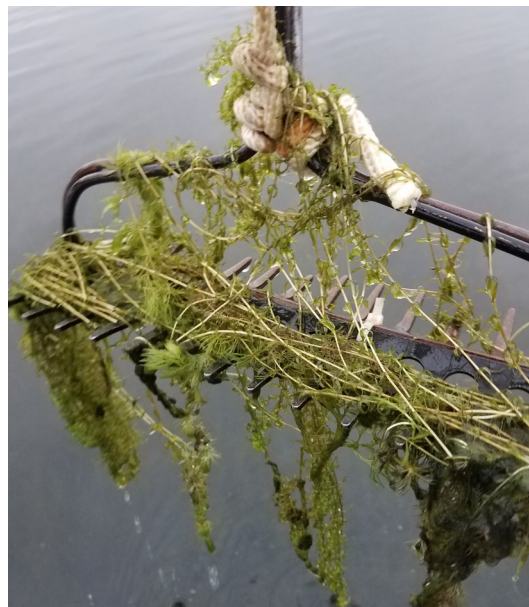
Based on observations from this survey and past surveys, Eurasian Watermilfoil appears to be less abundant in 2017 than previous years. Elodea and Coontail appeared to be more abundant and growing in historical areas usually occupied with more EWM. EWM plants were mostly scattered, with some dense patches found in several areas of the lake. Each area of the lake will be discussed in the following sections of this report, with some management recommendations for each area.

Elodea sampled on the rake during survey
