Technical BULLETIN

2002 SXV700G, SXV700ERG

Hood & Belly Pan Misalignment & Hood Cracking

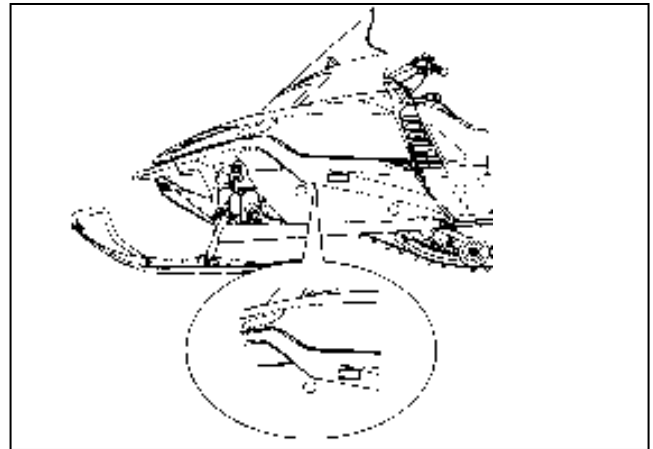
Problem: When riding in rough trail conditions, the hood can become dislodged and misaligned with the belly pan.

Cause: Belly pan flexing.

Remedy: Modify the hood and belly pan to prevent misalignment and hood cracking.
