## Battery Gunnison/New Battery Peck Hoist #1 Restoration

Ft. Hancock, New Jersey

*(Work completed 2002 through September 2021; outline remaining work)*

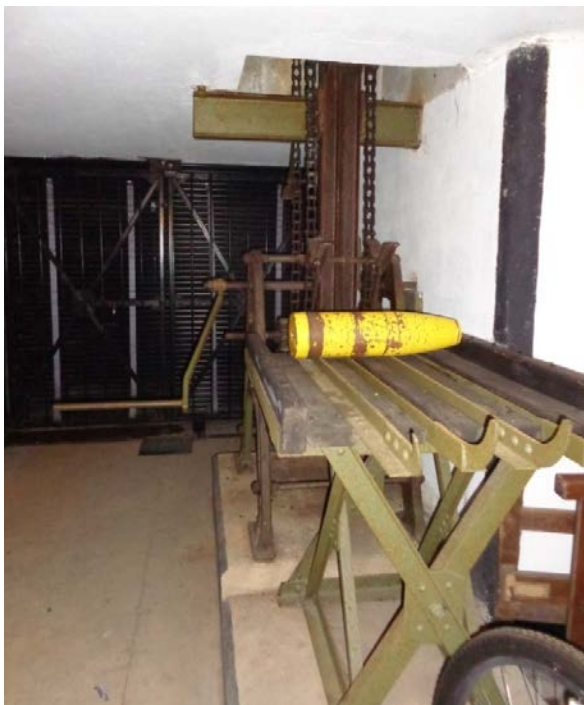
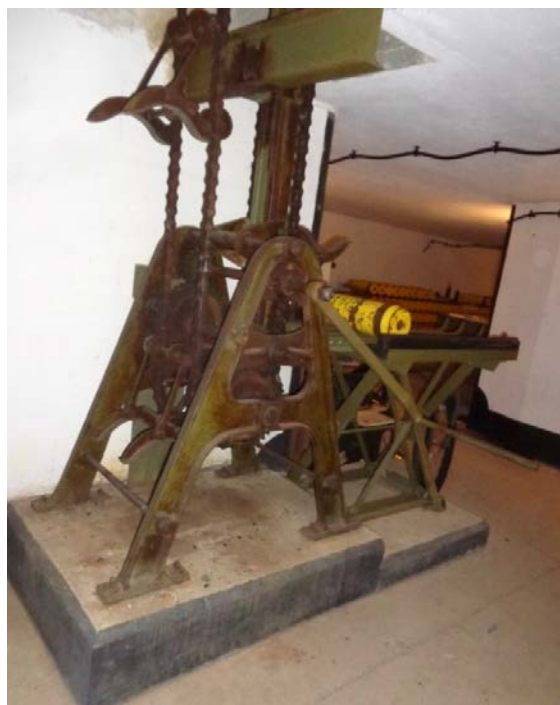
The two photos below show Gun #2 hoist as restored and painted by 2007. AGFA found a crank handle to replace the one that was missing. The shell table was in generally good condition. The existing wood was heavily soaked in linseed oil.

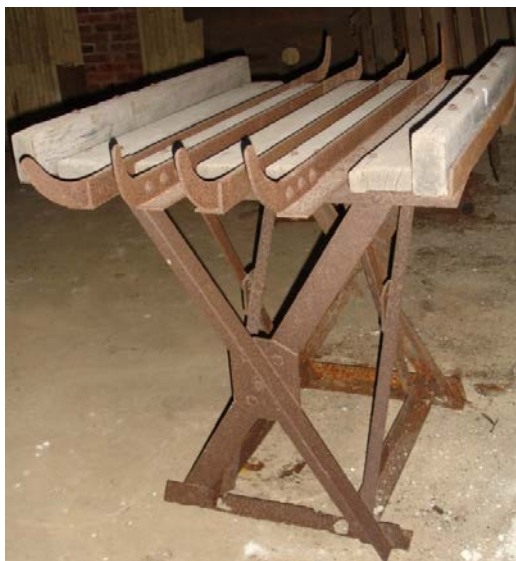
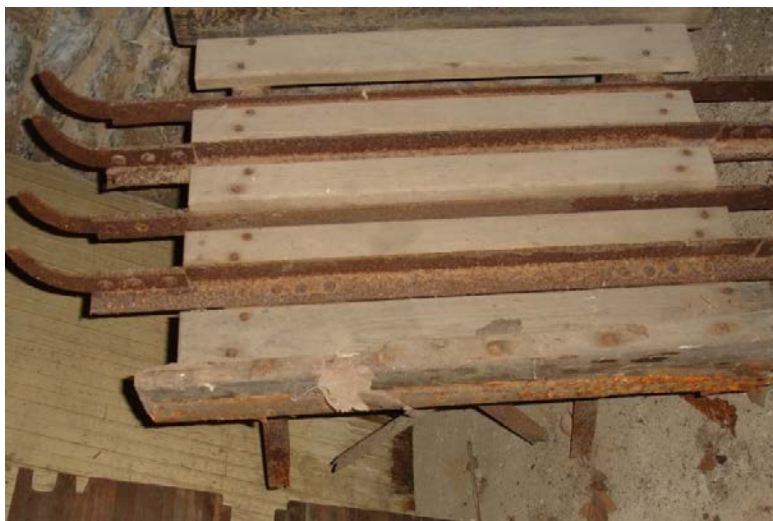
The lower receiving table for Hoist #1 and #2 were actually in storage. In 2007 we moved the hoist table for Gun #2 from storage to Battery Gunnison/New Battery Peck where it was cleaned, rust removed, primed and painted. The shell table for Hoist #1 (right picture) was more problematic with most of its legs rusted away. In 2007 this table awaited a future restoration.

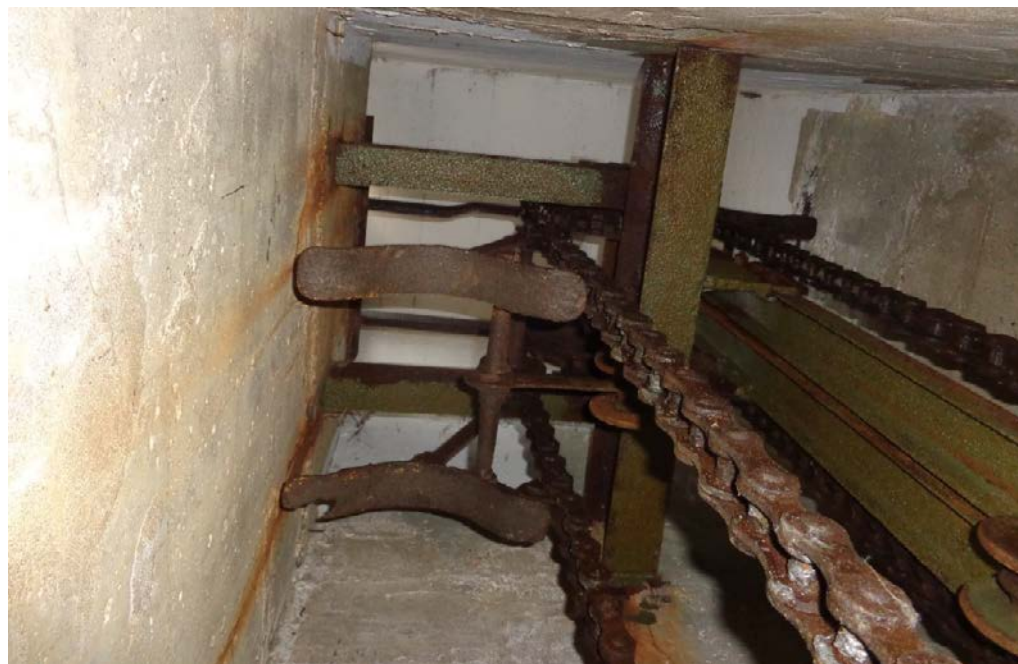
A view from the base of hoist #2 up the shaft is shown below. Notice inside the shaft is one large cross beam (7-inch web). The upper chain gear rests on the two smaller beams that are cast in the concrete and rest on top of the cross beam. The vertical beam is where the chain and hoist arm assemblies ride. Notice the basic fixtures are painted OD with a strong undercoat of rust reformer. The links are well greased.

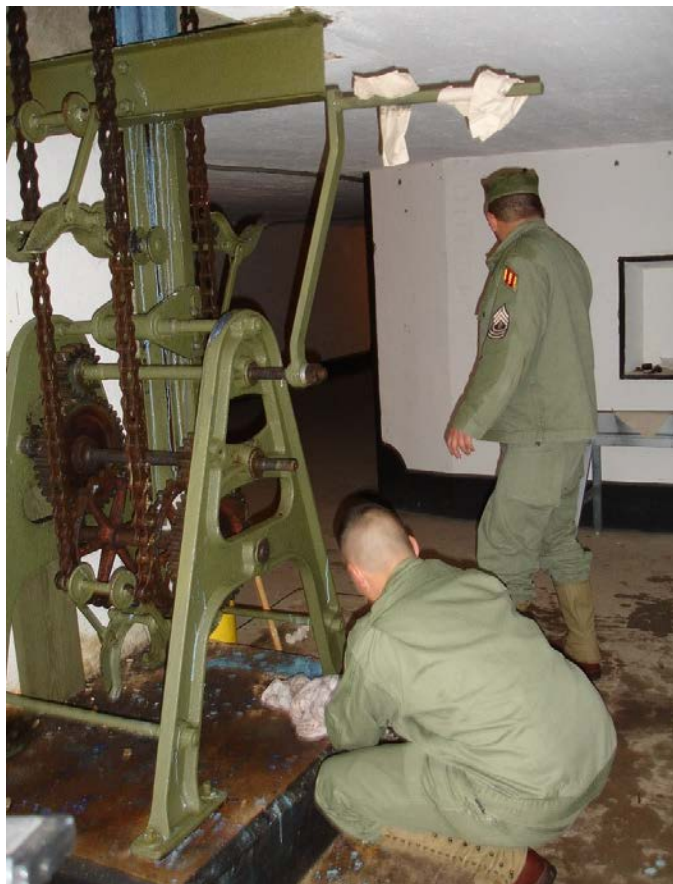
The photo below from April 2006 shows the hoist receiving its first full coat of OD Paint since probably 1945. This is after all moving parts were well greased. This is prior to the return of the Shell Table. Below 1<sup>st</sup> SGT Murray and PVT Minton clean the hoist.

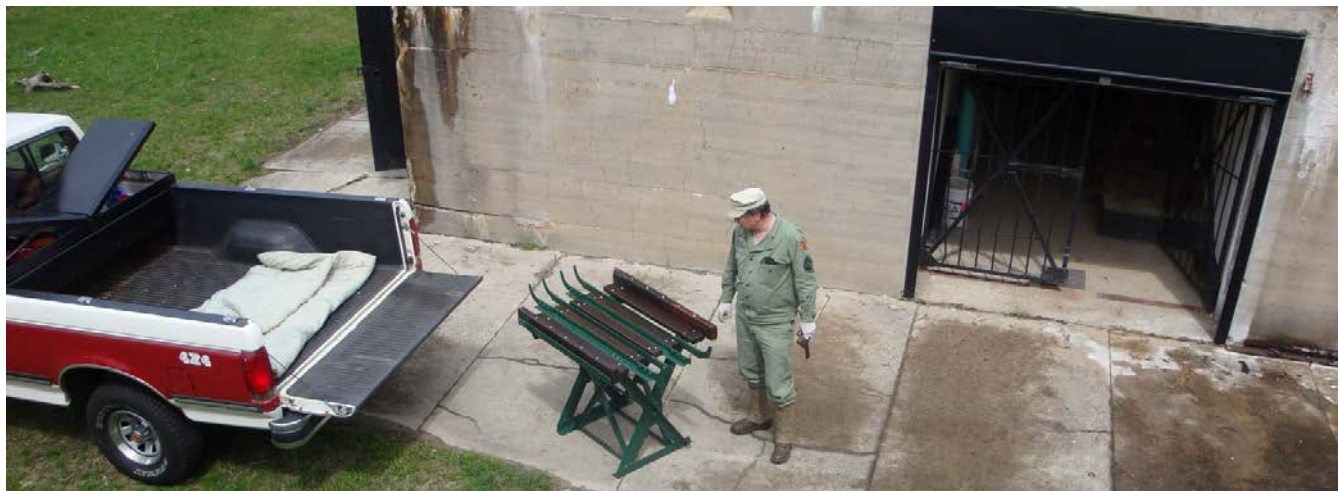
Work on Hoist #1 has been moving intermittently since about 2008. In April 2010 we received the reconstructed shot table for Hoist #1. In the photo below the contractor delivers the restored shell table. He performed the work under the direction of Dan Meharg and AGFA. Below 1<sup>st</sup> SGT Murray accepts the shell table.

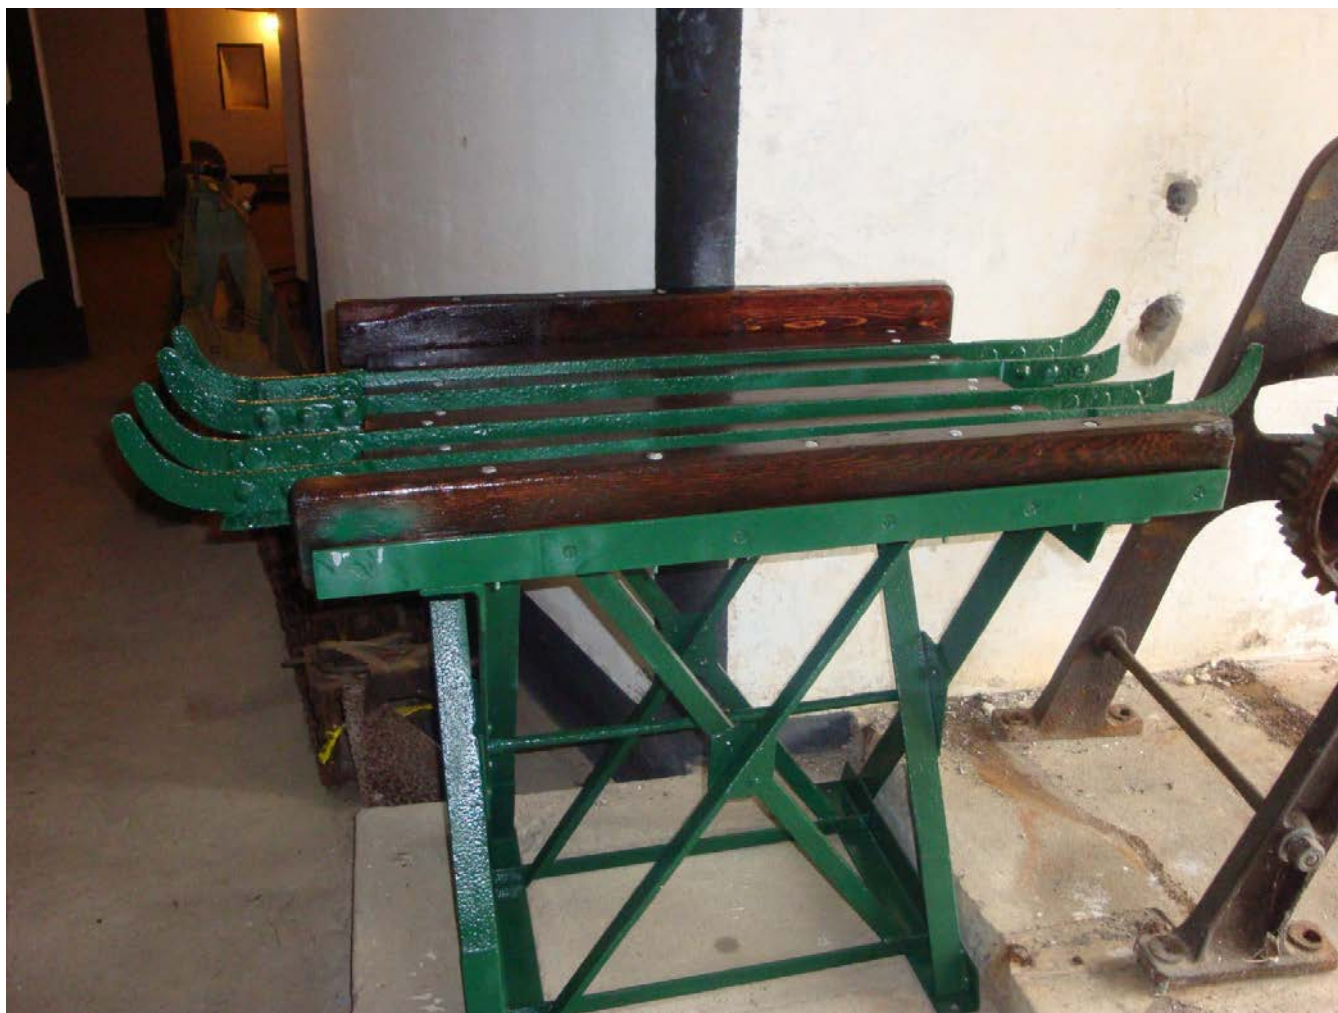
Below the reconstructed shot table, complete with new legs and supports, is placed in its original position on its concrete pad. The work was quite well done. The gloss paint was soon covered by flat OD paint.

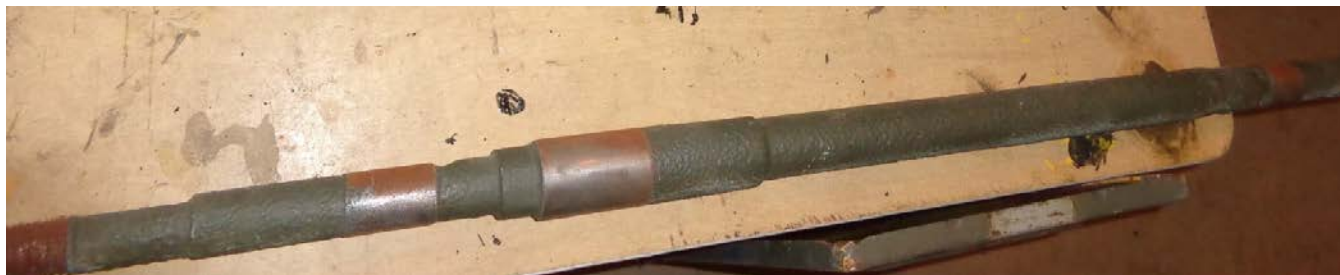
The primary shaft has been removed from the frame and has been polished.

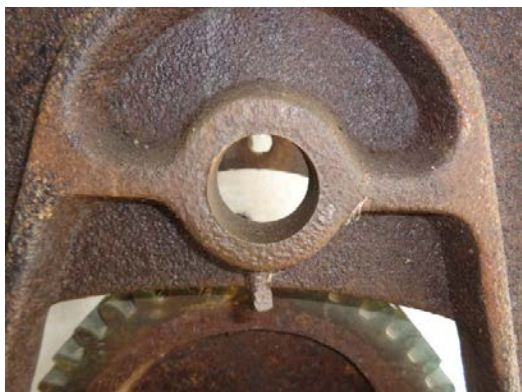
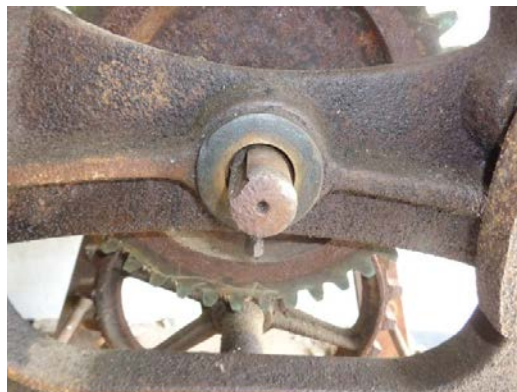
The photo on the left shows the upper location for the primary shaft. The photo on the right shows the second shaft and the brass shaft bushing insert.

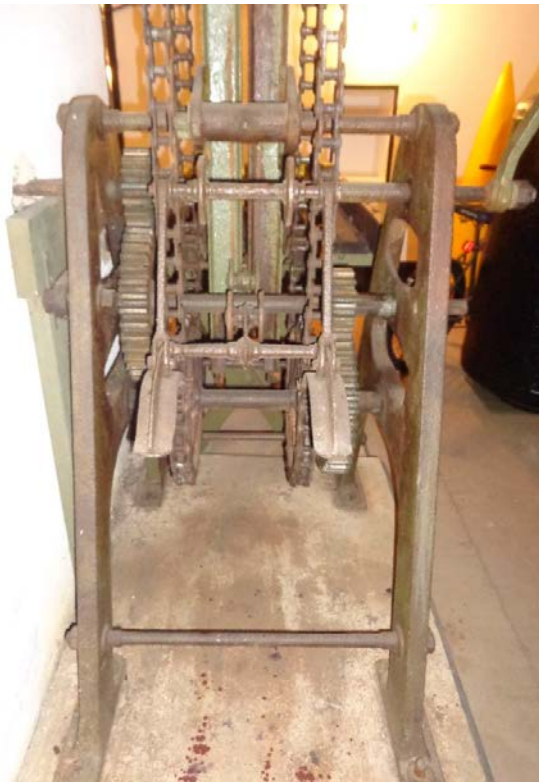
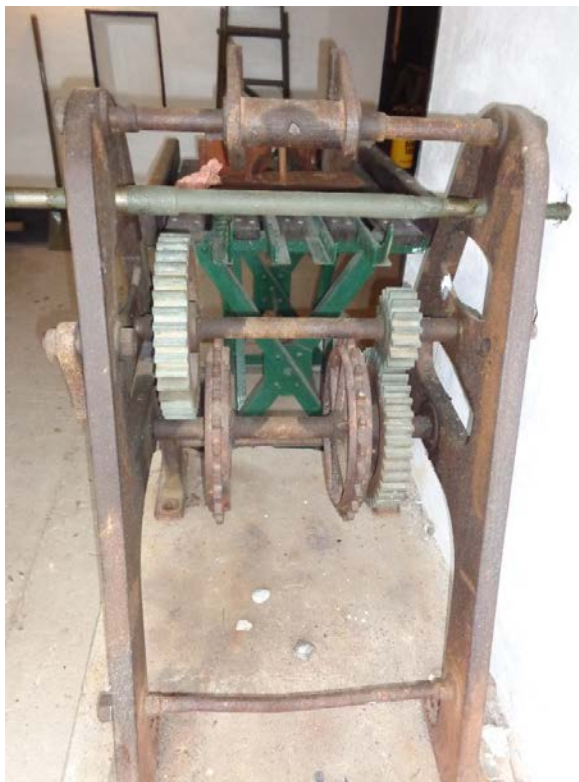
The photo on the left show restored hoist #2. The photo on the right shows the unrestored hoist #1 with the main shaft partially inserted into is location.

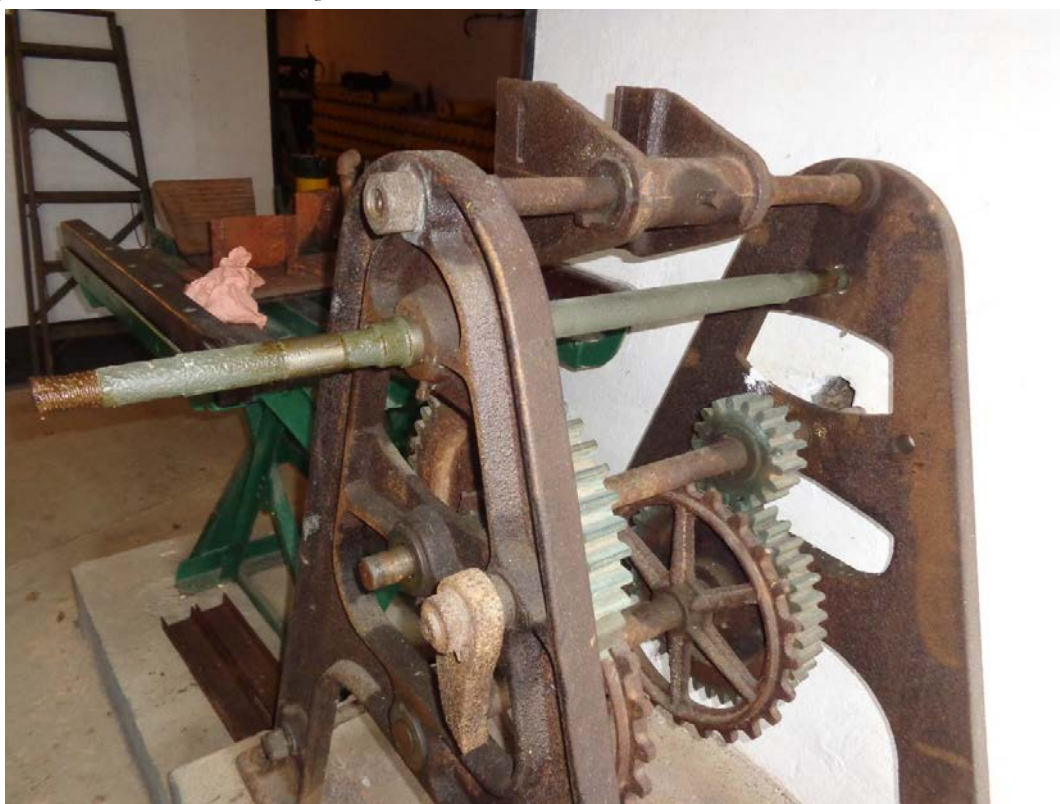
The photo below shows another view of Hoist #1 frame with the upper main shaft partially inserted into its position.

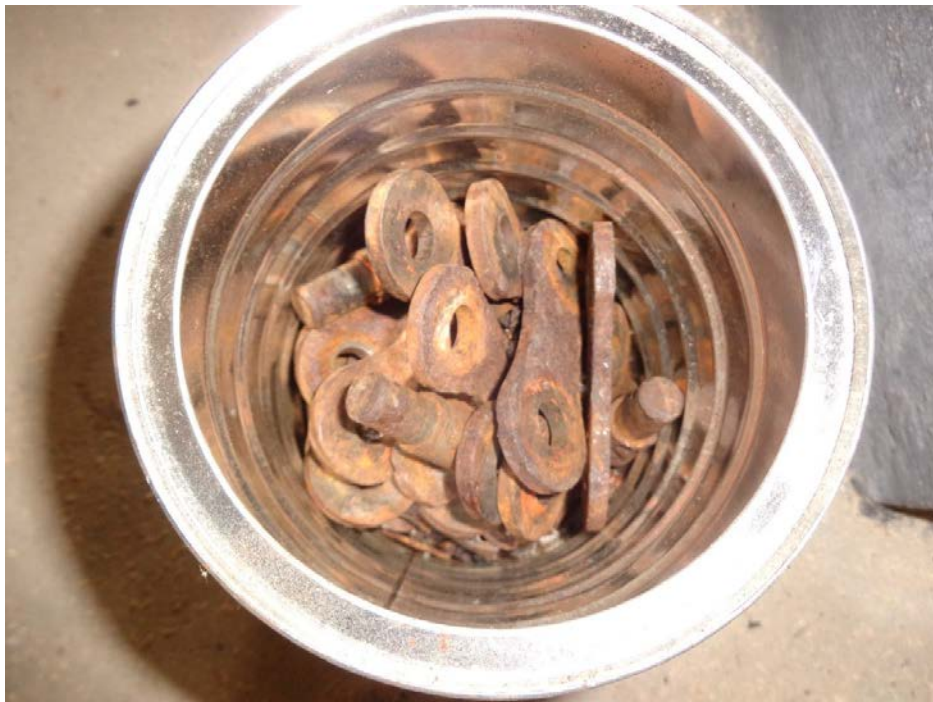
The hoist chain is very likely to need additional links and link parts. The can below show what additional parts we have on hand.

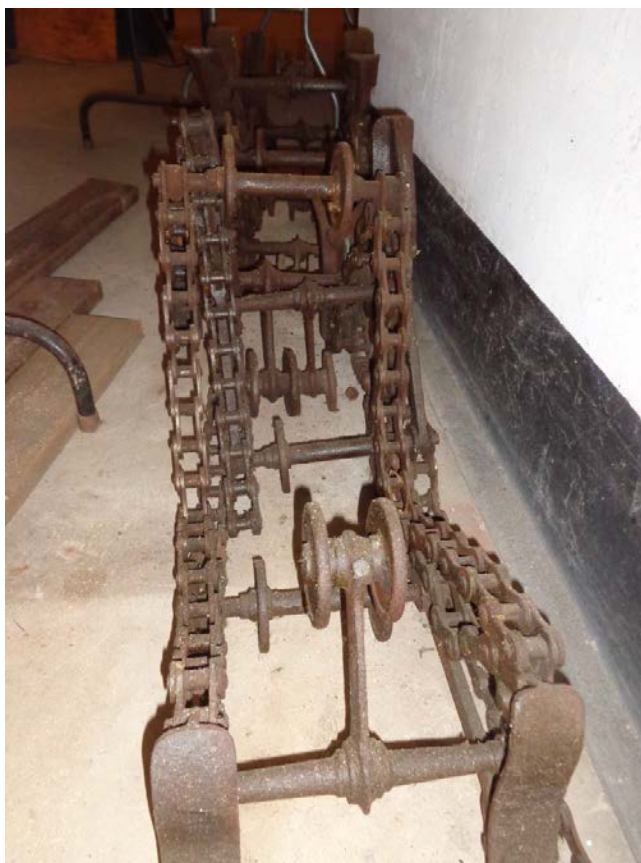
The chain assembly is in storage inside the magazine. This chain and shell hoist arms and rollers will be disassembled, cleaned of rust, reassembled and greased using cosmoline.

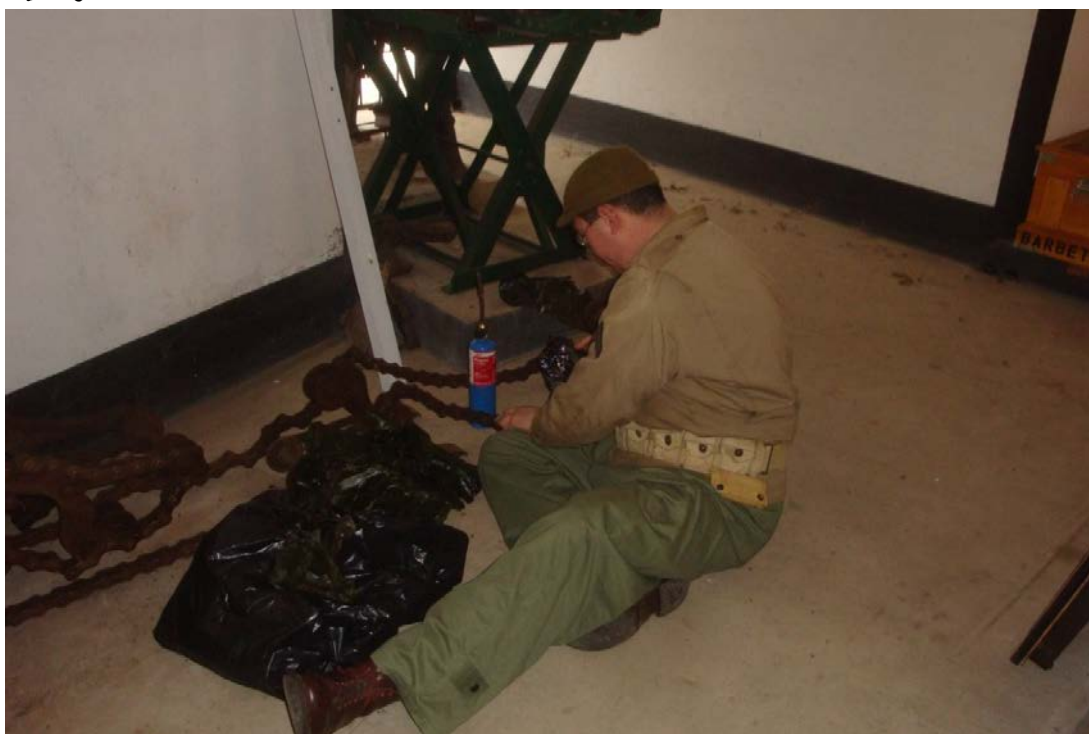
The chain has been given a rudimentary cleaning and greasing for protection pending rehabilitation. In the photo below the chain is receiving its first cleaning about 2015 by CPL Weiselman.

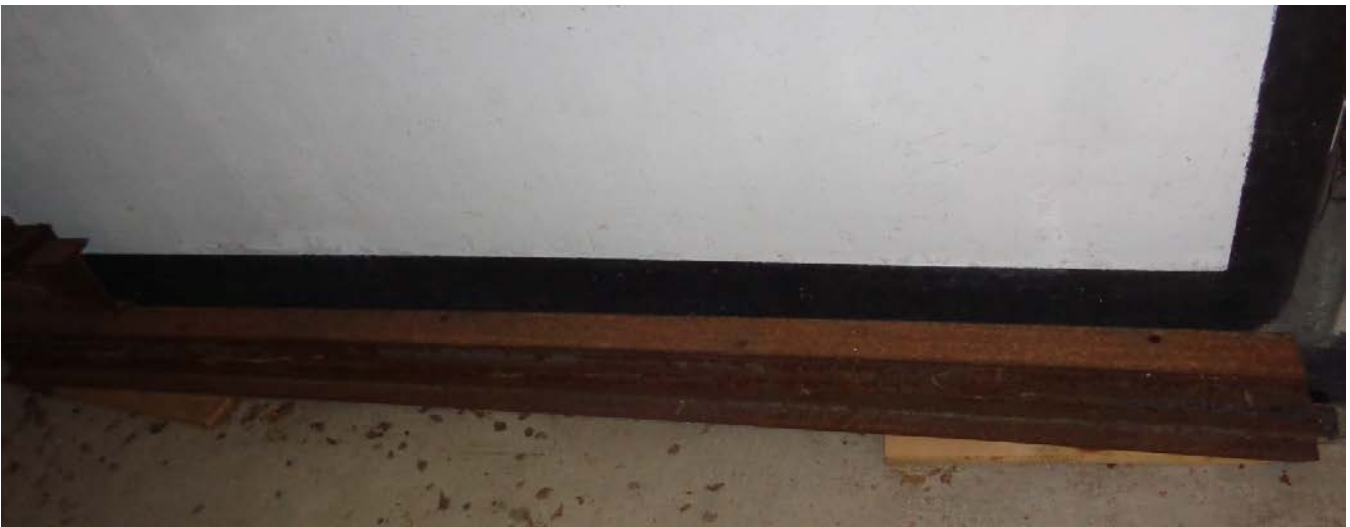
Critical to the hoist restoration is the location of a 7-inch beam. No steel company in 2018 will produce a 7-inch beam. We were extremely fortunate to find one in relatively good condition. Two sections of beam are required. One will be welded inside the shaft (see photo above). The other will be welded to a stub on the wall and secured with a keeper on ceiling of the magazine. These beams hold the vertical travel beams shown on the next page.

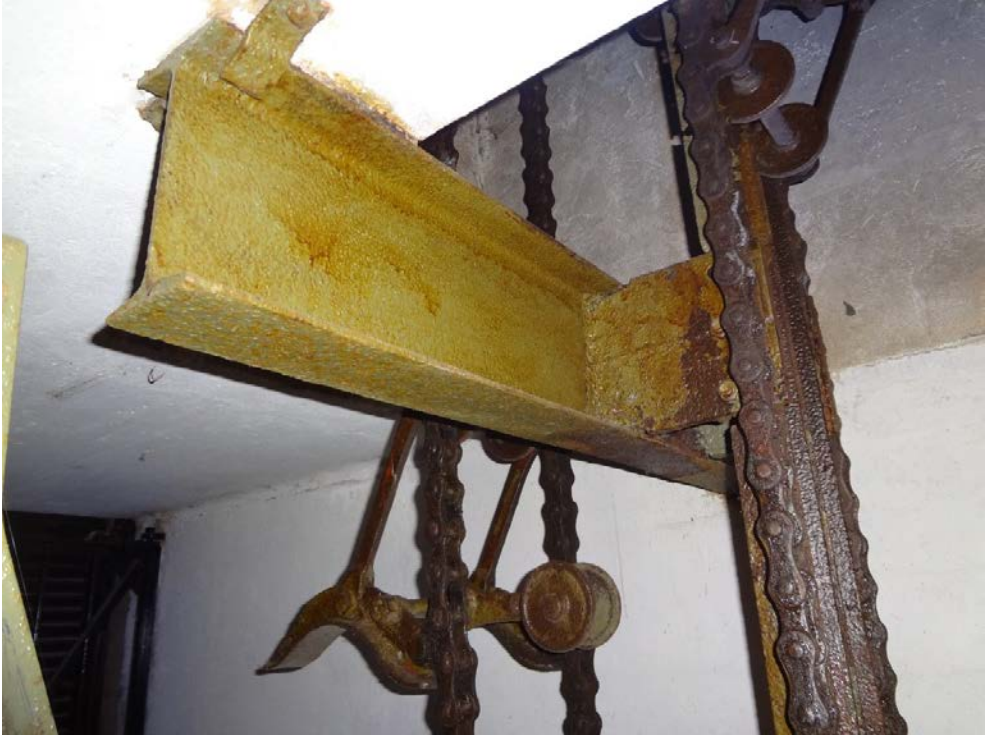
The photo below shows the Hoist #2 lower 7-inch I-beam in place. This beam will be welded back into the wall for Hoist #1 and secured to the ceiling of the magazine as shown below.

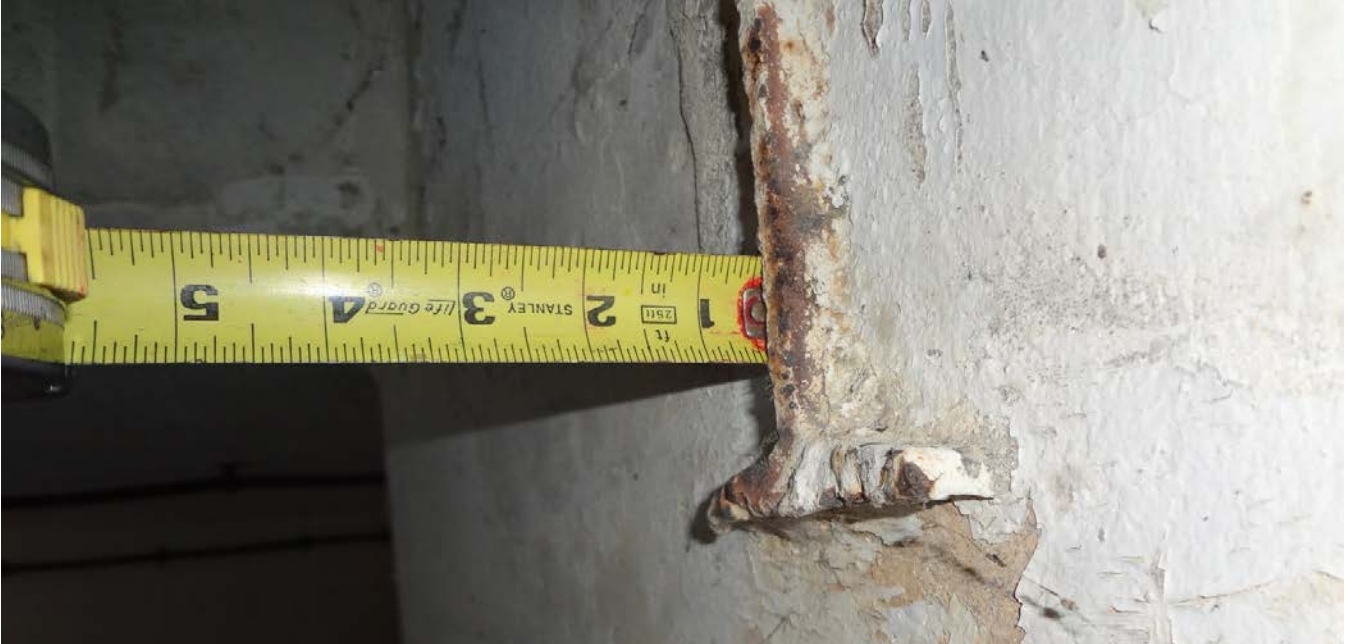
The photo below shows the remaining half inch stub in the wall for hoist #1's lower 7-inch I-beam. There is enough metal to work with to weld a new beam in place against this remaining stub.

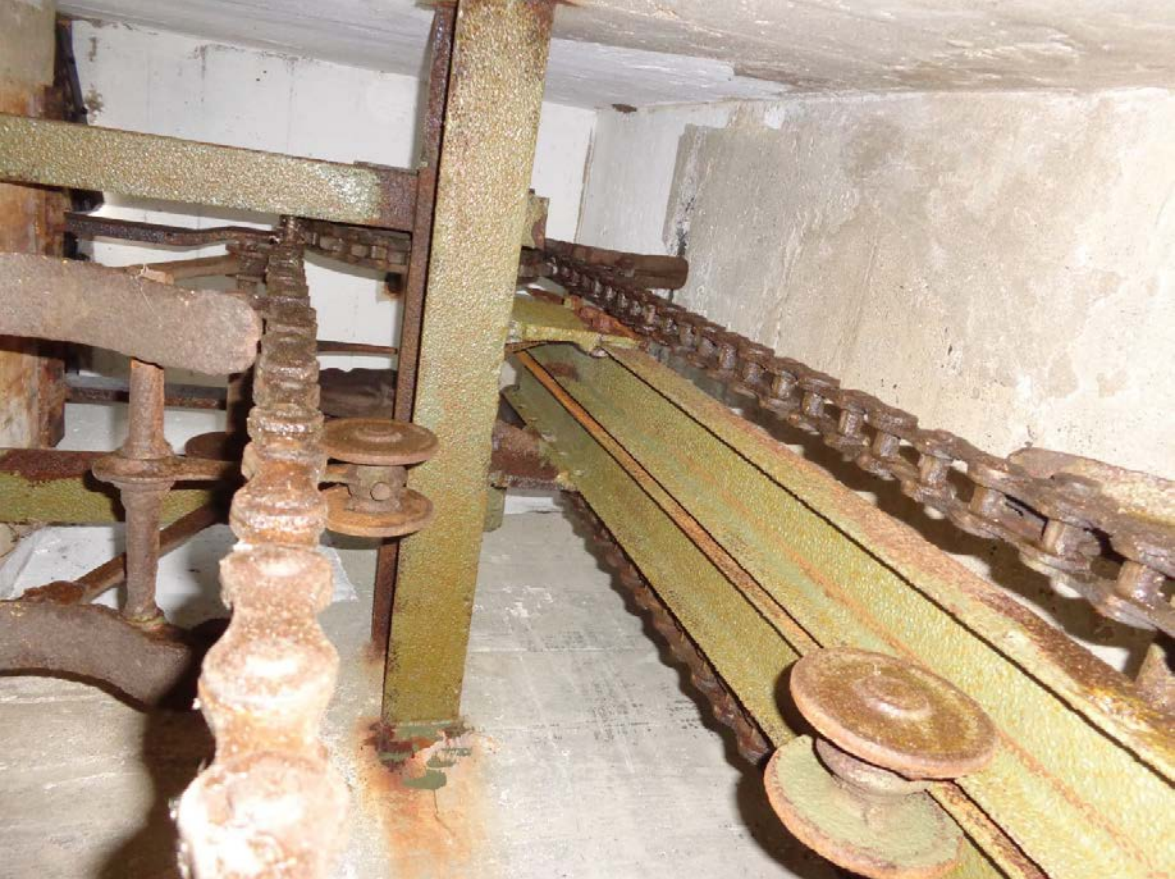
The photo below shows the double H-beams (right side) upon which the chain travels. For Hoist #1, these two beams will be fabricated. The dimensions are standard so procurement is readily executable.

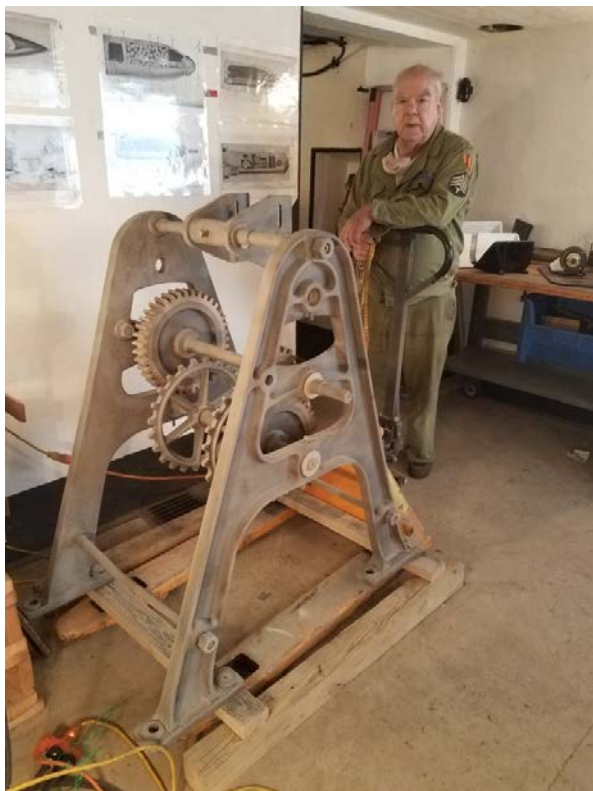
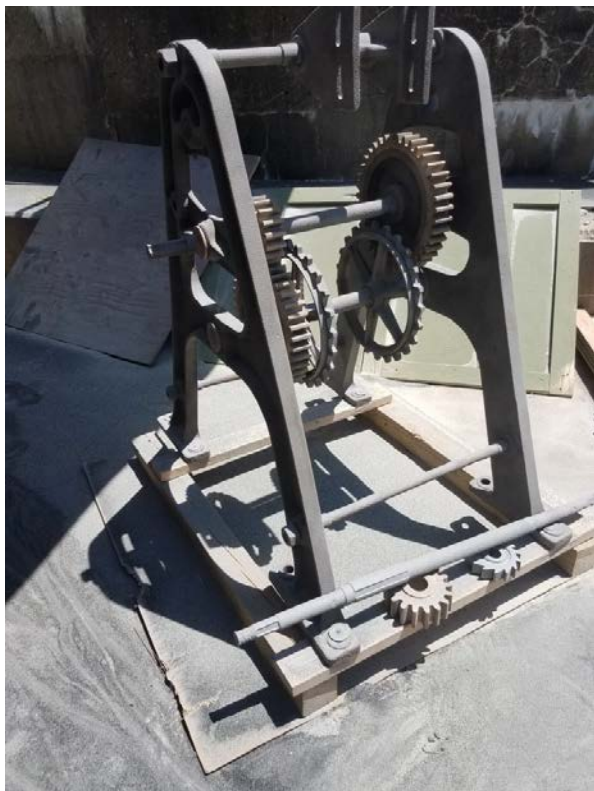
On 8 June 2020, T-4 King secured support of Chris Wisniewski (Blown Away Blasting, LLC) and removed the rust from all the hoist parts and the beams that were to be re-welded into the hoist shaft.

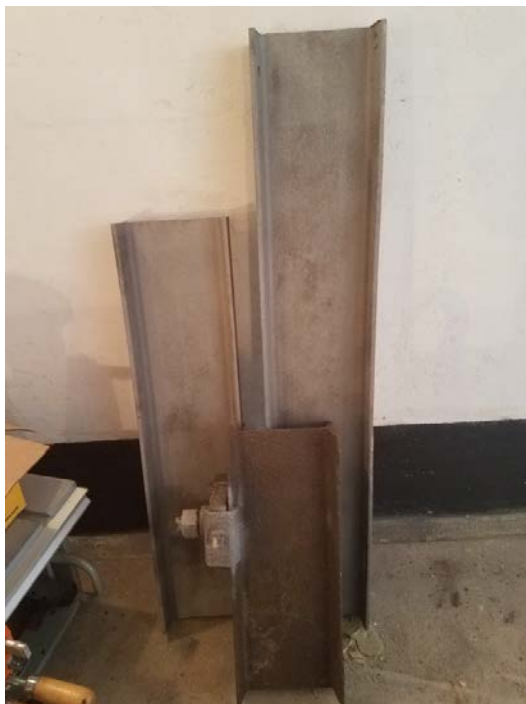
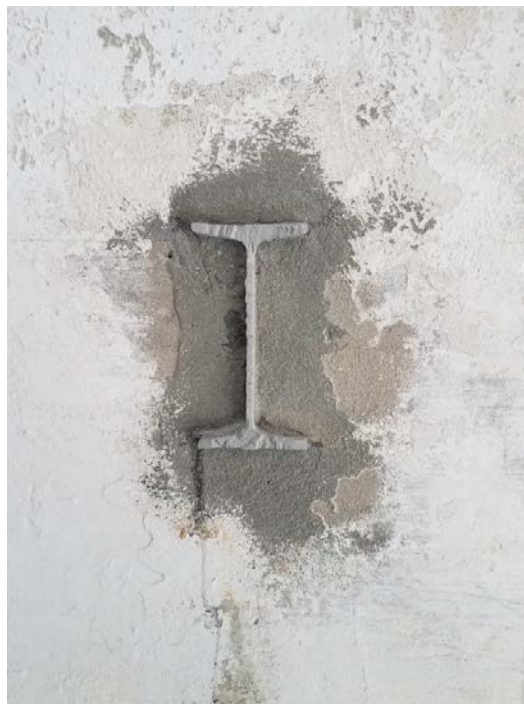
The photo on the left shows three beams. The short one on the left will be placed in the upper section of the hoist #1 shaft. The longer beam will be placed in the lower area. The photo to the right shows the torched beam stub where the longer beam will be attached by welding.

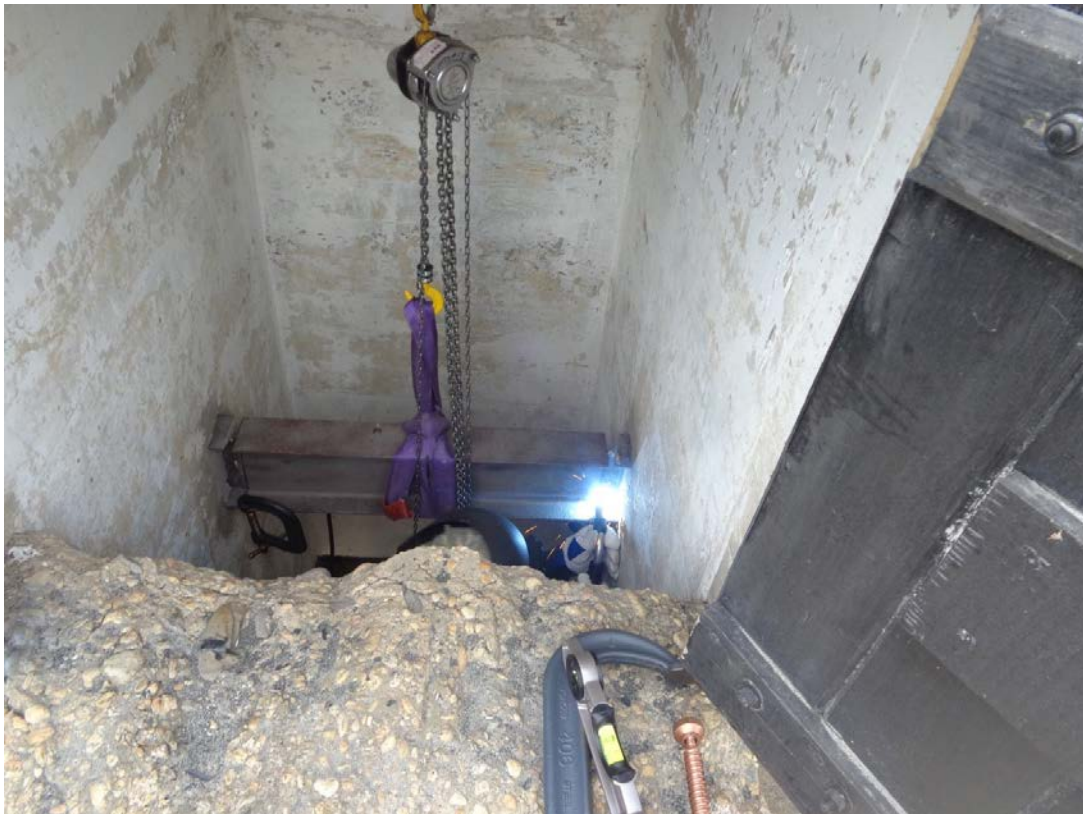
Below Mike welds the beam into place.

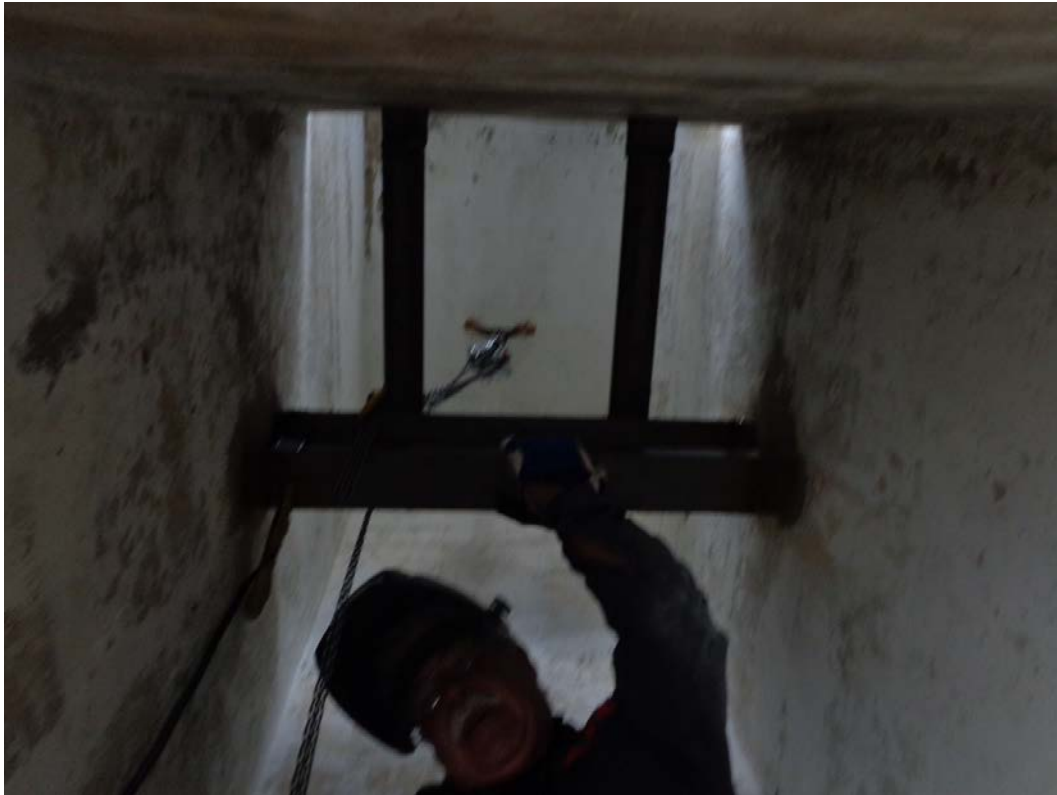
In the photo below Mike just finished welding the 3-inch I beams into place.

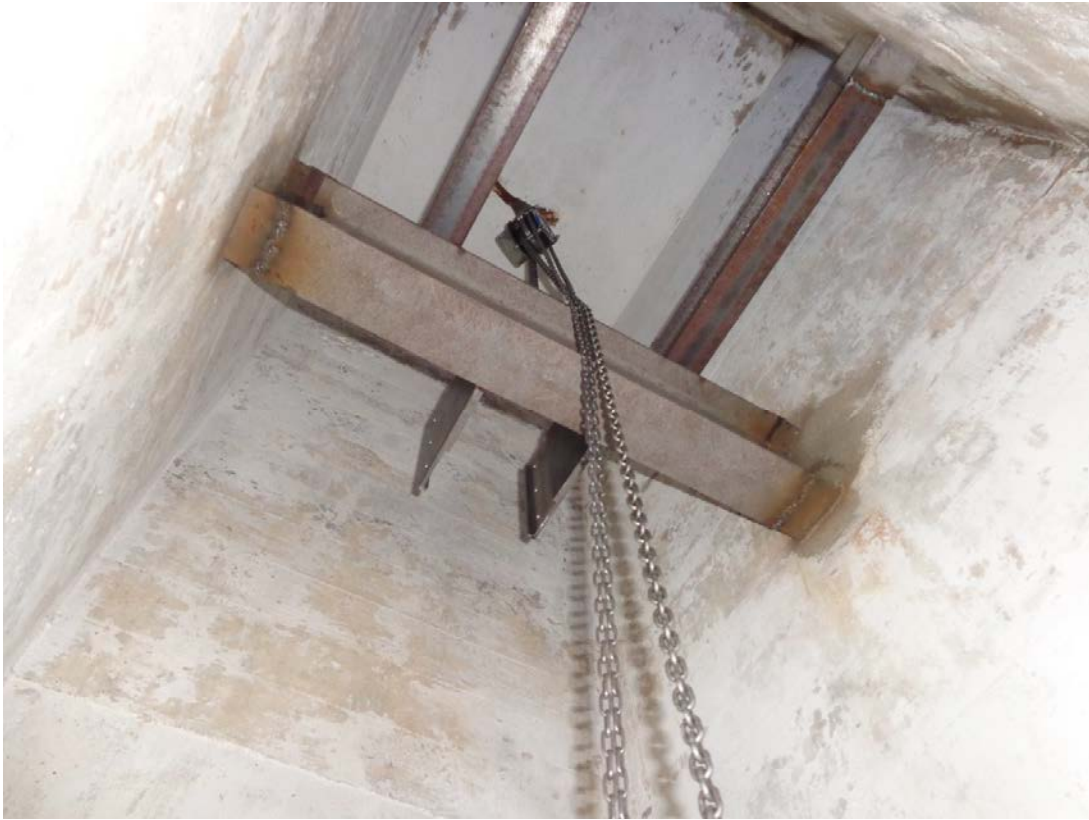
The photo below shows the two brackets welded into place.

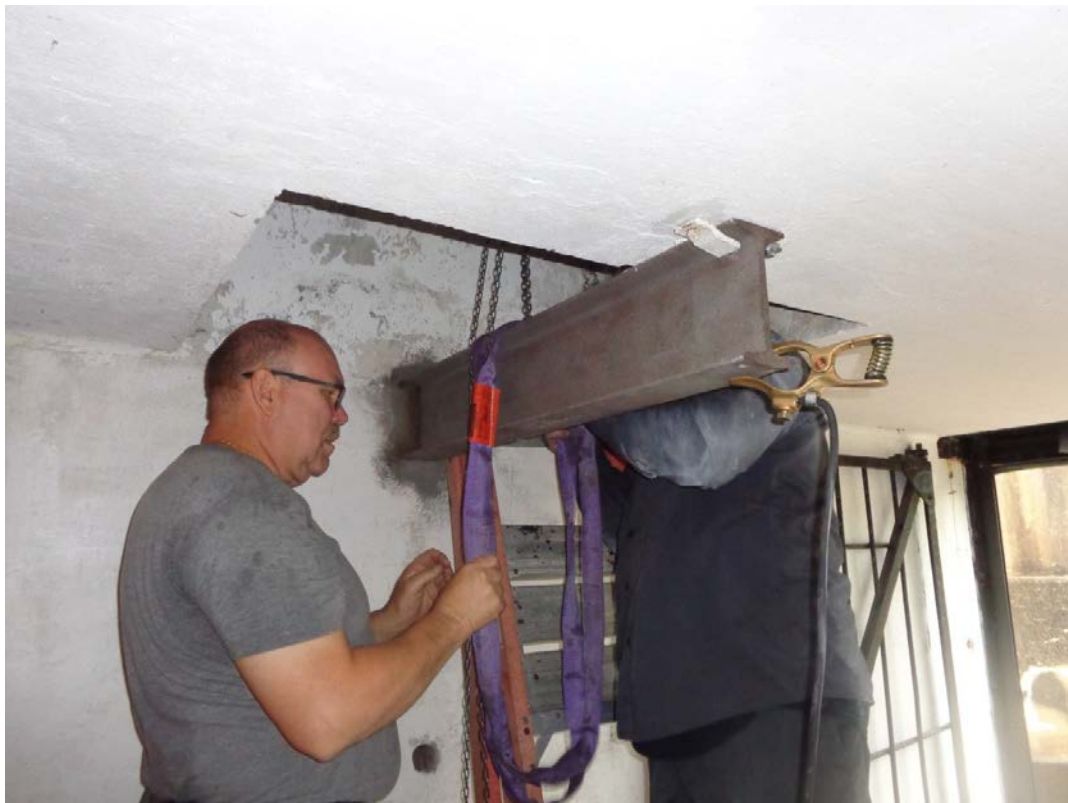
Below T-4 Ciemniecki and Mike Brennan prepare the lower 7-inch I beam for welding into place.

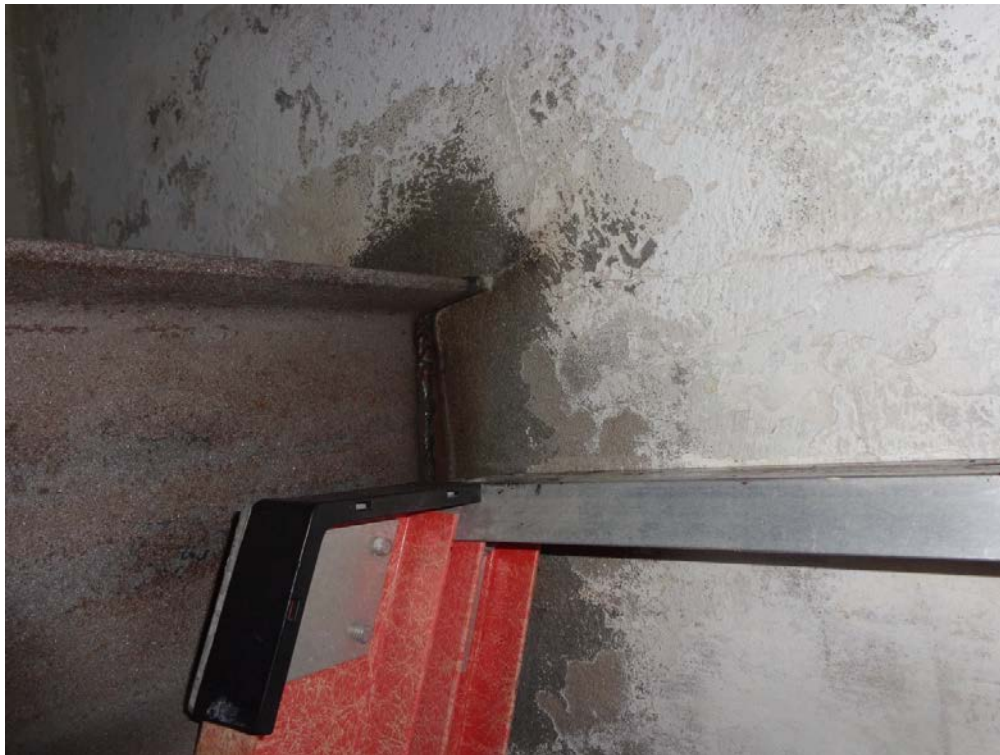
Below shows the welding point for the lower 7-inch I beam. The red/aluminum object next to the beam is a ladder.

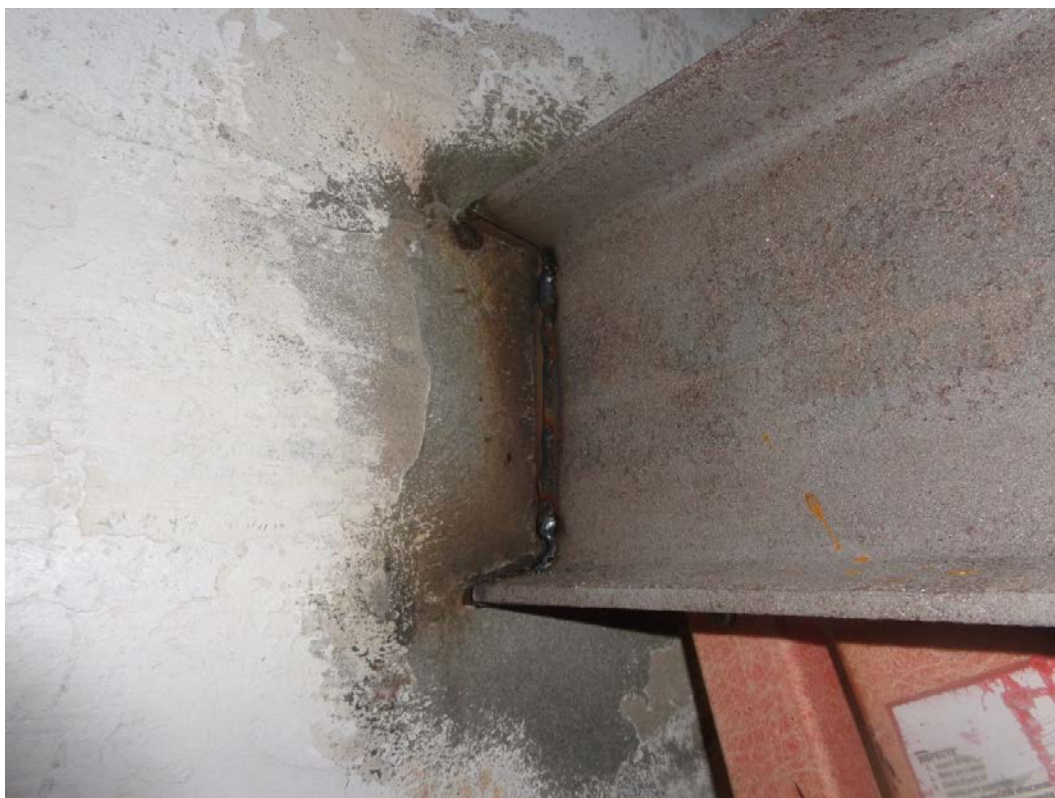
The view below shows the lower 7-inch I beam welded to the stub in the wall from the historic beam that was torched out in 1964.

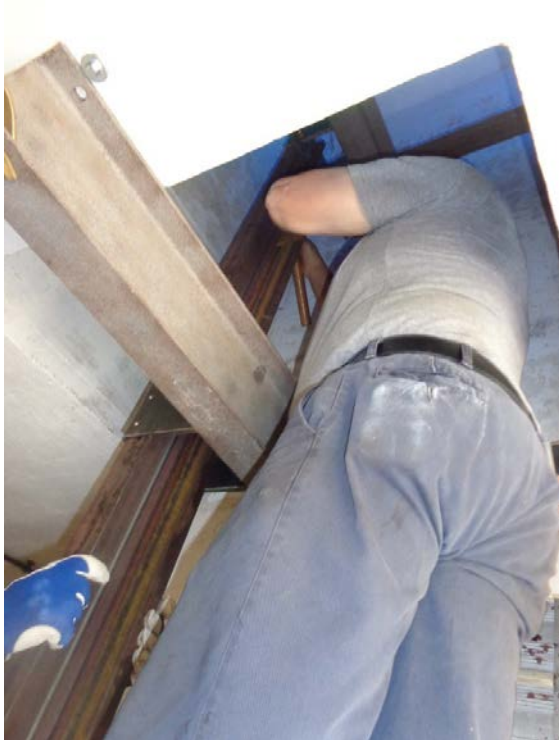
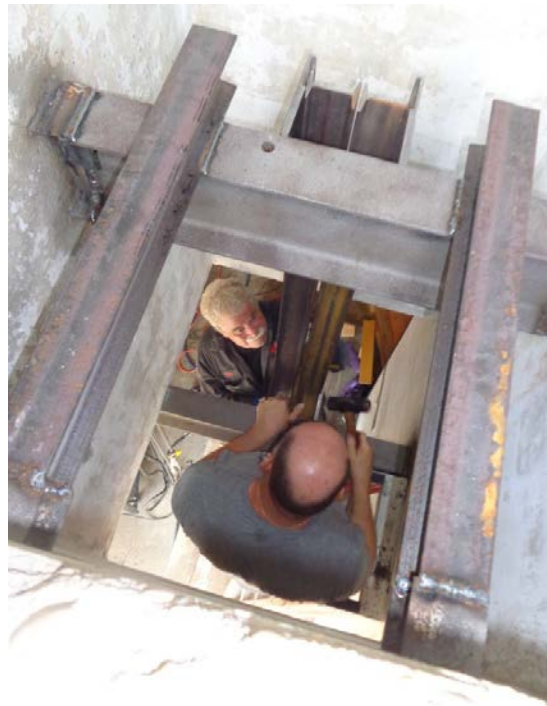
Once the two 7-inch I-beams and their brackets were in place, Mike and T-4 Ciemniecki placed the two long H-beams into place to check the distances.

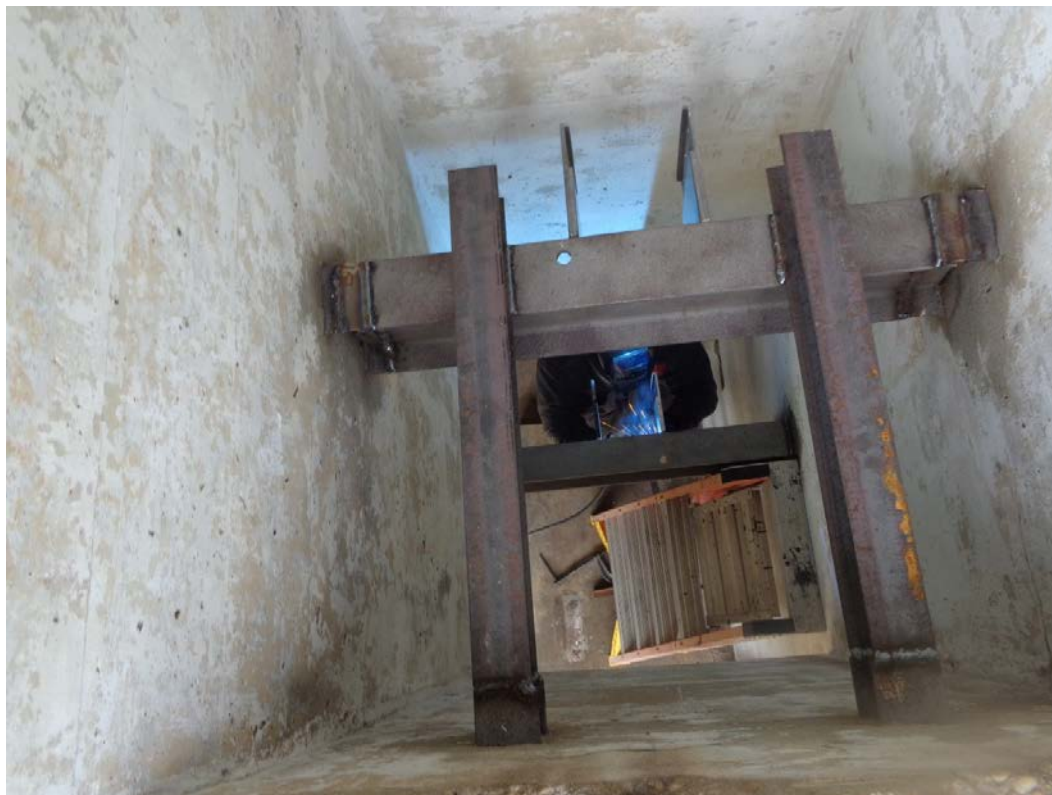
After the distances were confirmed, the two H-beams were removed and Mike made some welding adjustments to the lower 7-inch I-beam's brackets.
