## Battery Gunnison/New Battery Peck Hoist #1 Restoration

Ft. Hancock, New Jersey

*(Work completed 2002 through September 2021; outline remaining work)*

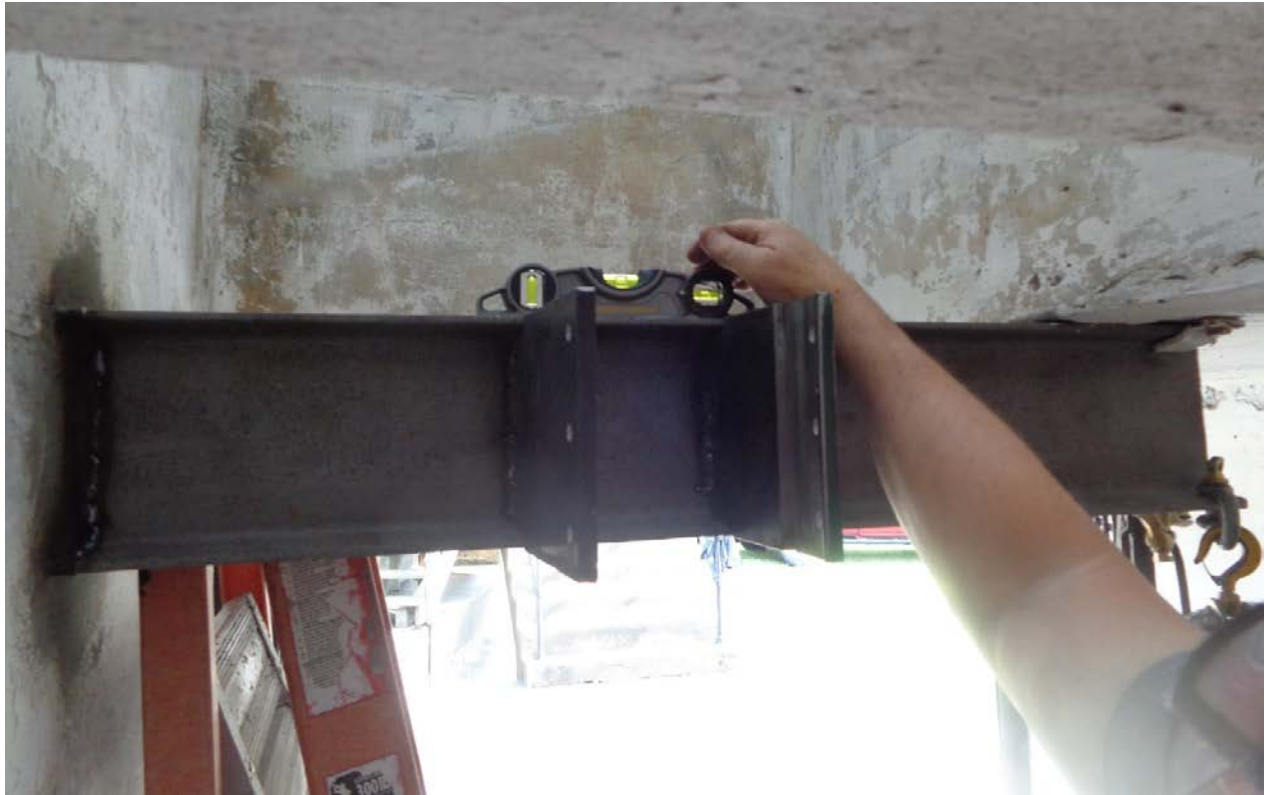
Below T-4 Ciemniecki confirms the level of the lower 7-inch I-beam.

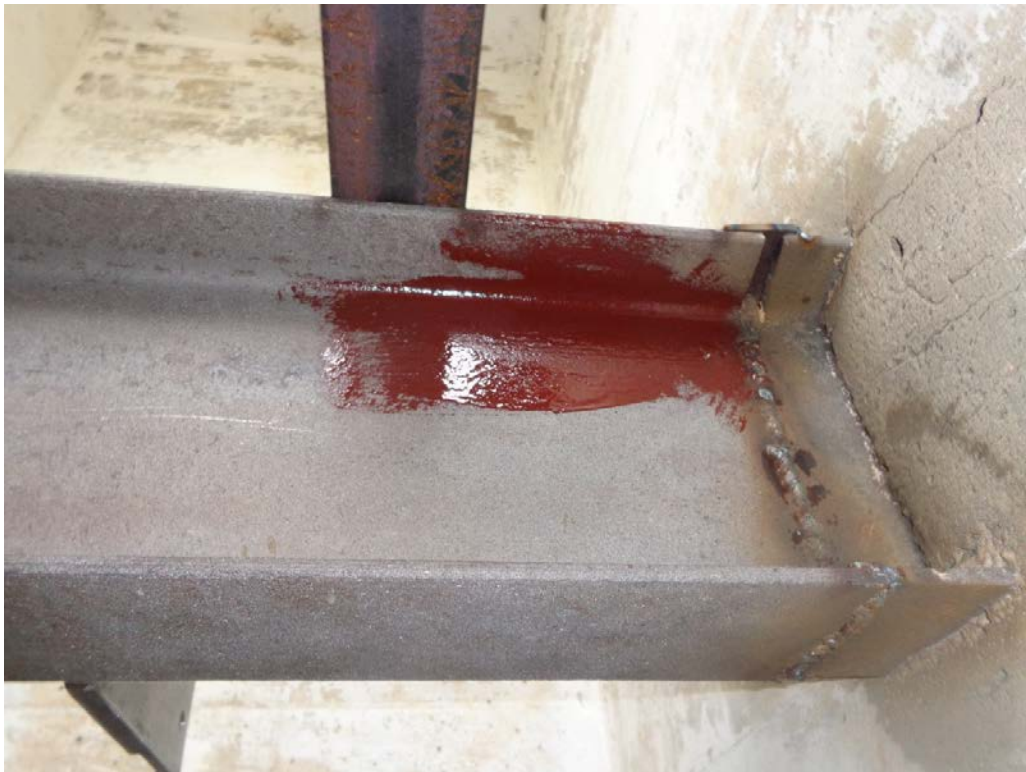
Below is a view of the upper 7-inch I-beam showing the weld to the stub in the wall and the first applications of red zinc primer.

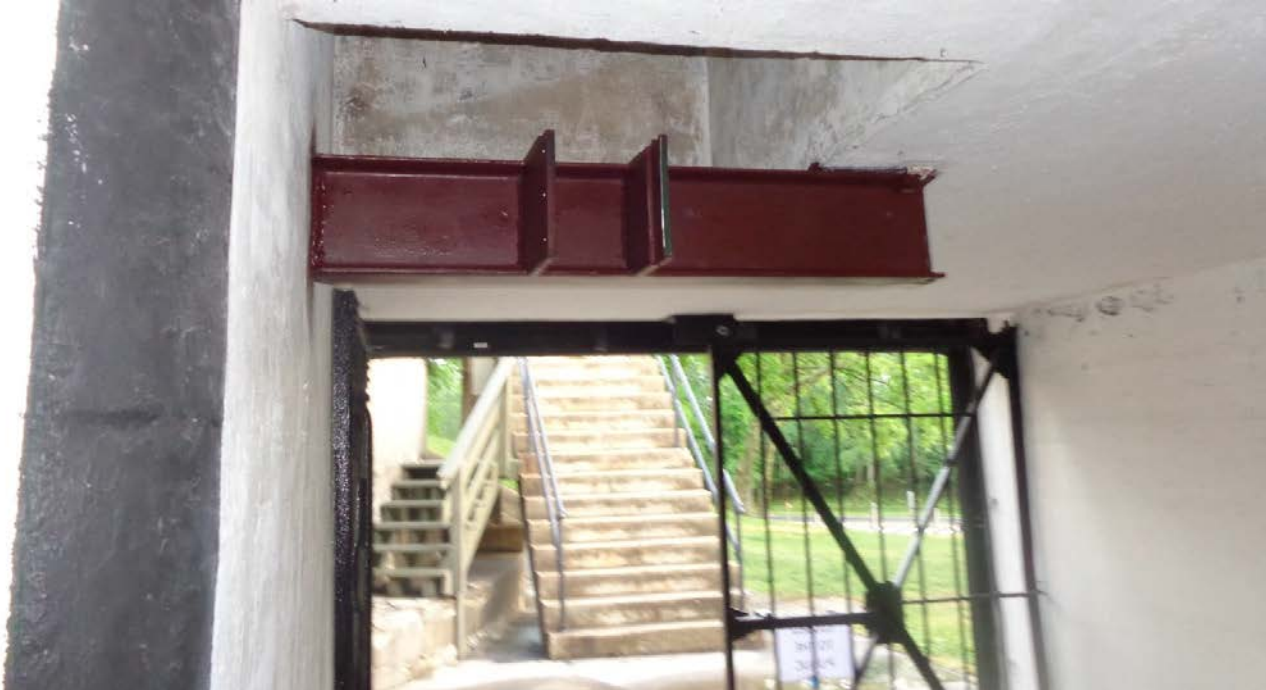
Finishing up on 11 June with the priming of the lower 7-inch I-beam shown below from the inside of the magazine side with the brackets.

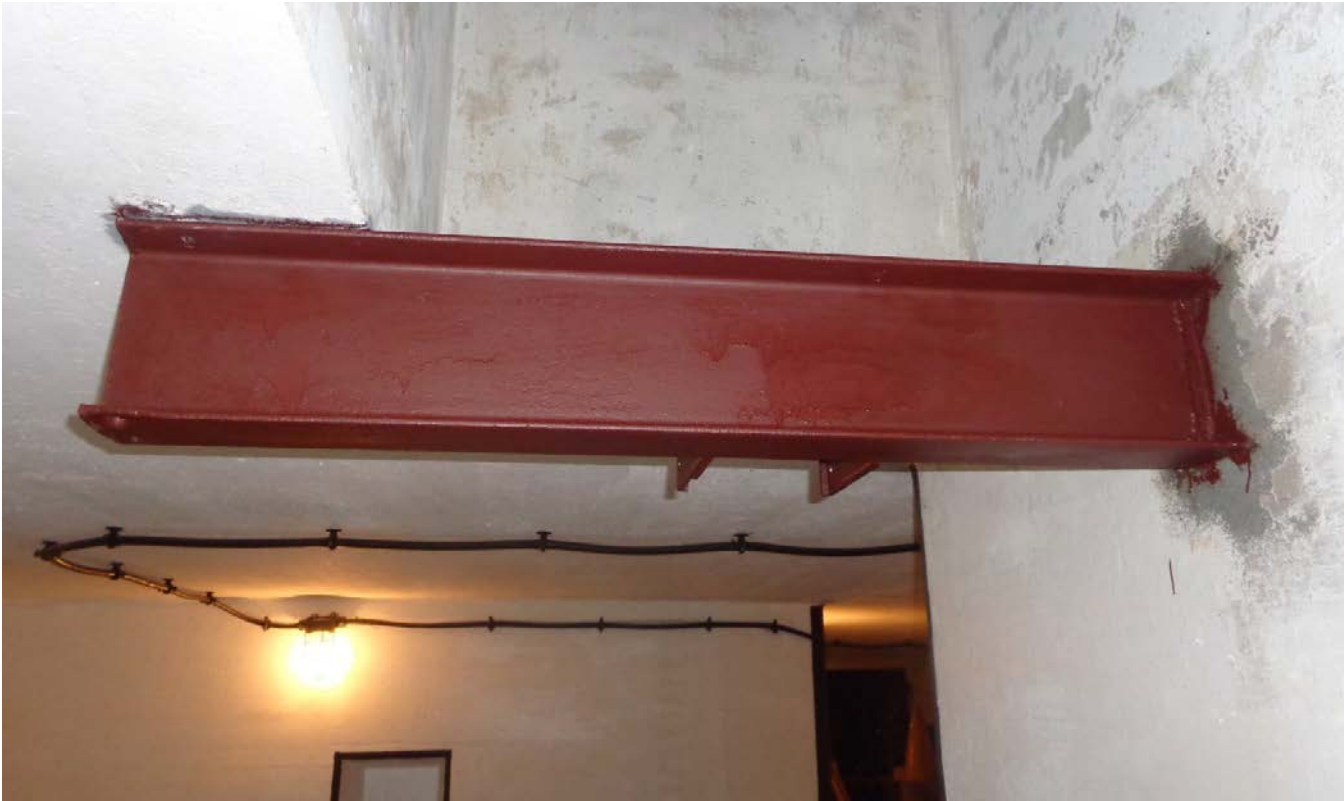
The lower 7-inch I-Beam as seen from the entrance to the magazine.

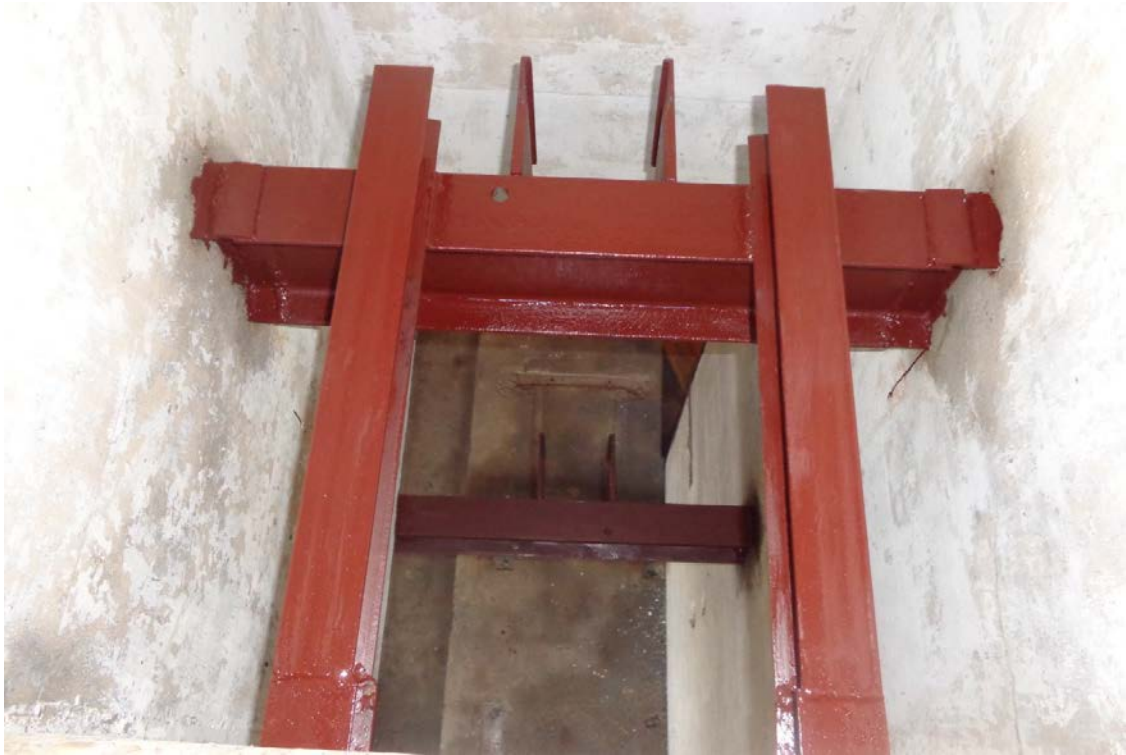
The primed beams inside the shaft for Hoist #1 are shown below.

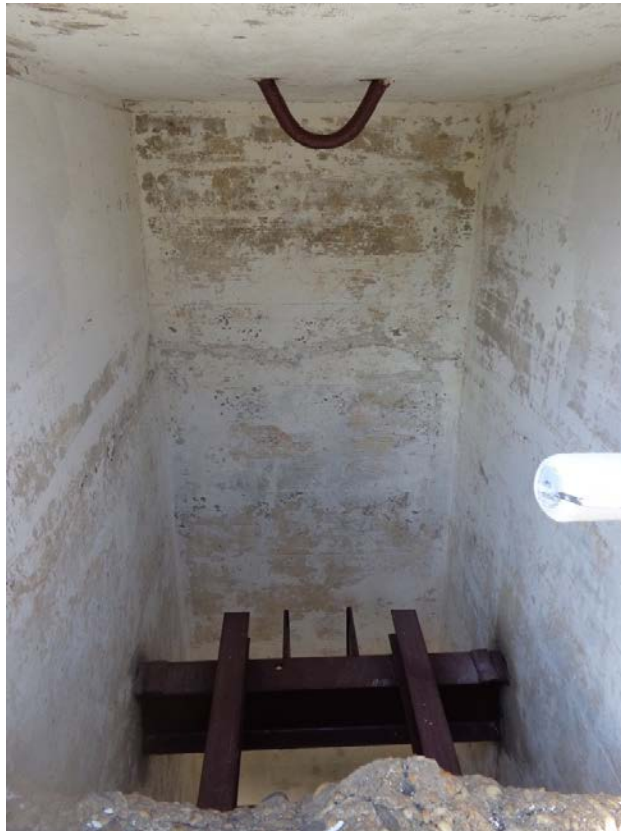
21 June 2020 we began the process of painting the interiors of both hoist shafts #1 and #2. In this photo is the top of shaft #1 before painting.

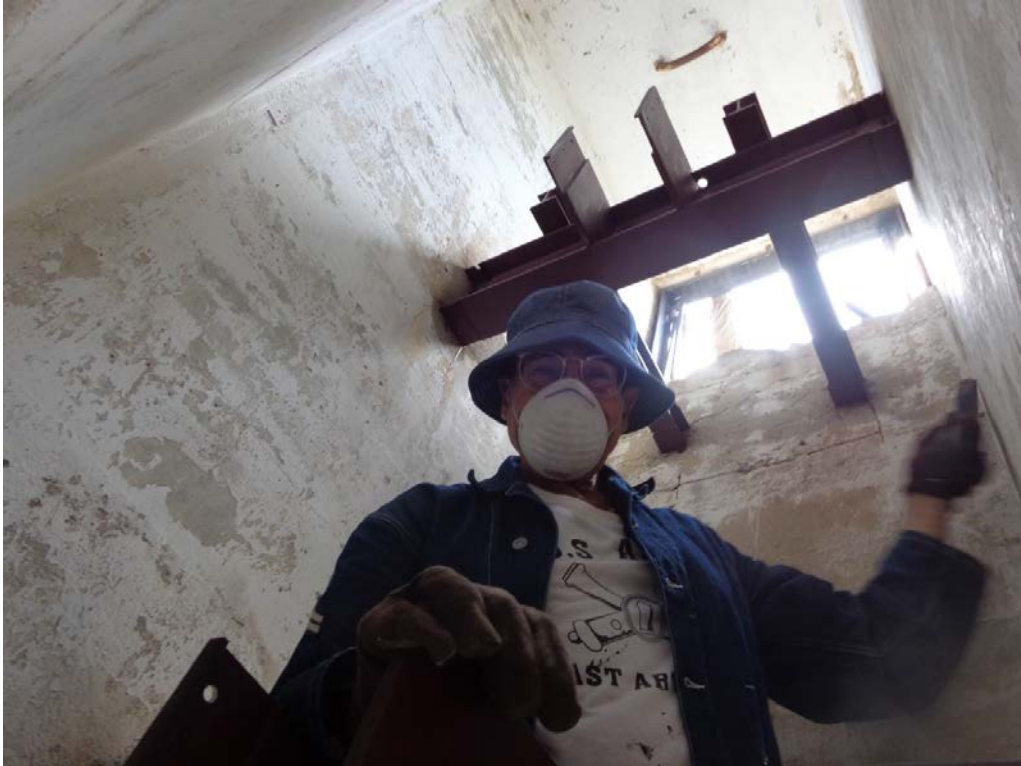
Below CPL Cusano is scraping the loose paint from the walls inside Hoist #1.

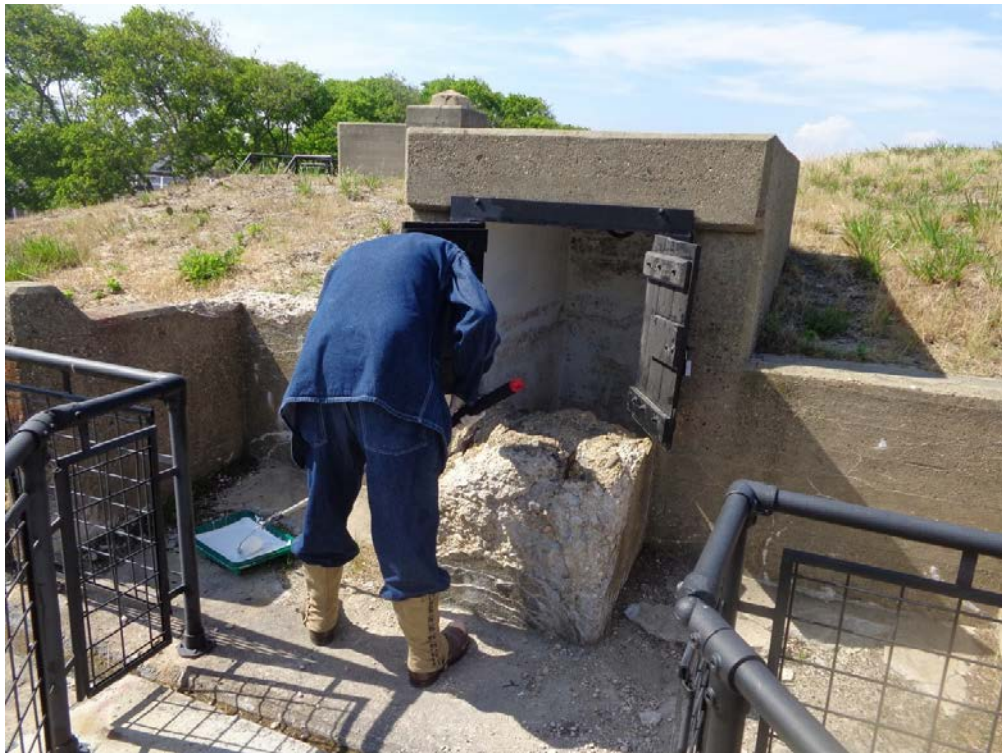
After he completed the scraping, CPL Cusano began using a roller to paint the interior of Hoist Shaft #1. Here is at the top of the shaft.

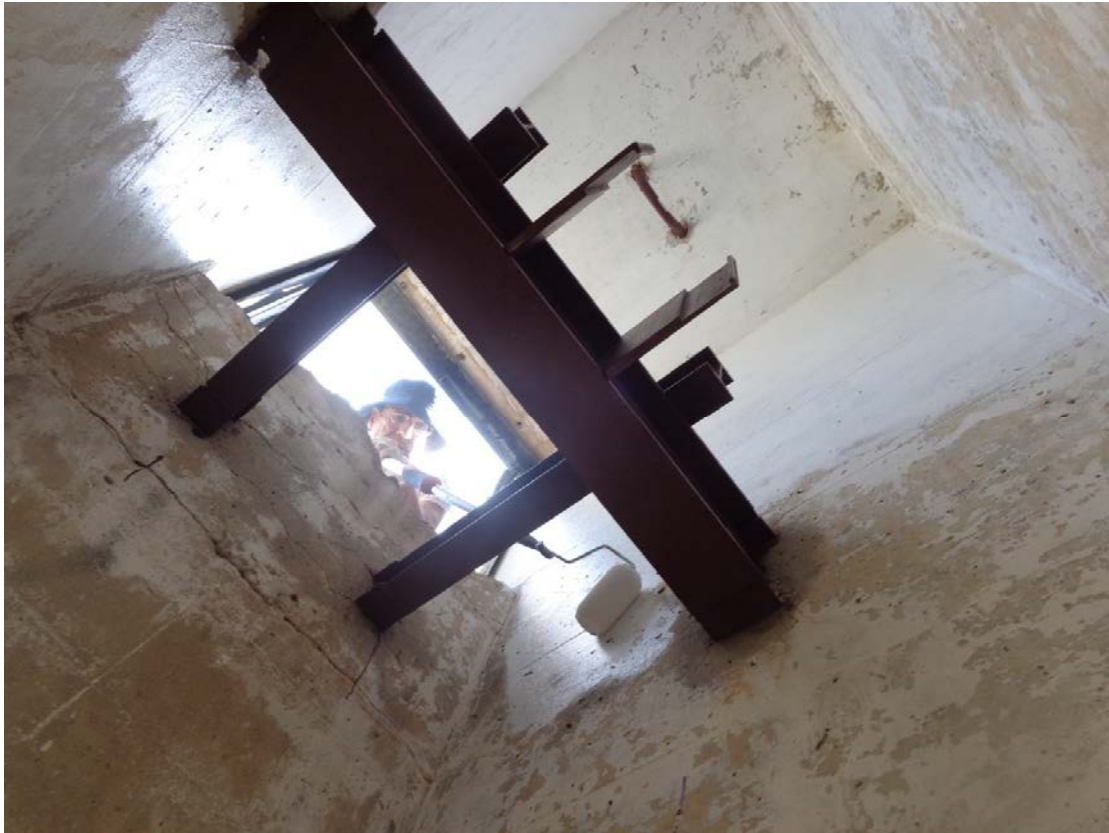
In this photo CPL Cusano is advancing down the inside of Hoist #1 shaft.

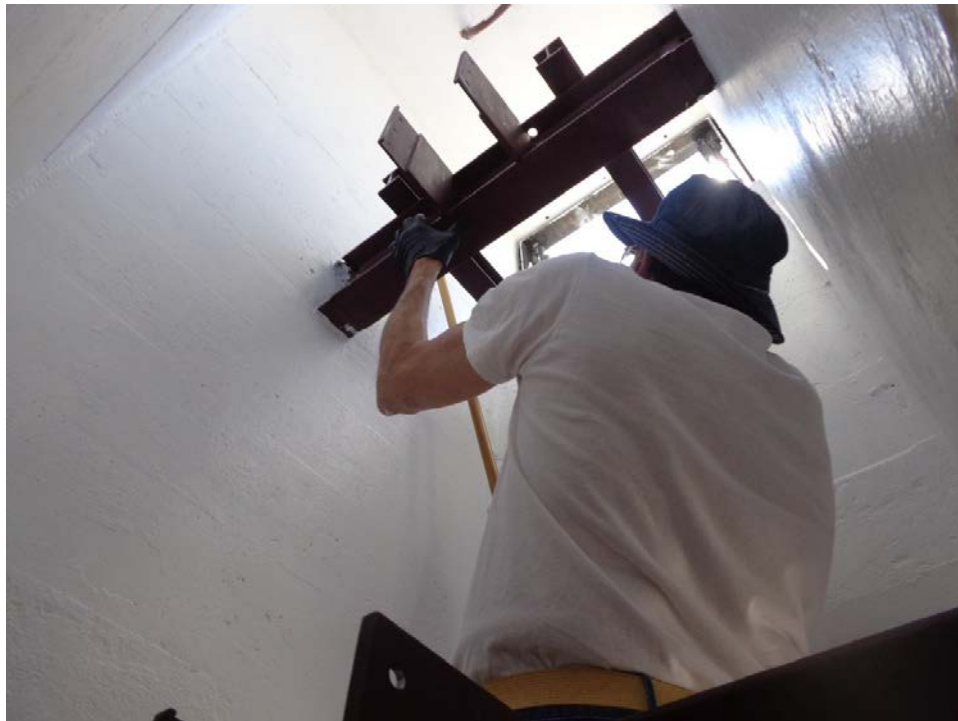
This view is looking up into Hoist #1 shaft as CPL Cusano completes the interior painting.

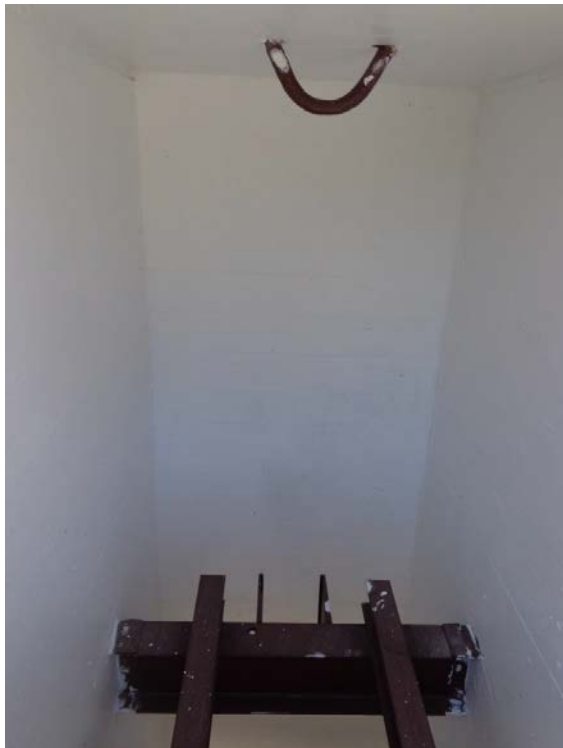
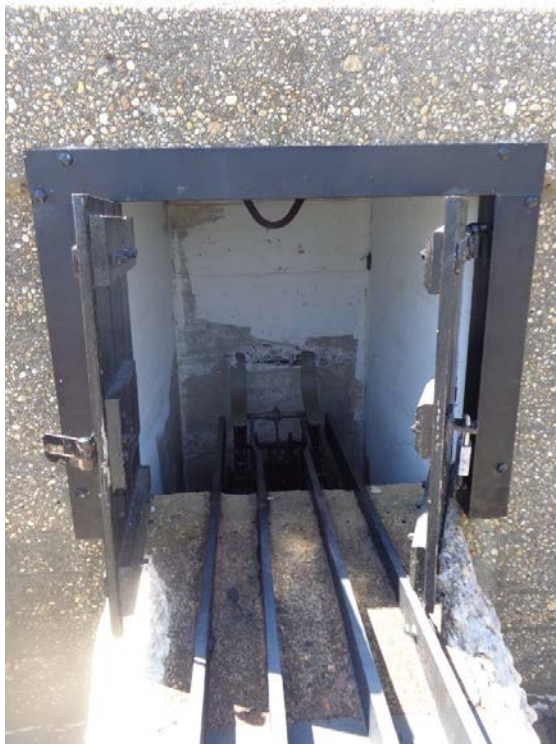
Below shows the completed paint job for the top of Hoist #1 on the left and Hoist #2 prior to painting on the right.

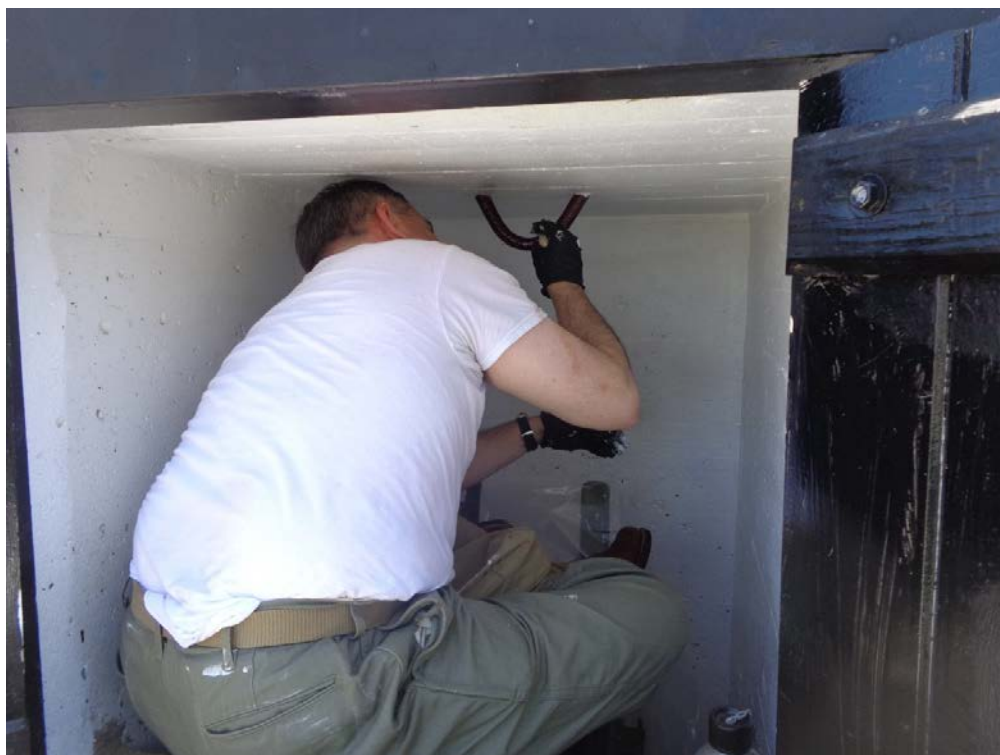
Below 2LT Gonzalez is painting the interior of the top of Hoist #2 shaft.

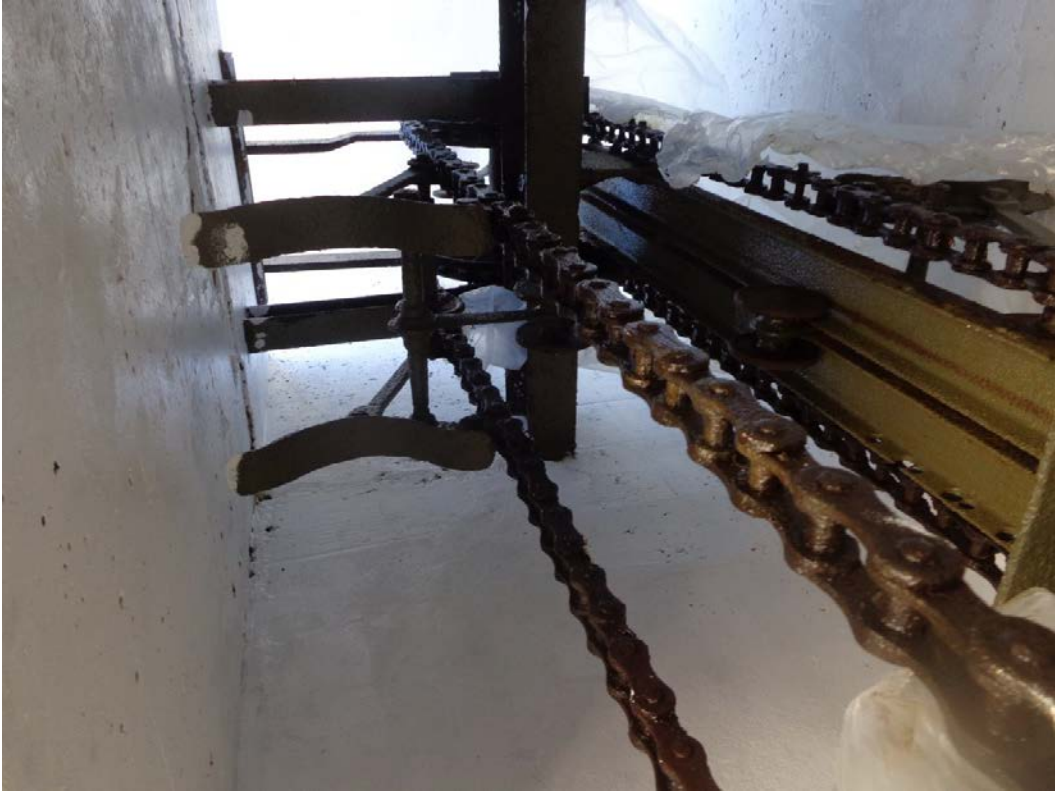
The photo below shows the inside of Hoist Shaft #2 after painting. This is the first time that AGFA has painted that shaft since the hoist was restored in 2005.

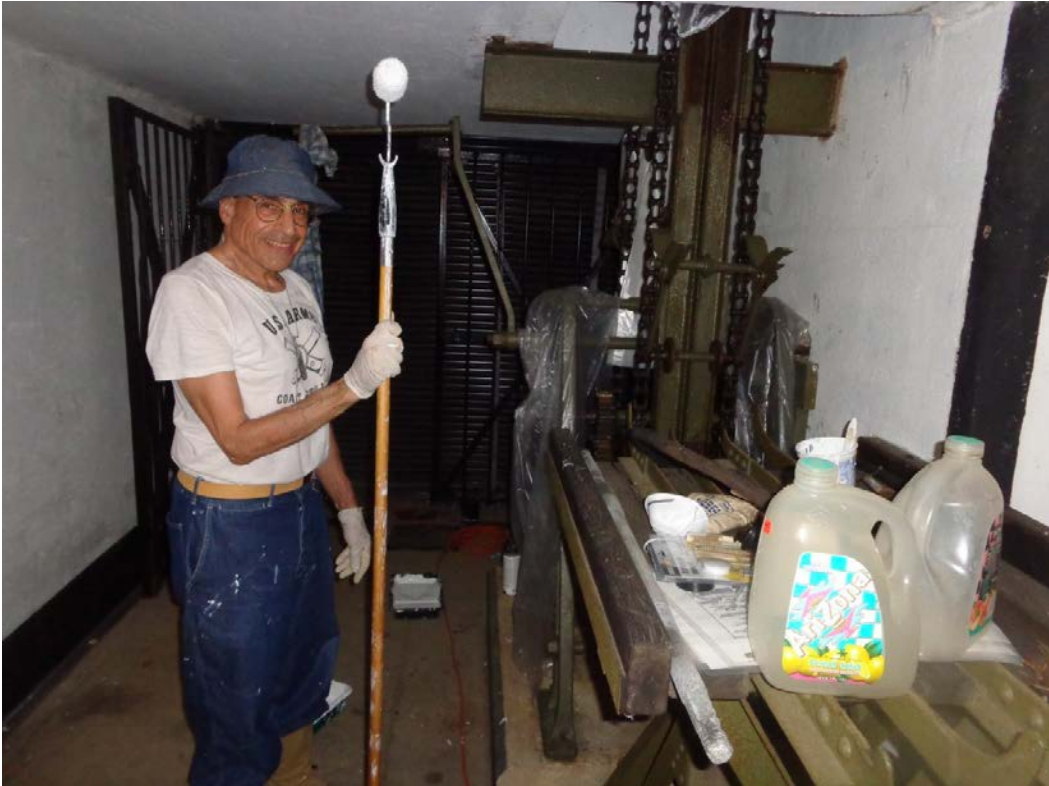
Below CPL Cusano prepares to continue the painting of the interior of Hoist Shaft #2 with a roller.

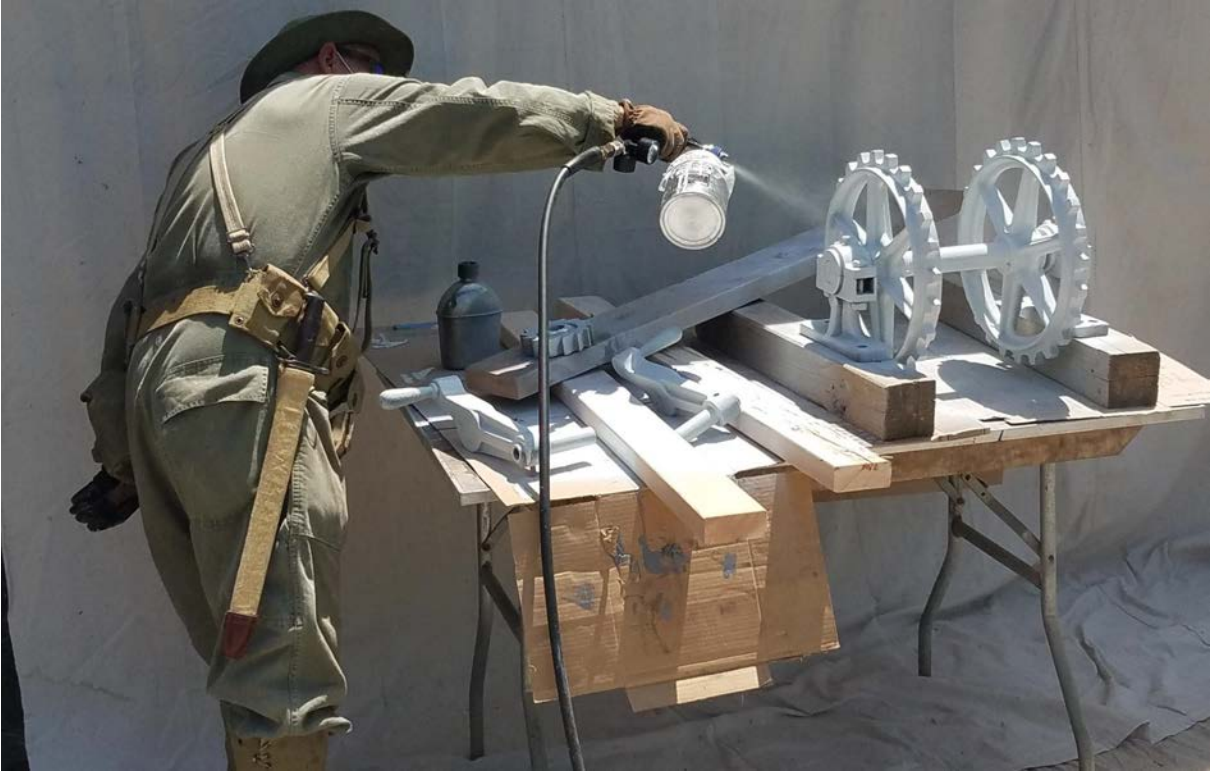
Below PFC Morrison uses a spray system to apply grey metal primer to the upper sprocket and trunnions for Hoist #1.

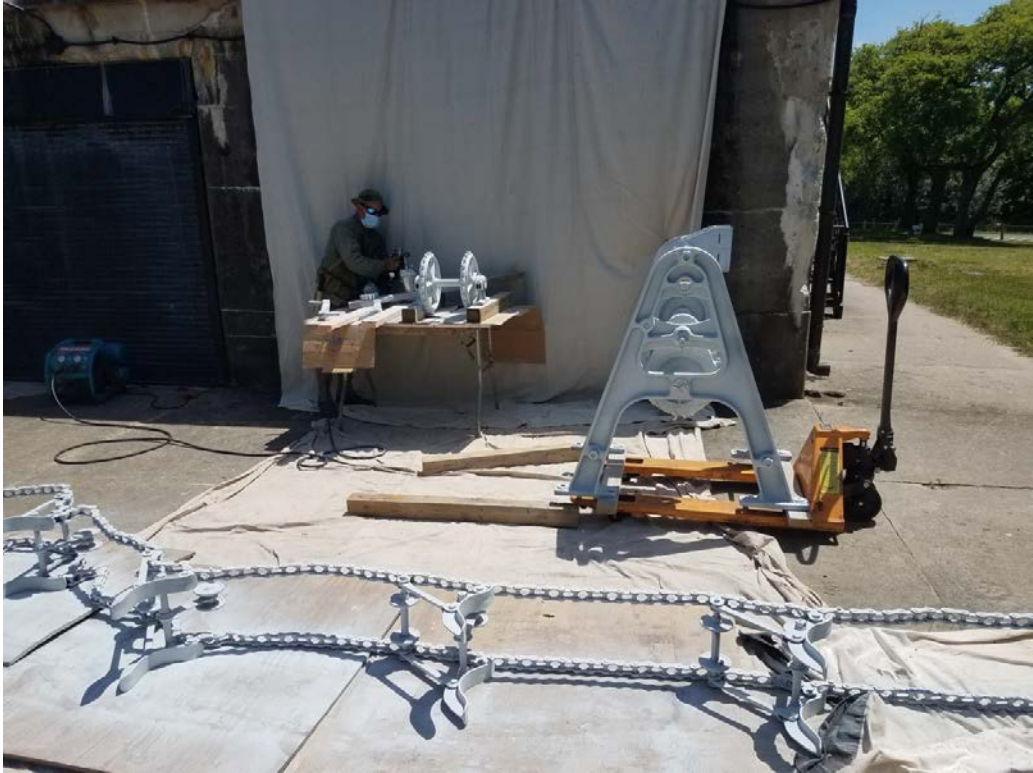
Below is a larger view of the area and hoist items that PFC Morrison was spray priming. He also primed the hoist #1 frame and the chain and shell tongs of the hoist.

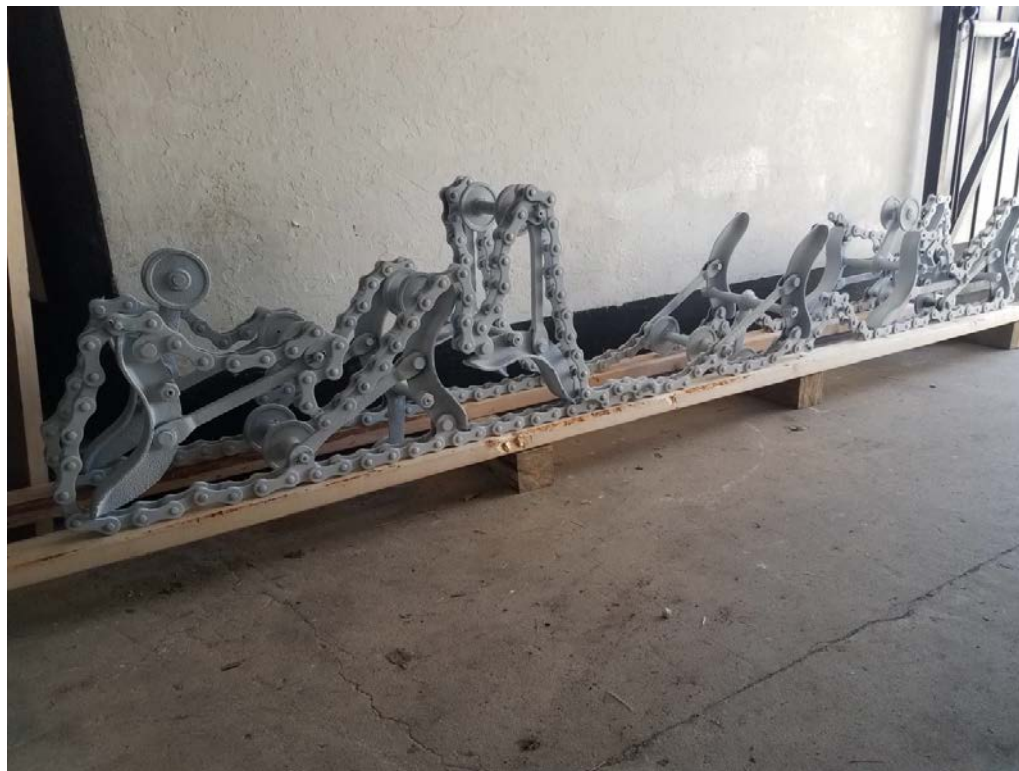
Below is the hoist assembly chain and shell tongs on a specially designed holder developed by T-4 King and T-4 Ciemniecki.

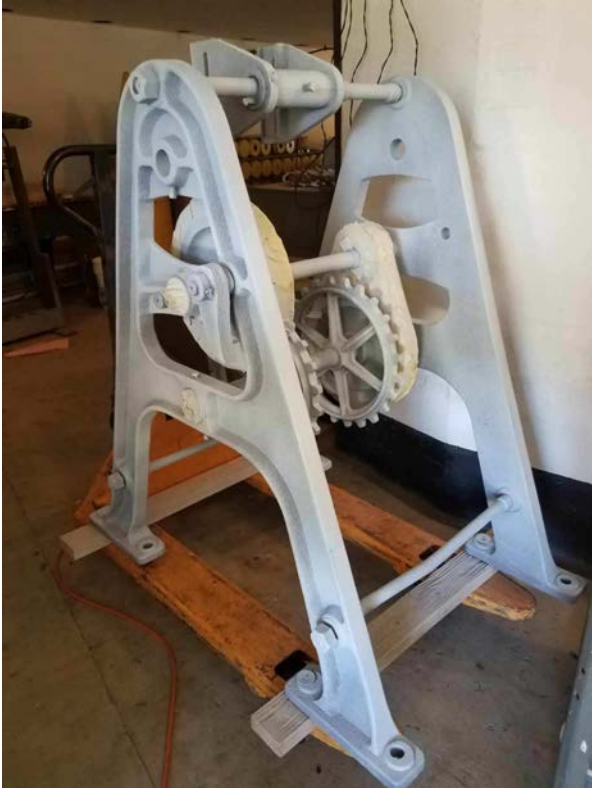
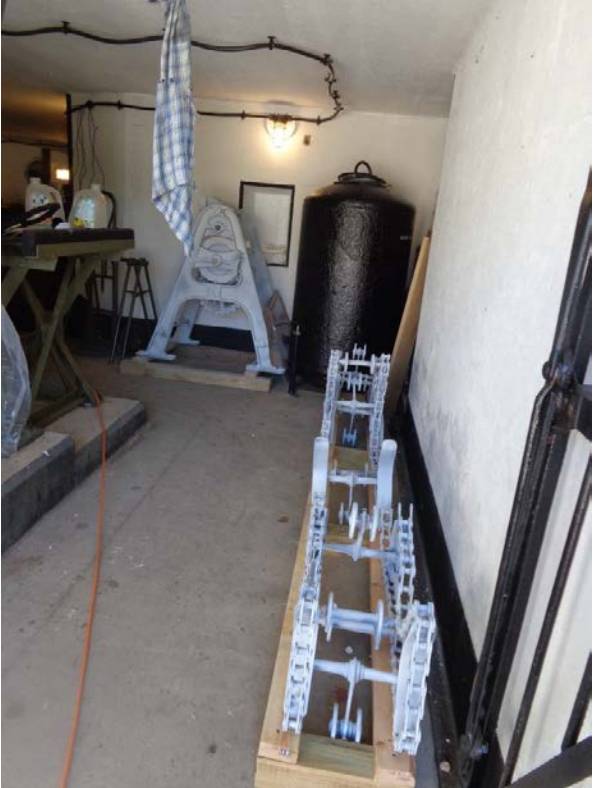
Once the priming work was done, the frame for Hoist #1 and the hoist chain and shell holders were returned to the magazine.

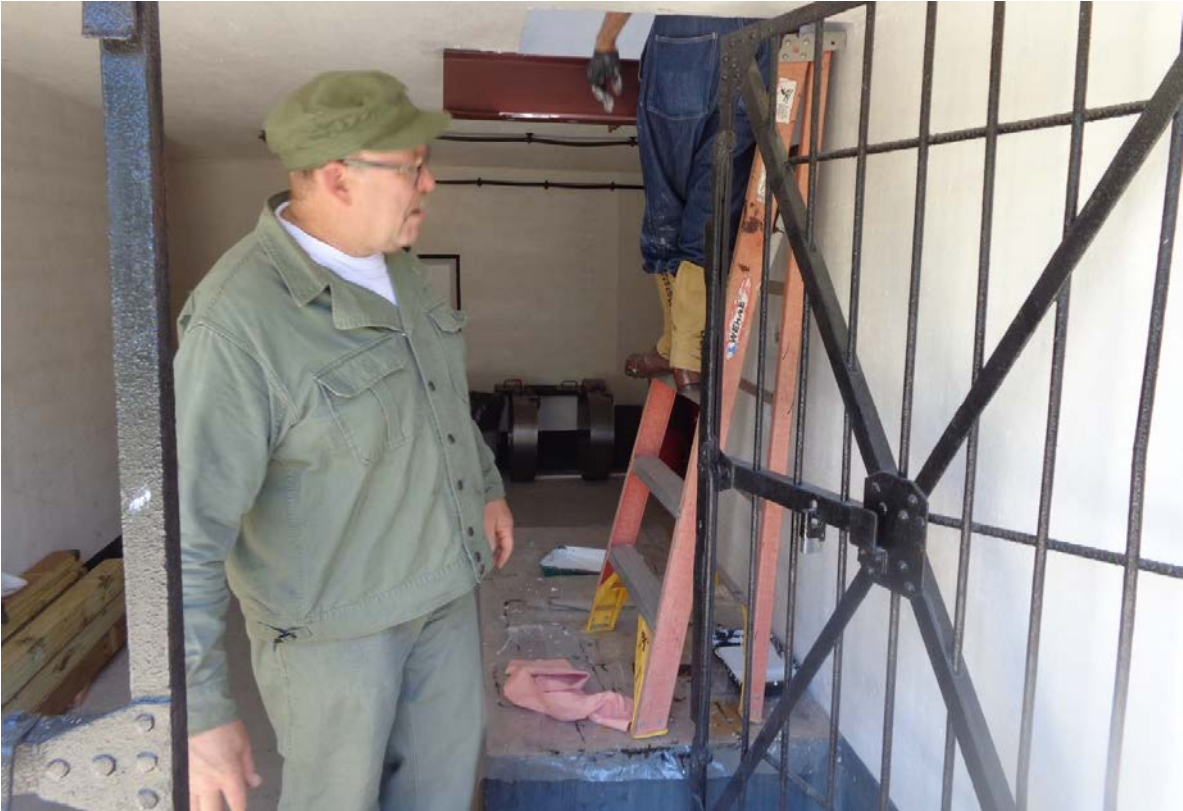
Below, CPL Cusano completes the interior painting of Hoist Shaft #1 as T-4 Ciemniecki looks on.

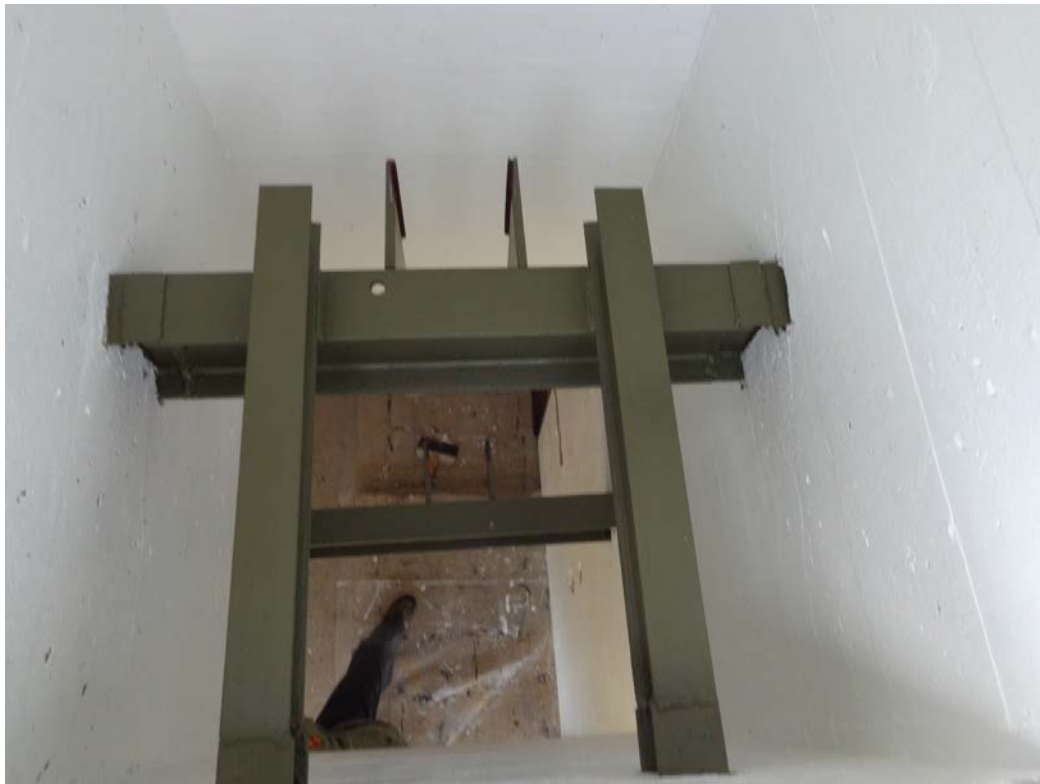
On 25 June 2020 we applied OD green paint to Hoist #1's metal I and H beams. This photo is from the top looking down into the shaft.

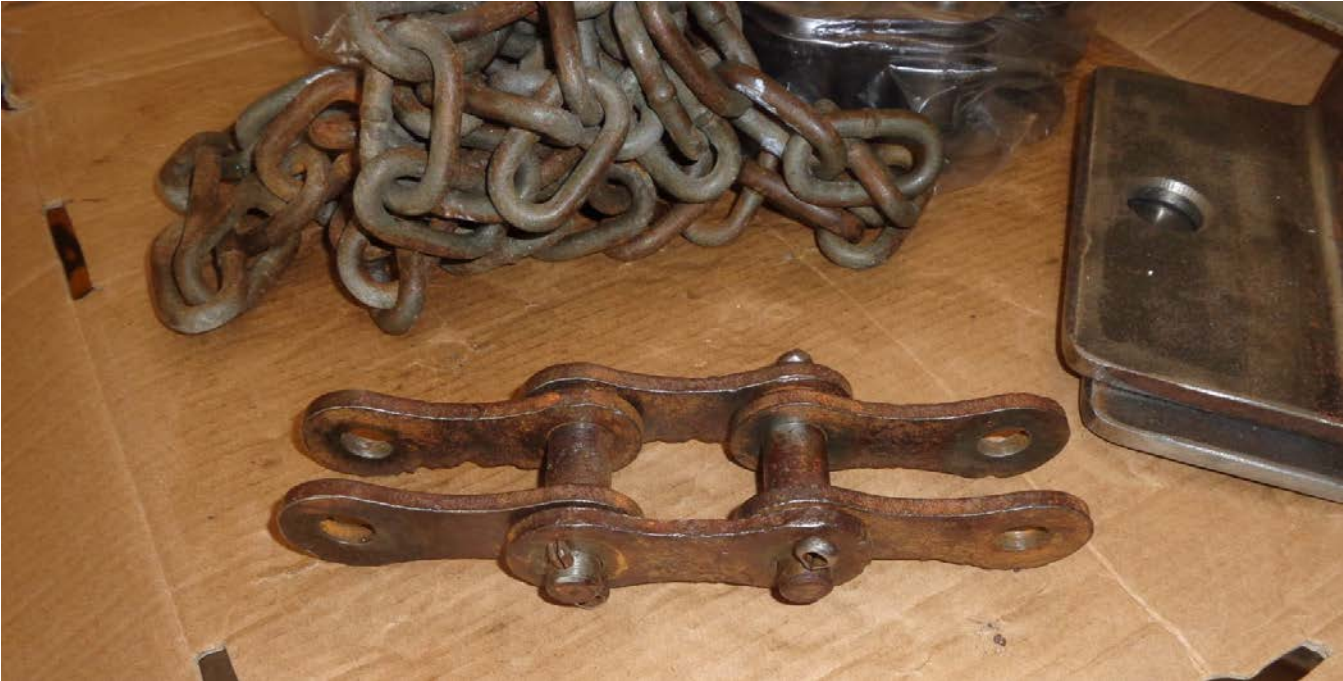
TSG Weaver assembled some of the loose parts into one link assembly. He will use one link assembly to find chain of the correct size to complete the hoist chain.

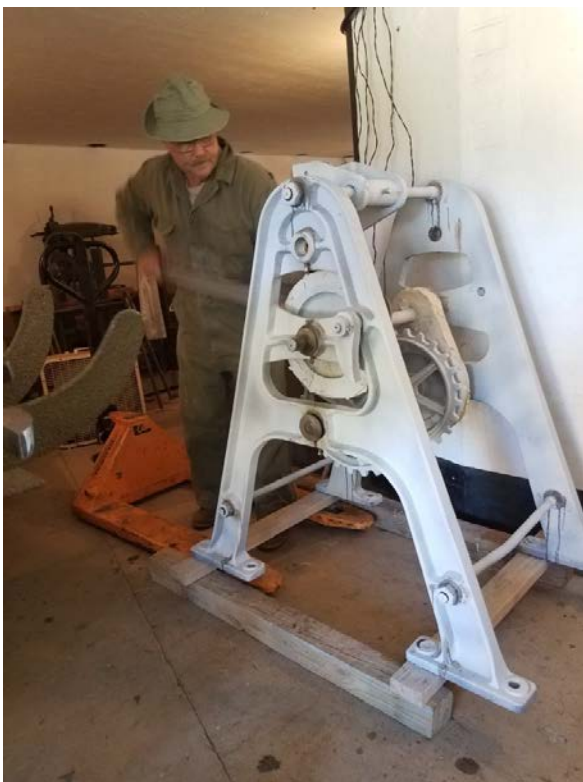
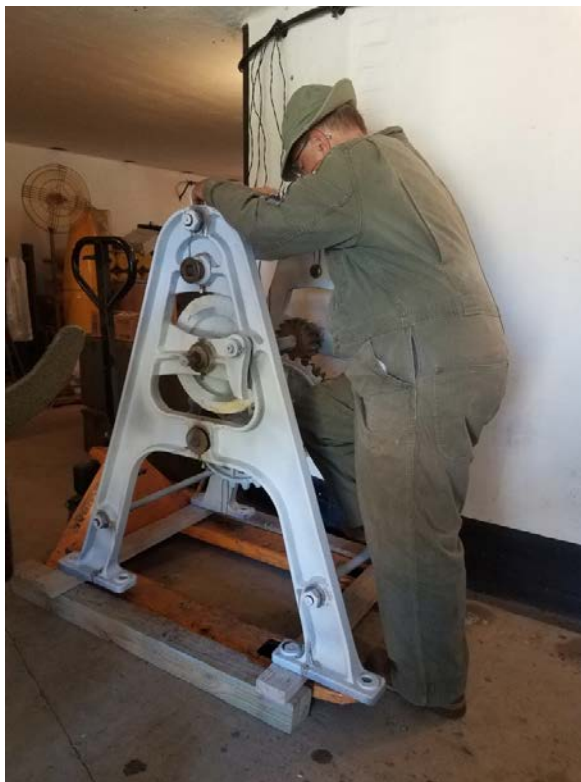
Beginning on 20 August 2020, T-5 Tunison and T-4 King began to work on unfreezing the shafts on the frame of Hoist #1. Below, T-5 Tunison uses a large pipe wrench to move the shafts.

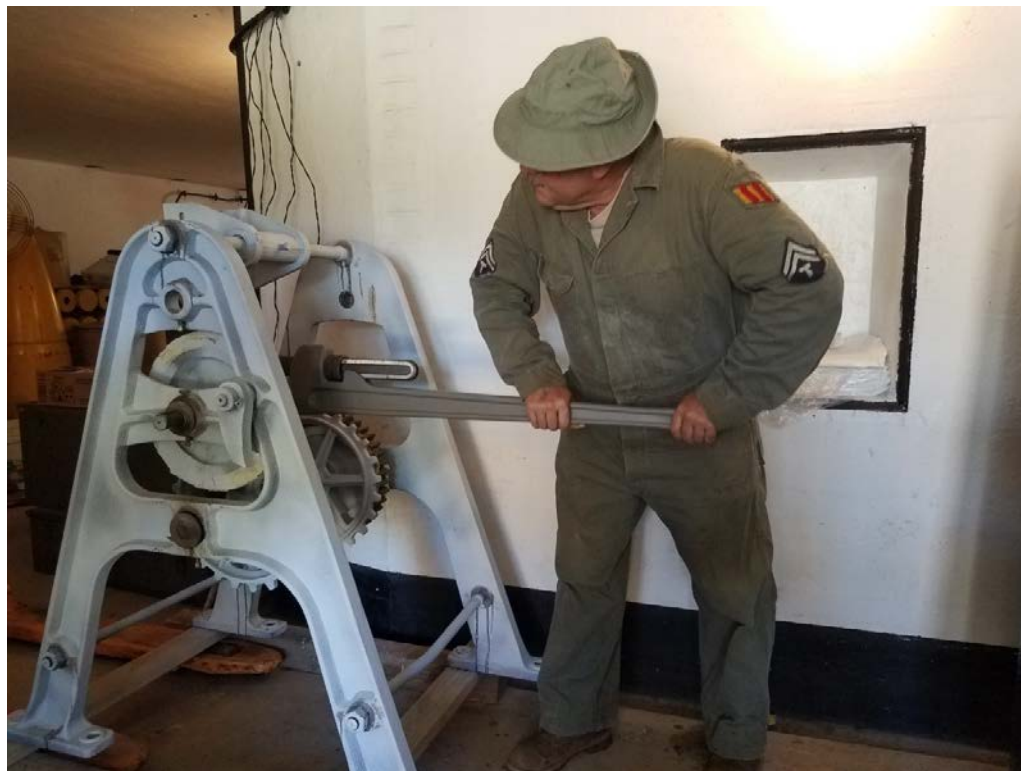
In this view T-5 Tunison is actually moving the shafts and gears for what is likely the first time in over 50 years.

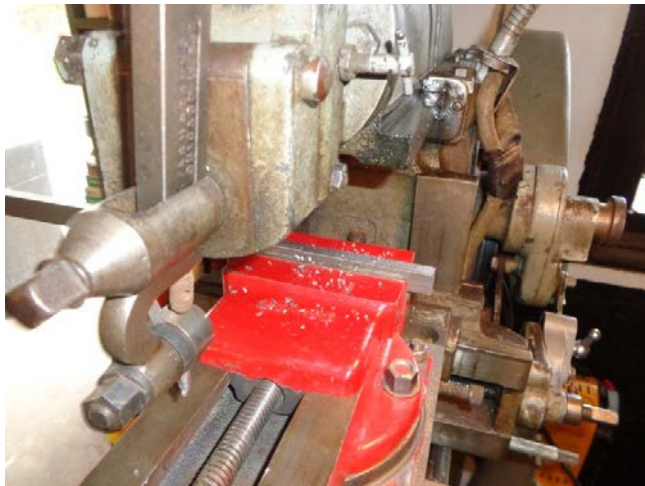
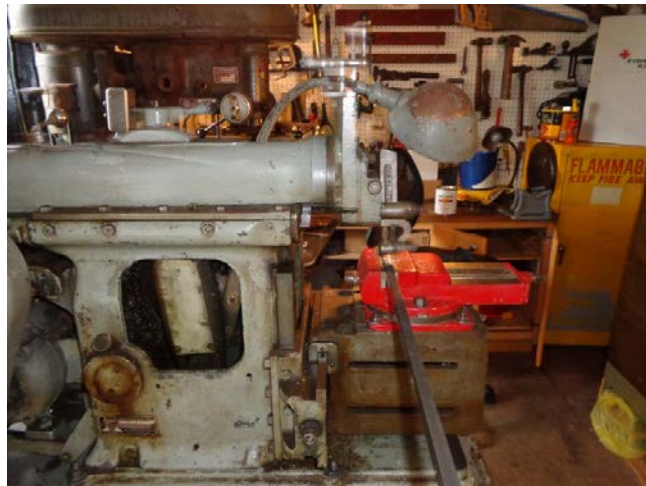
In March, 2021, we began work on fabricating "keys" to hold the two hoist elevation crank handles in place. Hoist #2 has a non-standard crank handle that was obtained in the 2005 timeframe. While it fits the shaft, it was not secure on the shaft. A close examination showed that it lacked a properly fitting "key". Upon an examination of the crank handle that is on hand for Hoist #1, it was determined it too needed a special key fabricated. Four keys were fabricated using the Atlas shaping and end mill machines in the Battery machine shop. The Atlas Shaping machine is shown below cutting the keys from long barstock.

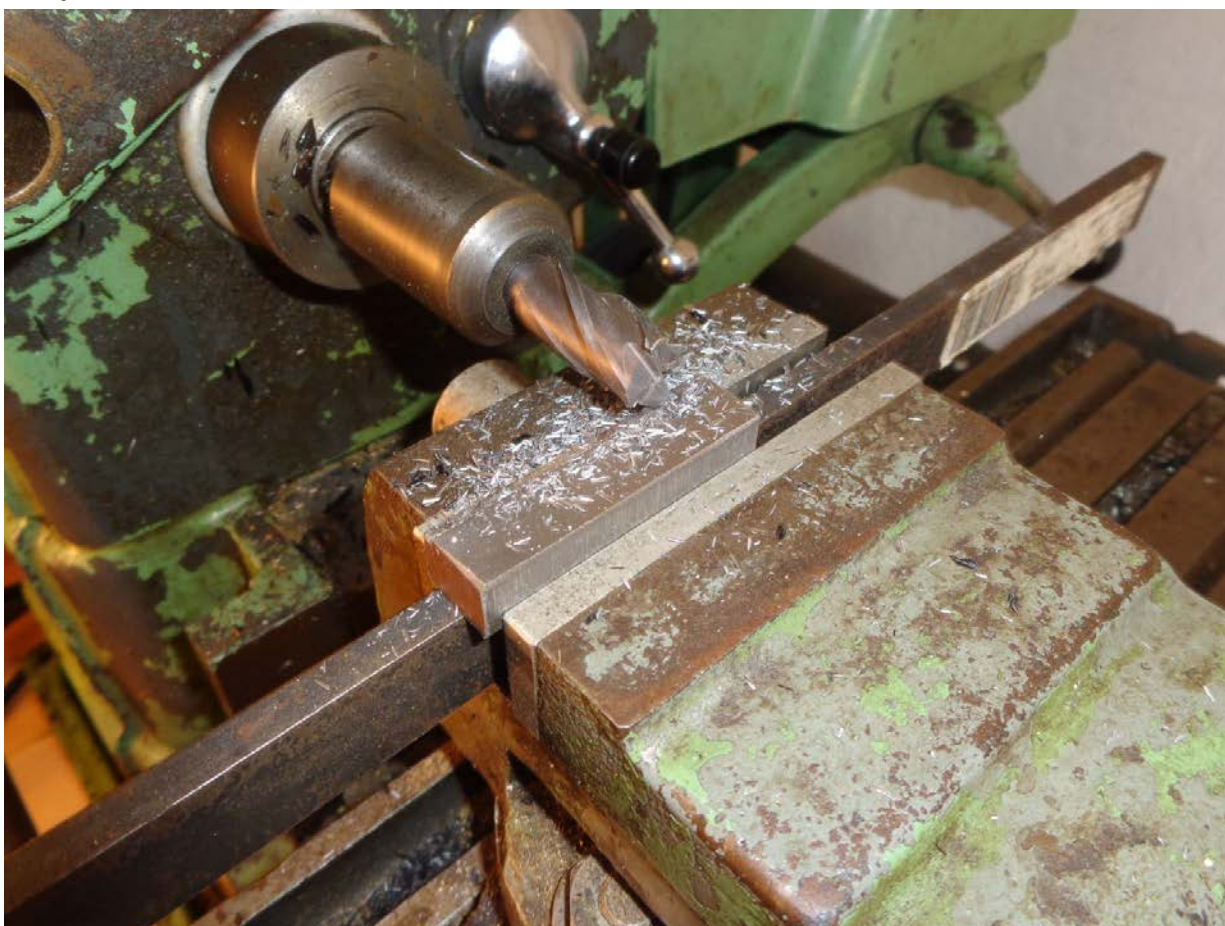
The photo below shows the Atlas End Mill machine cutting the leg of the "T" key. The two key handles have different lengths and different key leg widths and depths. Each key was a custom cut.

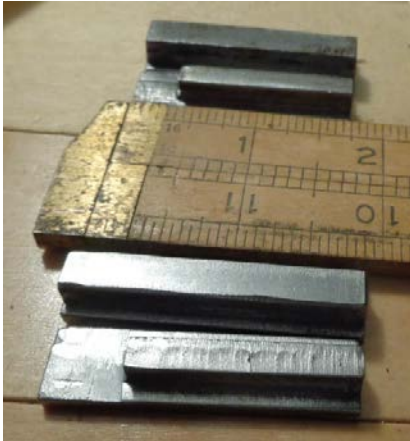
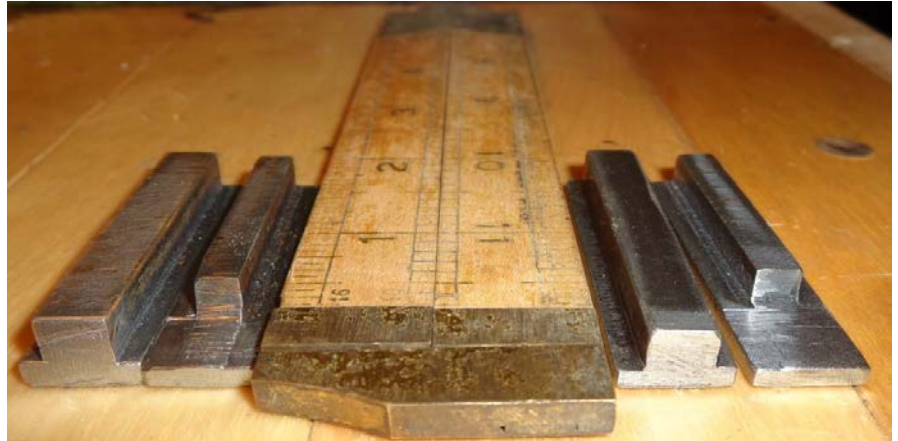
The four keys as completed are shown below. Notice the differences. The key to the right in each pair has a thin "T" leg and the leg does not extend the length of the key. This key is for the Long Handle crank.
