## Battery Gunnison/New Battery Peck Hoist #1 Restoration

Ft. Hancock, New Jersey

*(Work completed 2002 through September 2021; outline remaining work)*

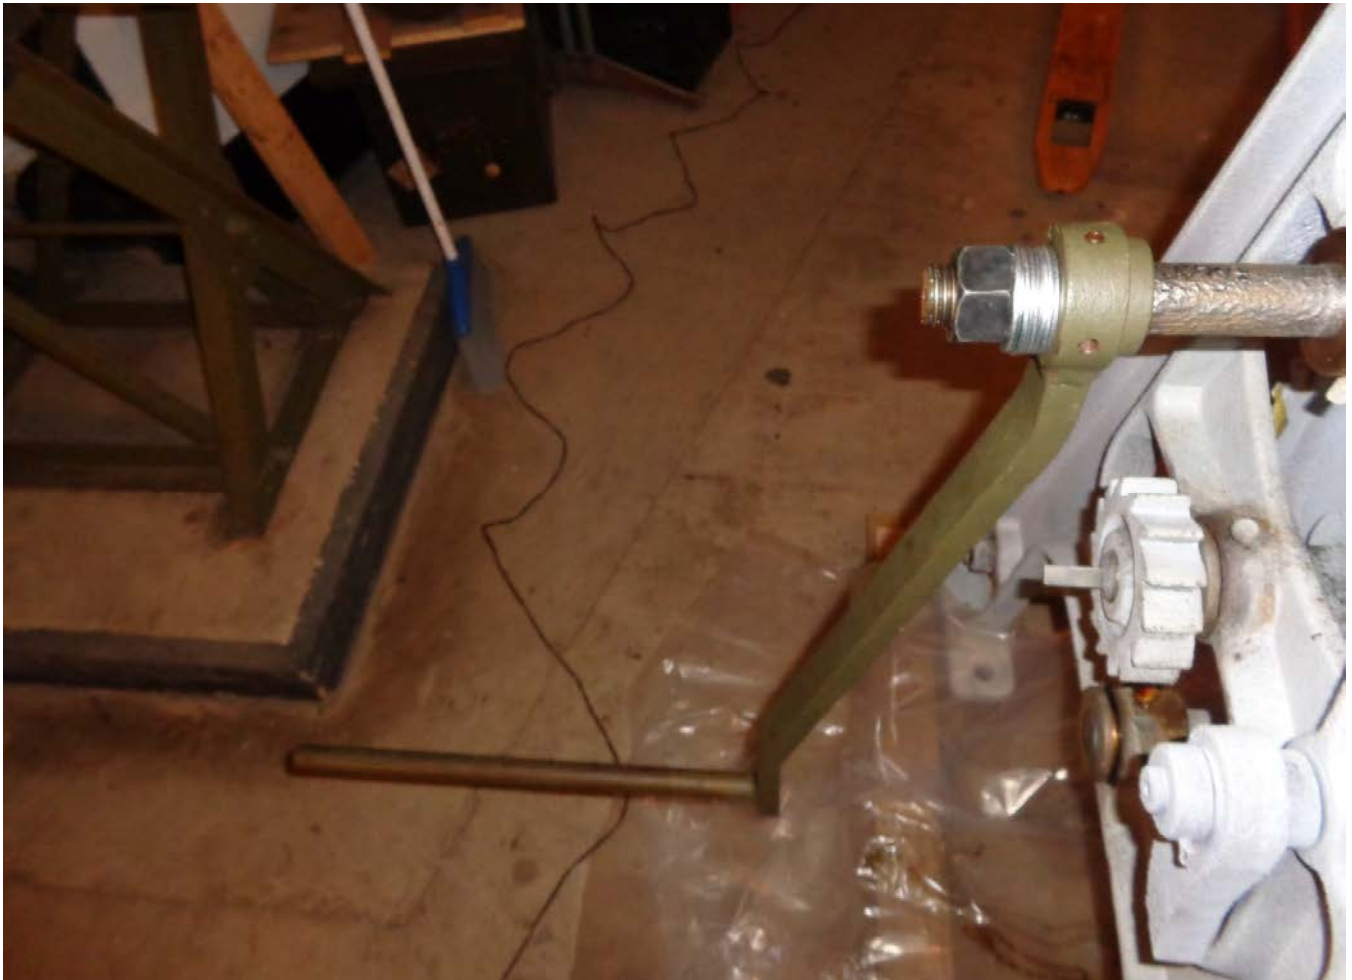
The long handle crank is shown below installed on Hoist #1. This handle is useful in its ability to generate torque for the hoist.

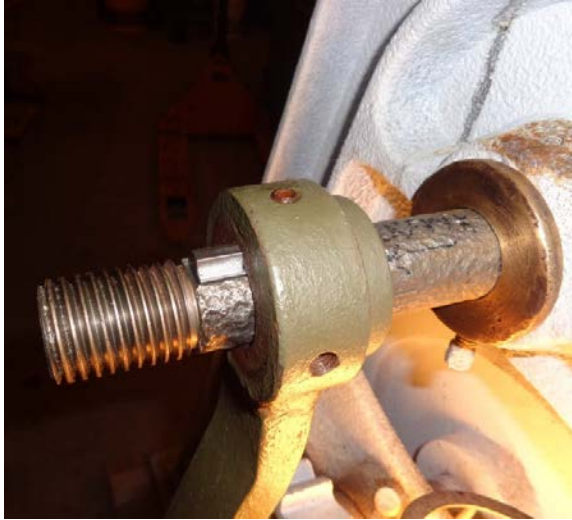
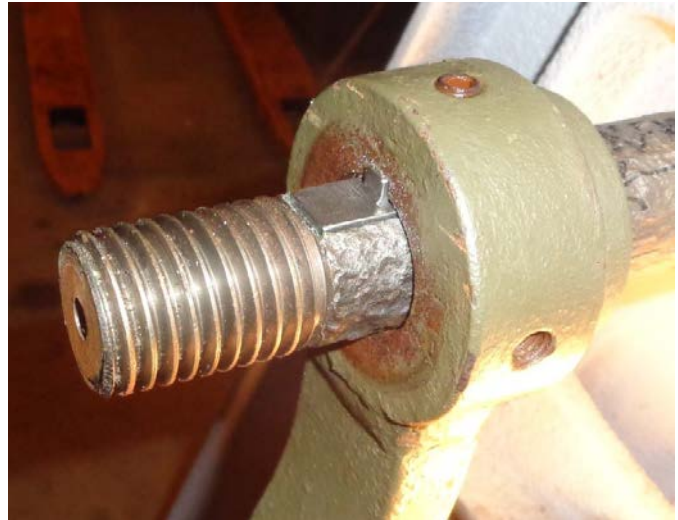
The two photos below show the fitting of the key for the long handle crank. The basic body of the crank handle that affixes to the shaft is thinner than the crank for Hoist #1. The photo to the left shows the long handle crank placed on the shaft with the key in place. However, the T leg of the key protrudes past the base of the shaft structure. The photo on the right shows that protruding leg cut flush to the face of the shaft handle. The "head" of the "T" key is in the slot on the shaft and locks the key in place.

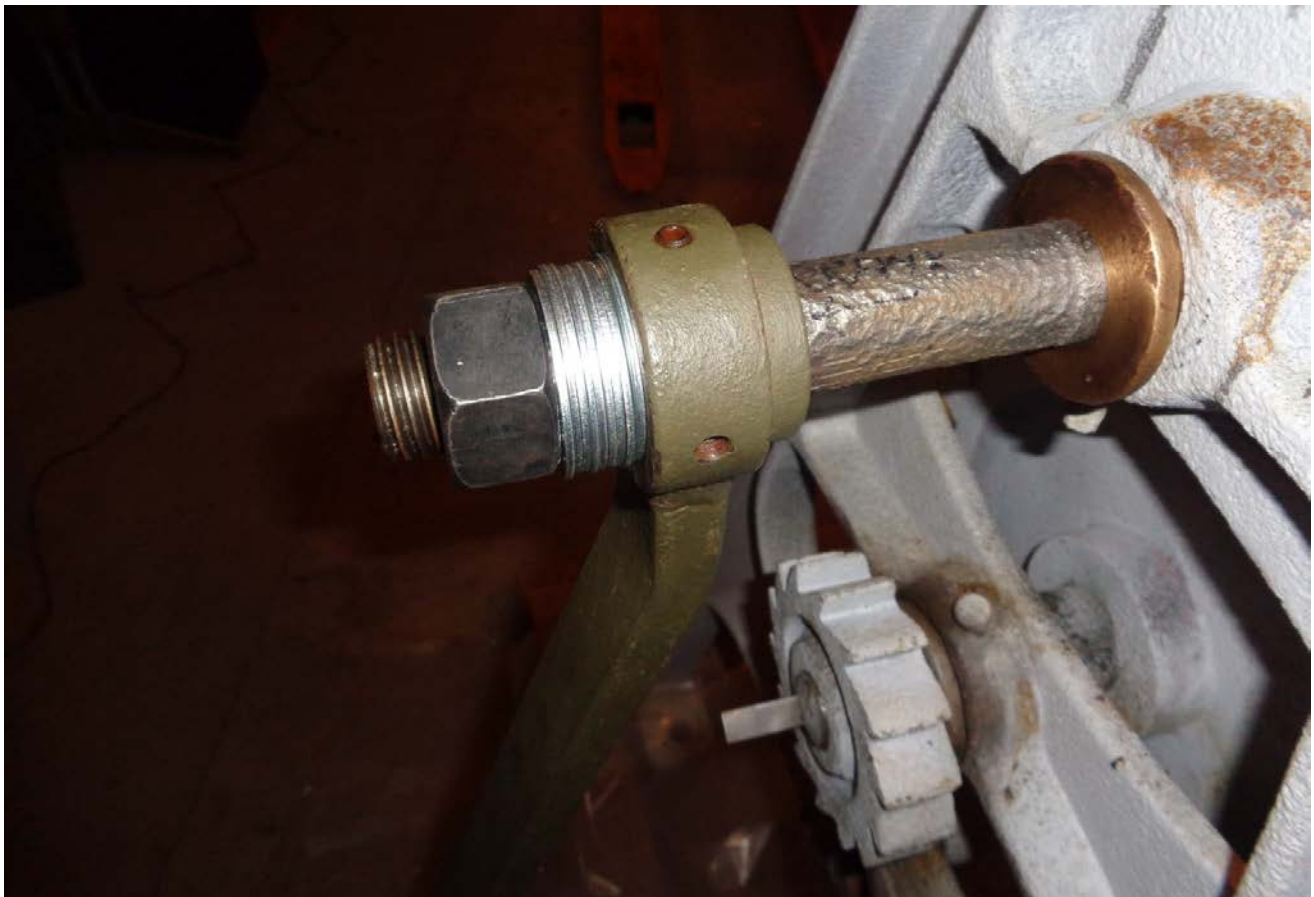
The photo below shows the long handle crank with the T leg trimmed with washers in place to hold both the key body and the handle proper in place on the top shaft.

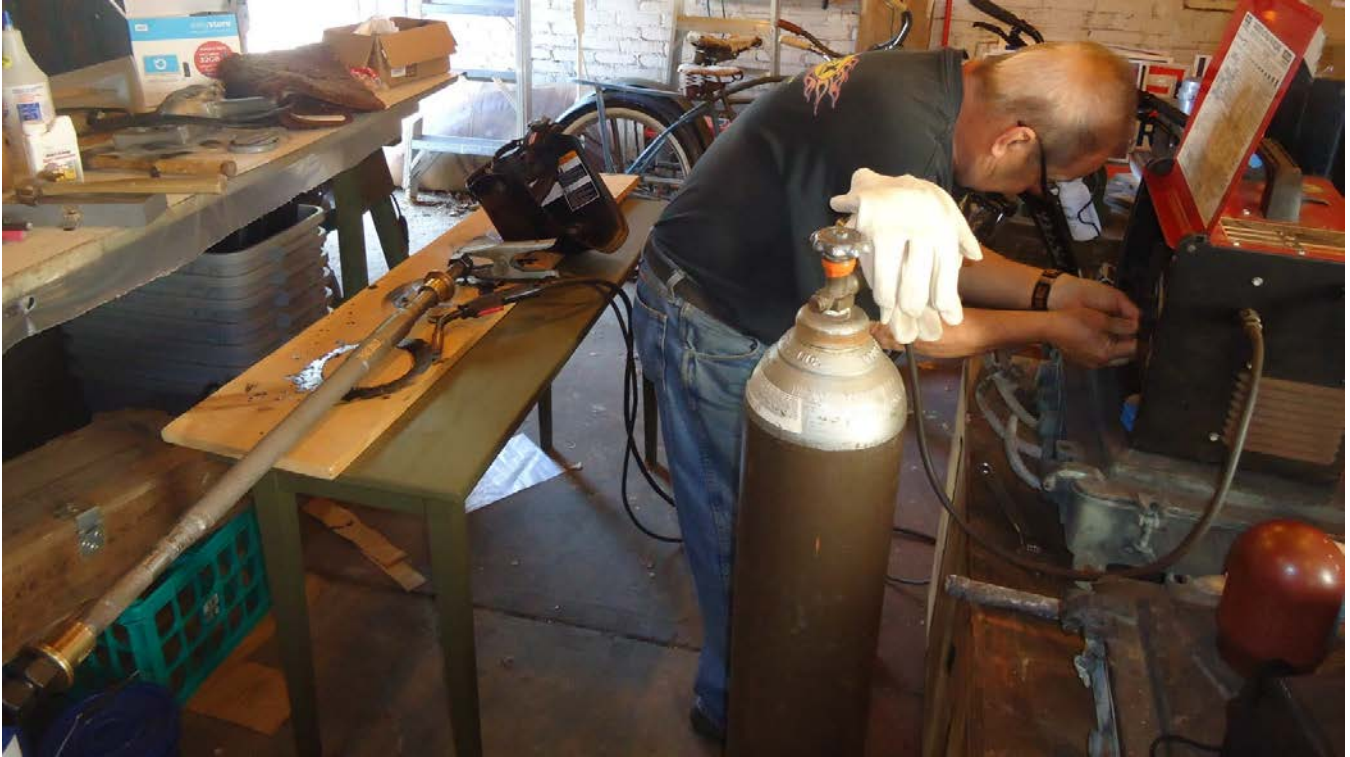
The photo below shows T-3 Brodzinski preparing the build-up the weld on the upper shaft. The shaft is on the table and ready to begin!

The restoration of the upper shaft involved three people. T-3 Brodzinski built up the rusted bearing surfaces with weld. Jim Wolf then used his large lathe to turn down the built up weld to make a smooth bearing surface. The top two photos are before and the bottom two are after welding buildup.

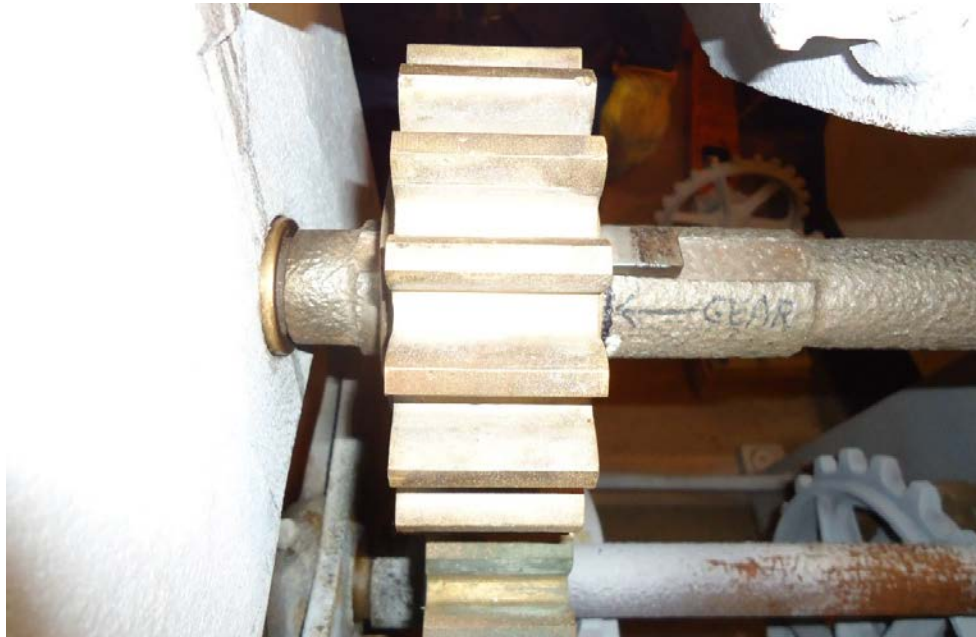
The photo below shows the top shaft with the drive gear installed and key in place. The brass bushing is installed correctly on the left and the shaft collar supports the end of the bushing. This is installed as designed.

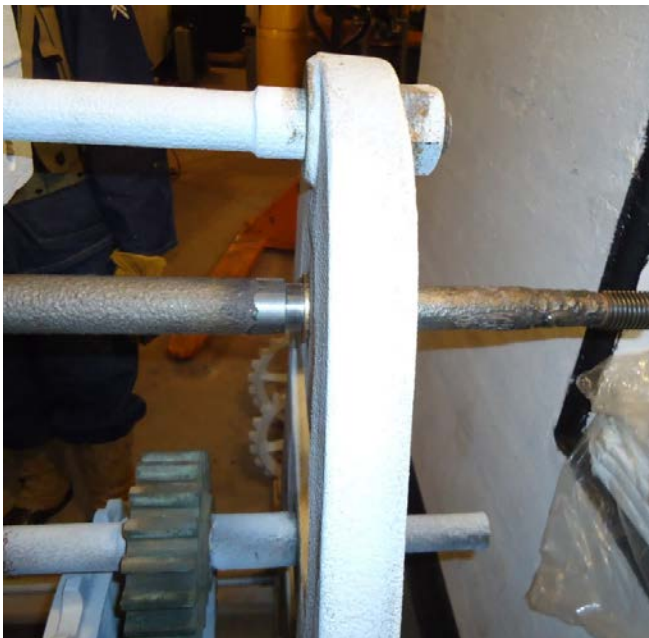
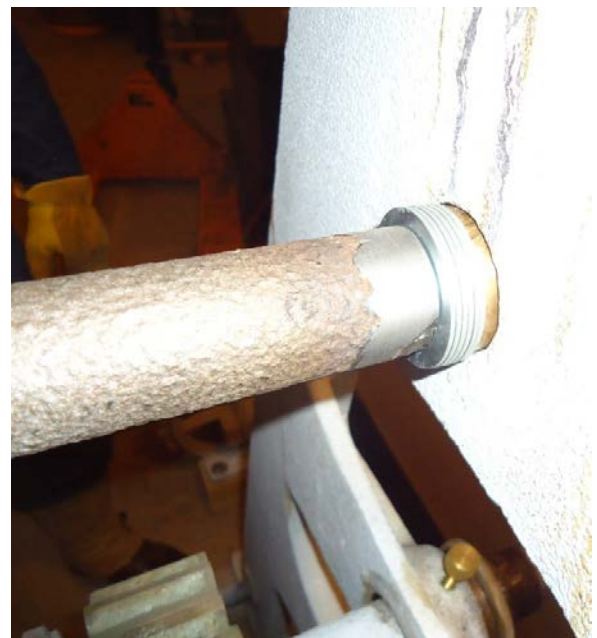
On the left side of the hoist (wall side when installed), the photo the he left shows clearly the over-cut of the seating collar of the shaft for the bushing. The photo to the right shows six "washers" in place to hold the shaft in the correct position. Both brass bushings are locked into place using the locking bolts on the underside of the frame. This work was completed on 11 June 2021.

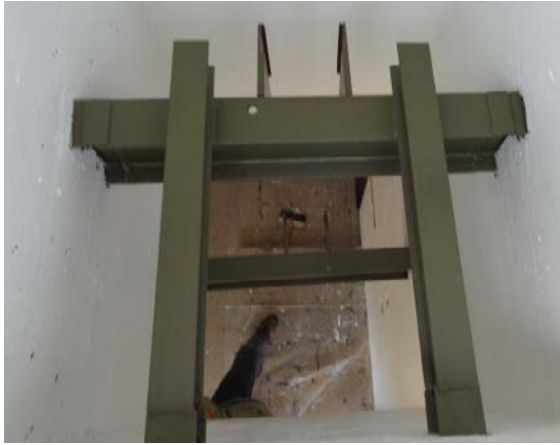
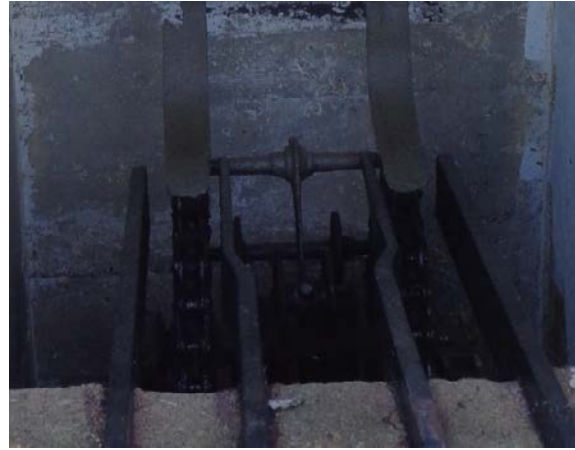
Assembly of the hoist fixtures in the hoist shaft was initiated on 18 June 2021. The photos below show the Hoist #1 beams before drilling and fitting the trunnion assemblies. The right photo shows Hoist #2 upper chain sprocket assemblies as it is currently in place. The inside face of the trunnion blocks are approximately 15-1/2 inches from inside face of wall (top opening side) to face of trunnion block.

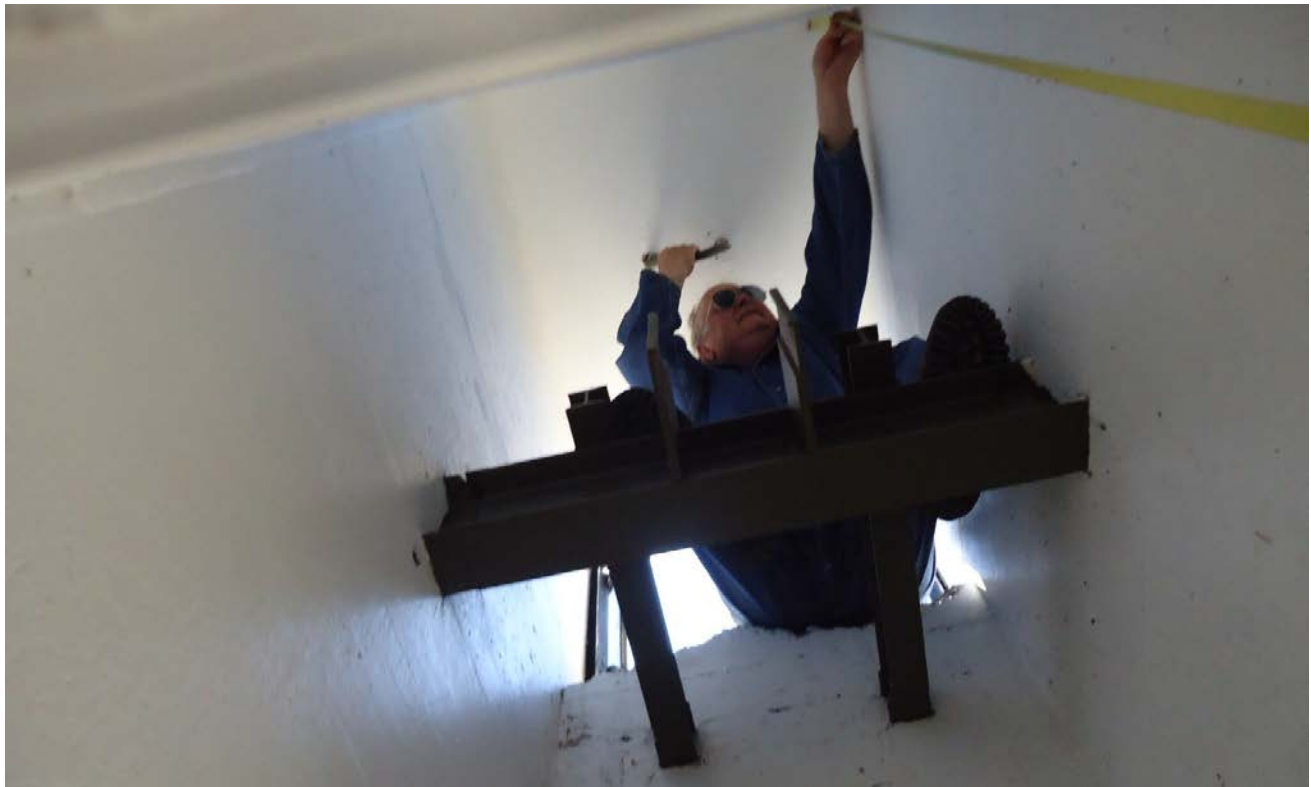
As part of the siting process for the trunnion assemblies and the two H Beams we confirmed all key dimensions for the two shafts and fixed metal beams.

The height of the shaft from the platform for the hoist frame to the roof of the shaft is 13 feet 4-3/4 inches for Shaft #1 and 13 feet 5-1/2 inches for Shaft #2. Measuring from the floor, to bottom beam (underside) is 5 feet, 3-1/2 inches (average - varies from 3/8 inches to 1/2 inches difference).

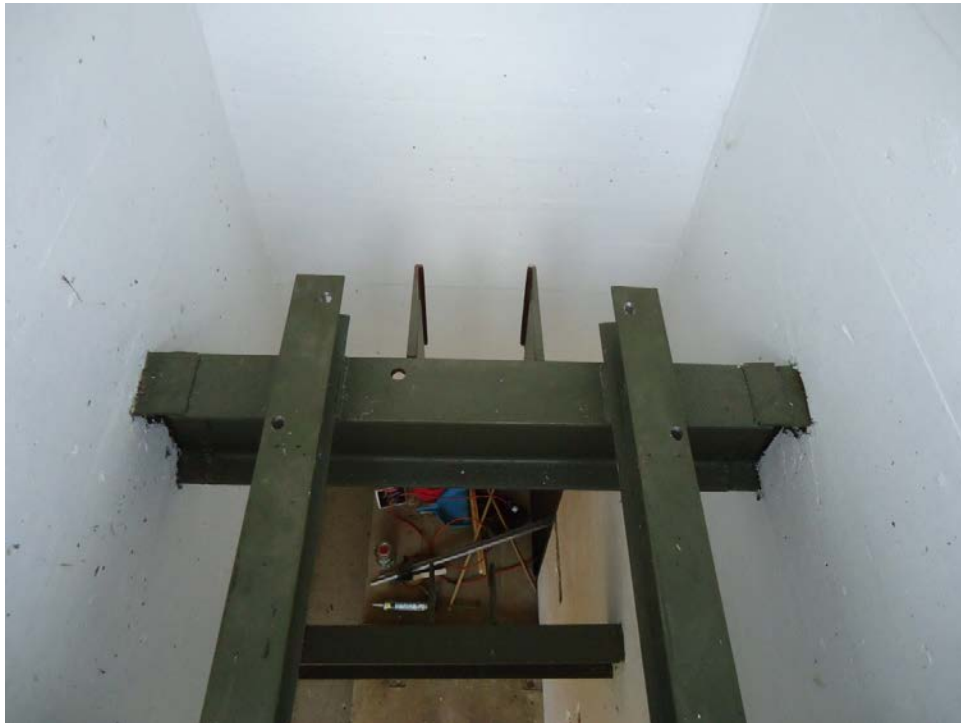
The photo below shows the four new holes drilled in the I Beams for the Trunnion bases. The next step is to prime and paint the trunnion bases, upper sprocket and shaft. Once that is complete the entire grouping will be assembled and secured to the I-Beams shown below.

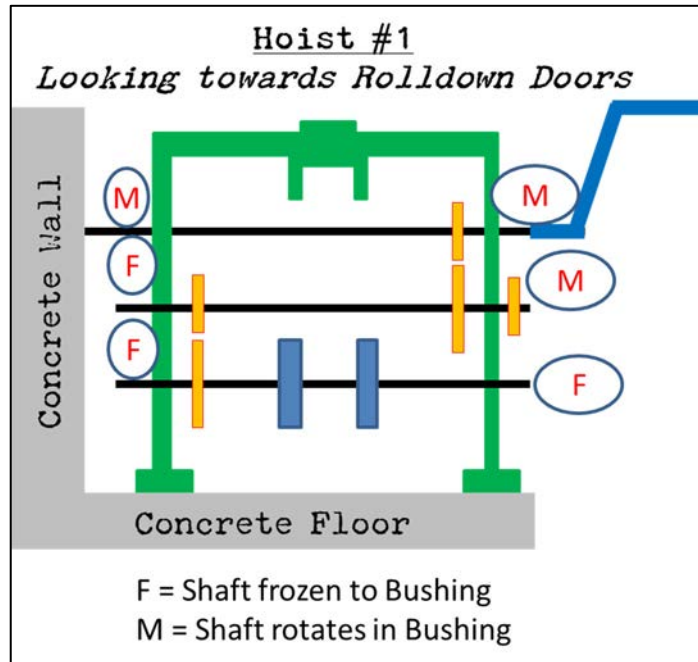
The drawing of Hoist #1 below shows that three of the six the bronze bushings are frozen to their shafts. The frozen bushings move within the frame as opposed to the shaft riding within the bushing and the bushing locking stationary in the frame using the locking bolt on the frame. On 15 July 2021, work began to release the three remaining frozen bronze bushings from the shafts.

T-4 Tunison used a propane torch to heat up the bushings and then LTC Welch would move the crank with maximum force to break the shaft free of the bearing. Over a period of two hours all three bushings were freed from the shafts. Then a process of lubricating and moving the shafts within the bearings began which lasted for another two hours.

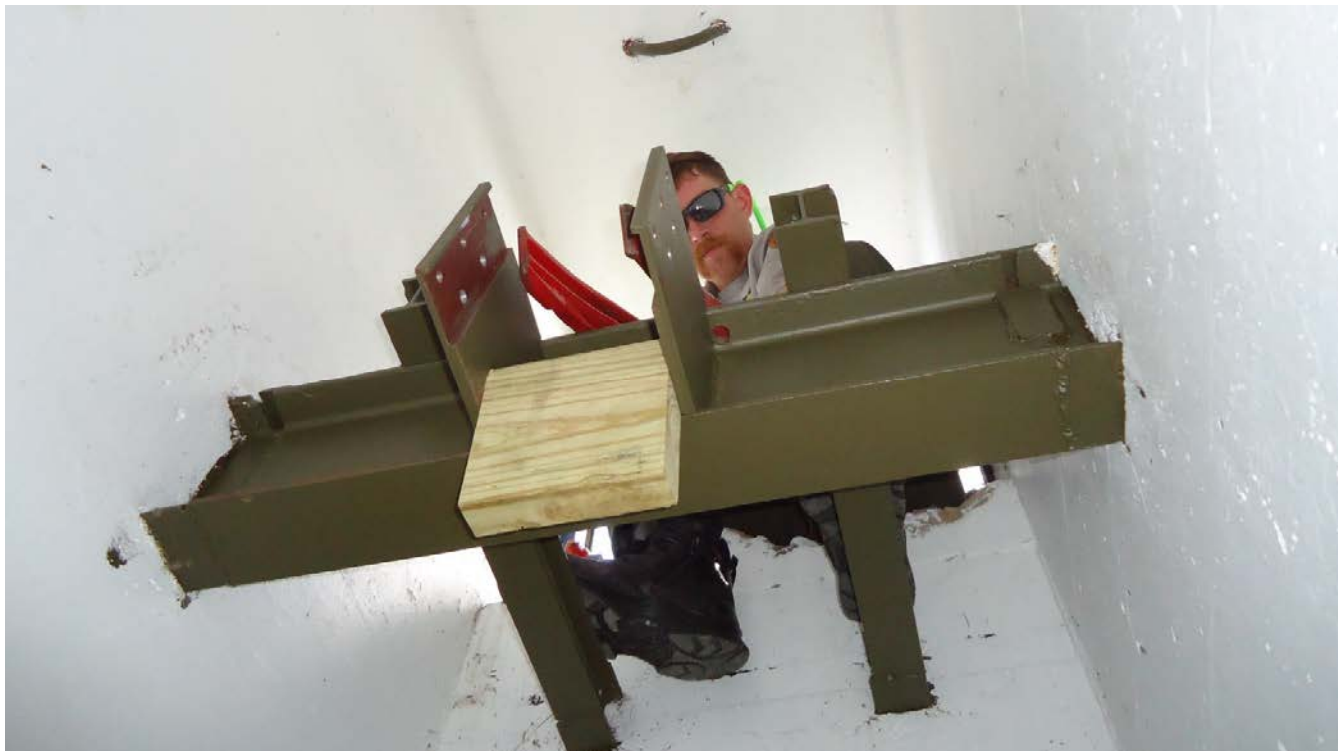
On 23 July it was discovered that the upper H-Beam mounting plates were too close together. The only option was to use some type of "jack" to pry them apart. The National Park Service assisted by providing a crash rescue spreader (jaws) with the requisite power to spread the plates. The photo below shows the Ranger having just used the jaws to open the plates and insert a wooden block.

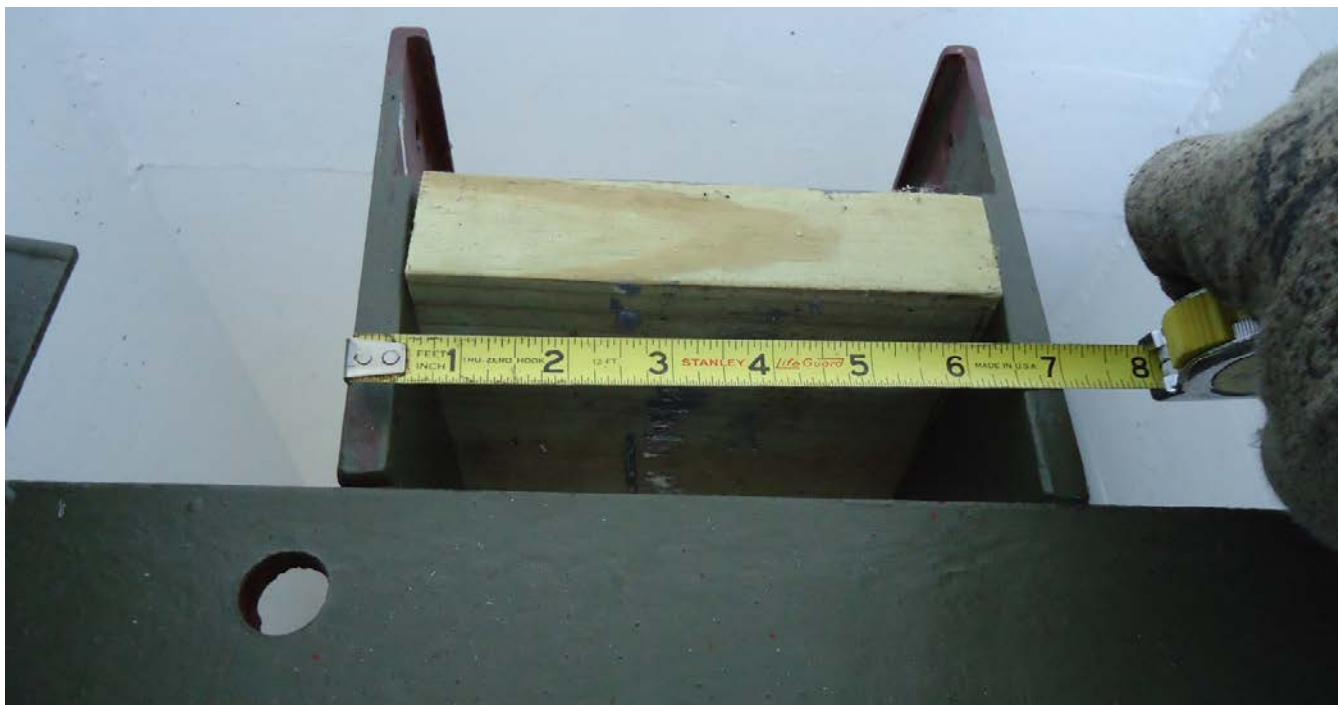
The final placement of the block is shown below. The intent was to leave the block in place for at least a month to dampen the potential tendency for the metal to "spring" back into place. The jaws spread the plates to seven inches - about half an inch more than required to compensate for the return "spring" expected.

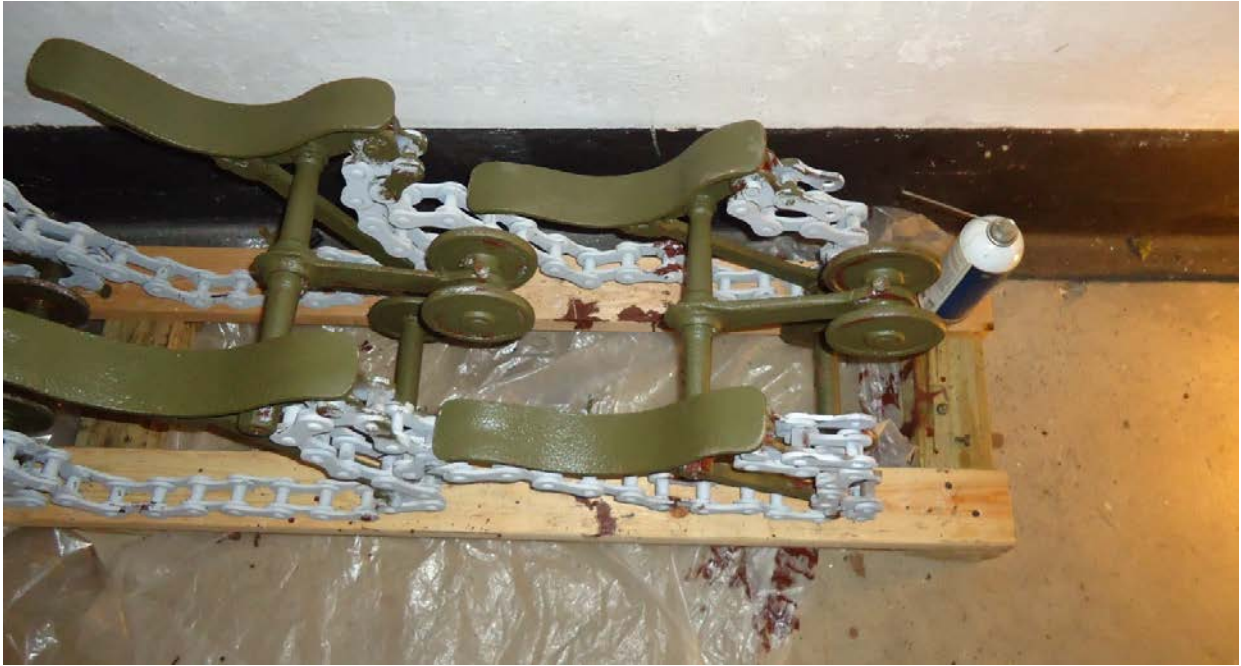
On 12 August, once all the OD paint had dried, work began on loosening and lubricating all the caster wheels on the hoist chain. Of twelve pairs, eleven were made operational and spun freely.

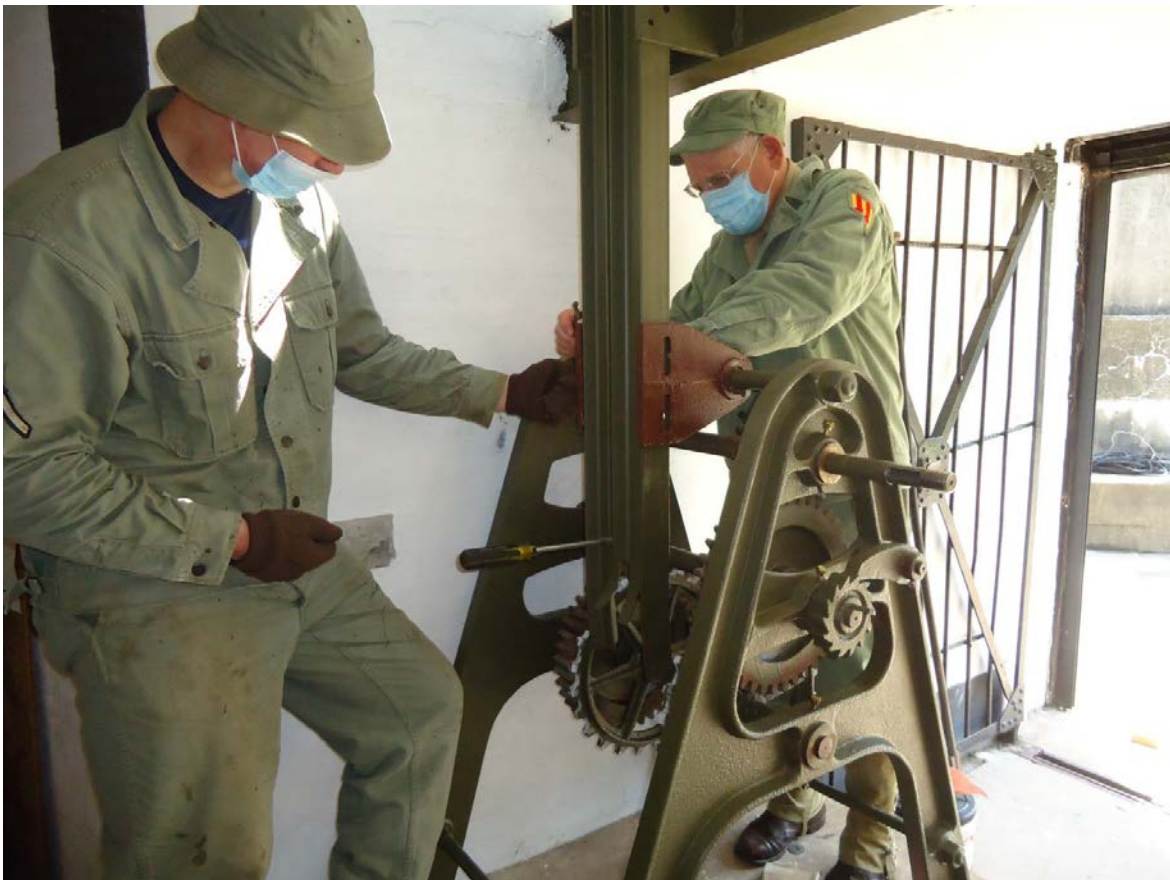
As work continued, it was soon discovered the H-beams did not fit properly into the frame's mounting brackets. The bolts had to be removed and the H-beams ground to fit the recesses in the plates. Below 2LT Still and PFC Bujdos remove the bolts.

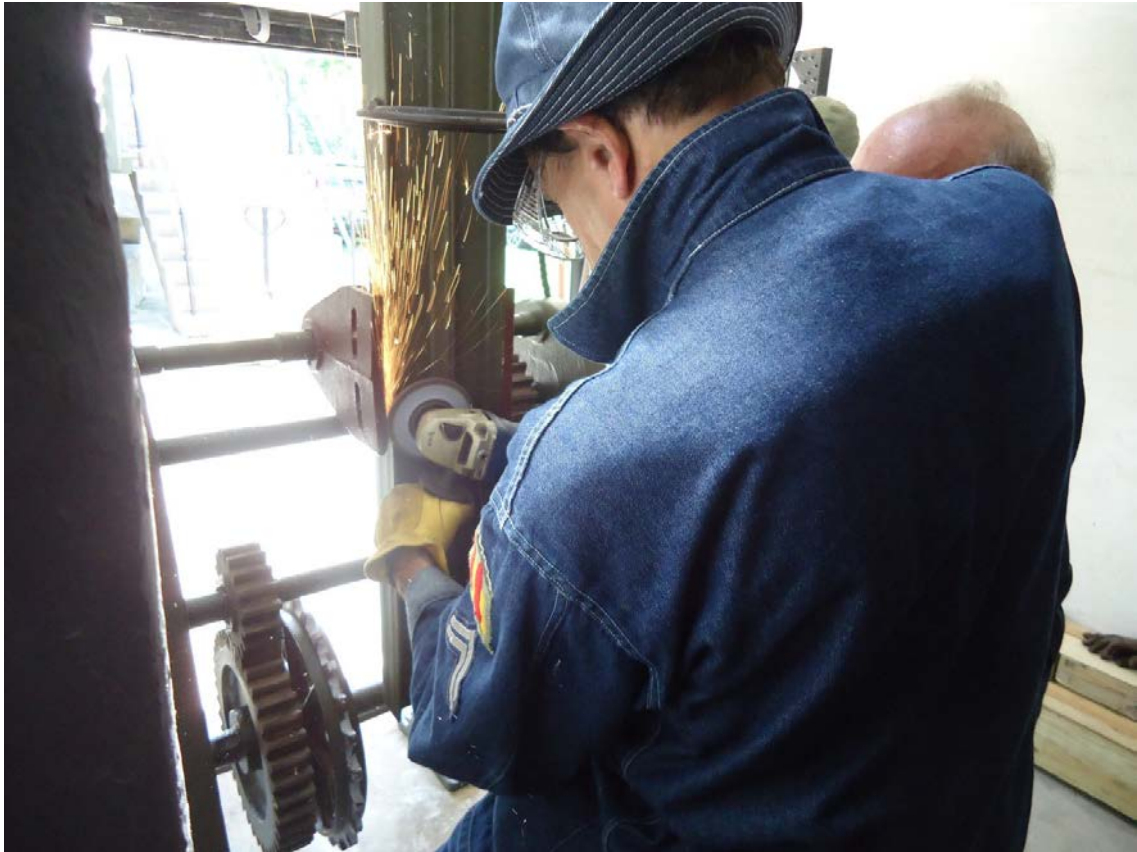
Below CPL Cusano uses a side grinding machine to remove metal from the H-Beams.

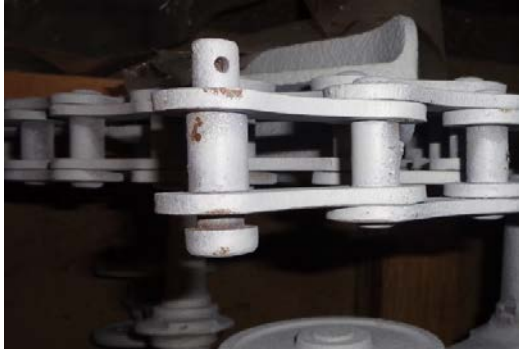
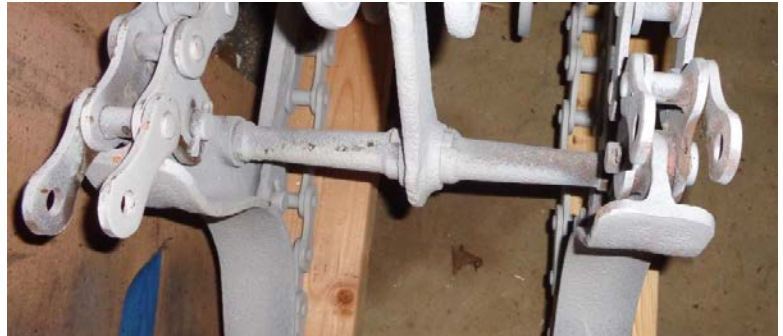
The master links are both in place. One of the master link pins are shown on the left photo and the two connection points for the links are shown on the right. The link pin itself passes through a "spacer" that maintains the proper distance of the links on the chain. Each pin has this spacer. The master pin had to be removed from the spacer. Then both pin and spacer were cleaned and polished, and then the entire pion and spacer assembly was lubricated. Once this was completed, the chain was able to be connected.
