## **5.0 DEORBIT/ENTRY**

### 5.3 HARDWARE FORENSICS

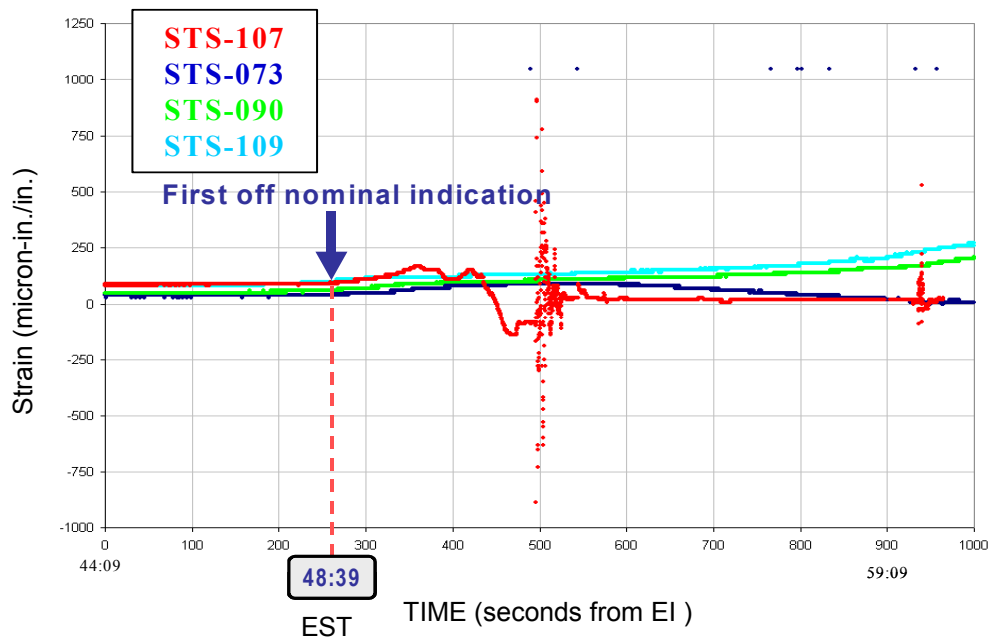
At approximately 8:48:39 EST (EI + 270 sec.), a left wing leading edge spar strain gauge began a small off-nominal increase. Figure 5-11 shows the STS-107 response of this strain measurement along with three other previous Columbia missions. Figure 5-12 shows the location of this sensor (WLE Strain V12G9921) and others on the wing leading edge. The damage in lower RCC panel 8 is believed to be the cause of this strain increase. The breach allowed hot gas intrusion onto the panels 8 through 9 wing leading edge spar area leading to extreme heating and thermally induced strain. The strain increase grew over time and reached a maximum at approximately 8:50:09 EST (EI + 360 sec.). Thermal and structural analyses indicate that a breach would need to be within approximately 15 inches of the strain gauge to create the observed strain increase.

**Figure 5-11. Left wing RCC panel 9 strain gauge is first measurement to indicate an off-nominal event. Note that EI was at 8:44:09 EST.**

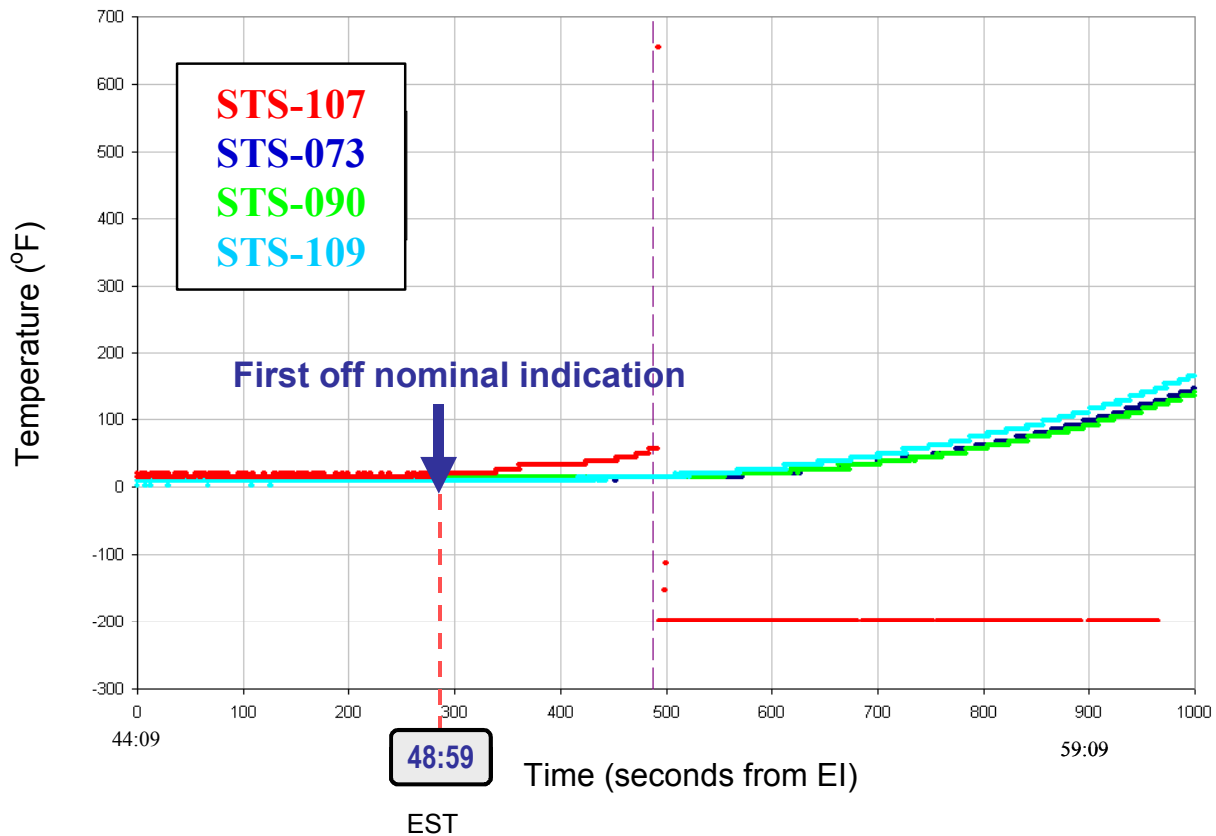
Twenty seconds later at 8:48:59 EST (EI + 290 sec.), the left wing lower attach clevis temperature sensor (between RCC panel 9 and 10) began an early off nominal temperature trend. Figure 5-13 shows the abnormal temperature response when compared to other Columbia missions. This temperature rise is consistent with an early entry of hot gas into the RCC cavity. This Modular Auxiliary Data System (MADS) measurement (V09T9910) is the only temperature measurement located in the RCC cavity along the left wing leading edge. It is positioned on the lower attach fitting between panel 9 and 10 and is well protected thermally by Inconel foil insulation. The sensor is also thermally isolated since it sits on the attach fitting away from other structure as shown in Figure 3-15. In order to get an early temperature rise for this sensor, unlike that observed on any other flight, there must be a path in the RCC cavity to allow hot gas to reach the sensor.

A thermal analysis was performed with heating rates from various hole sizes in the bottom of RCC panel 8 in an attempt to match this temperature rise. The analysis used a thermal math model of the wing leading edge (Inconel Cerachrome insulation, Inconel 718 and A-286 steel attach fittings, and aluminum honeycomb spar). The results indicated that the heating equivalent of a 6 to 10 inch diameter hole with a 10 percent “sneak flow” around the insulation would be required to match the thermal response of the clevis temperature. In the same timeframe several MADS lower surface temperatures on the left wing showed a slight off nominal early temperature rise when compared to previous flights of Columbia of the same inclination.

**Figure 5-13. Left wing RCC panel 9/10 clevis temp sensor is second measurement to indicate an off-nominal event**

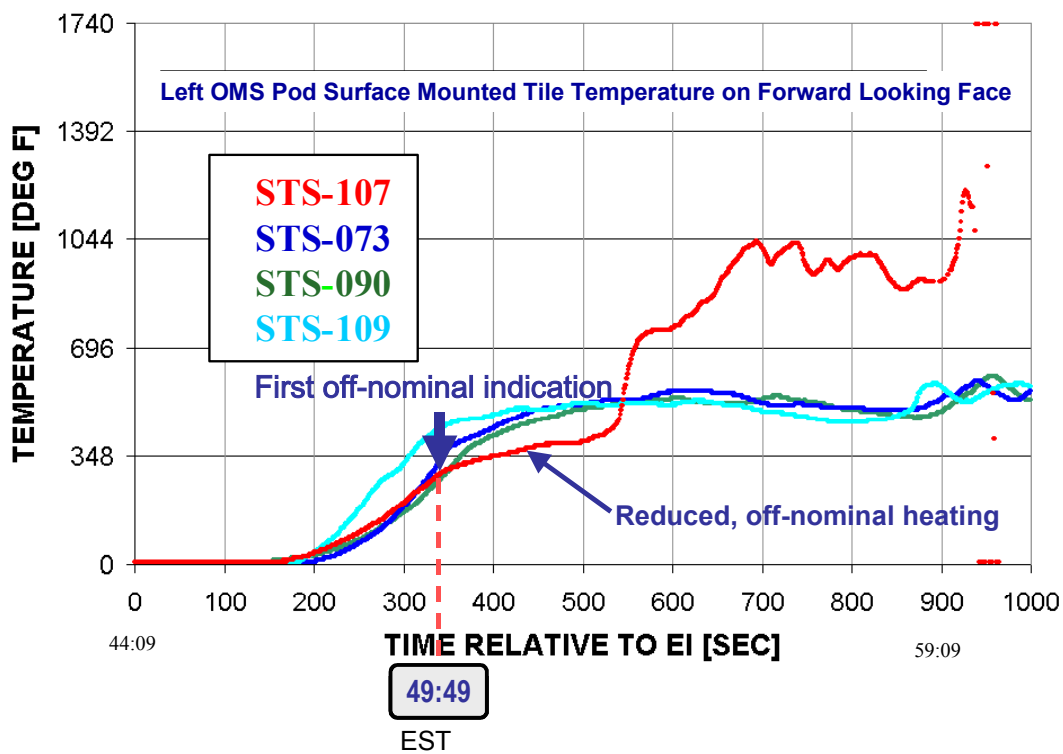
**Figure 5-14. Typical off-nominal OMS pod thermocouple (V07T9220A)**

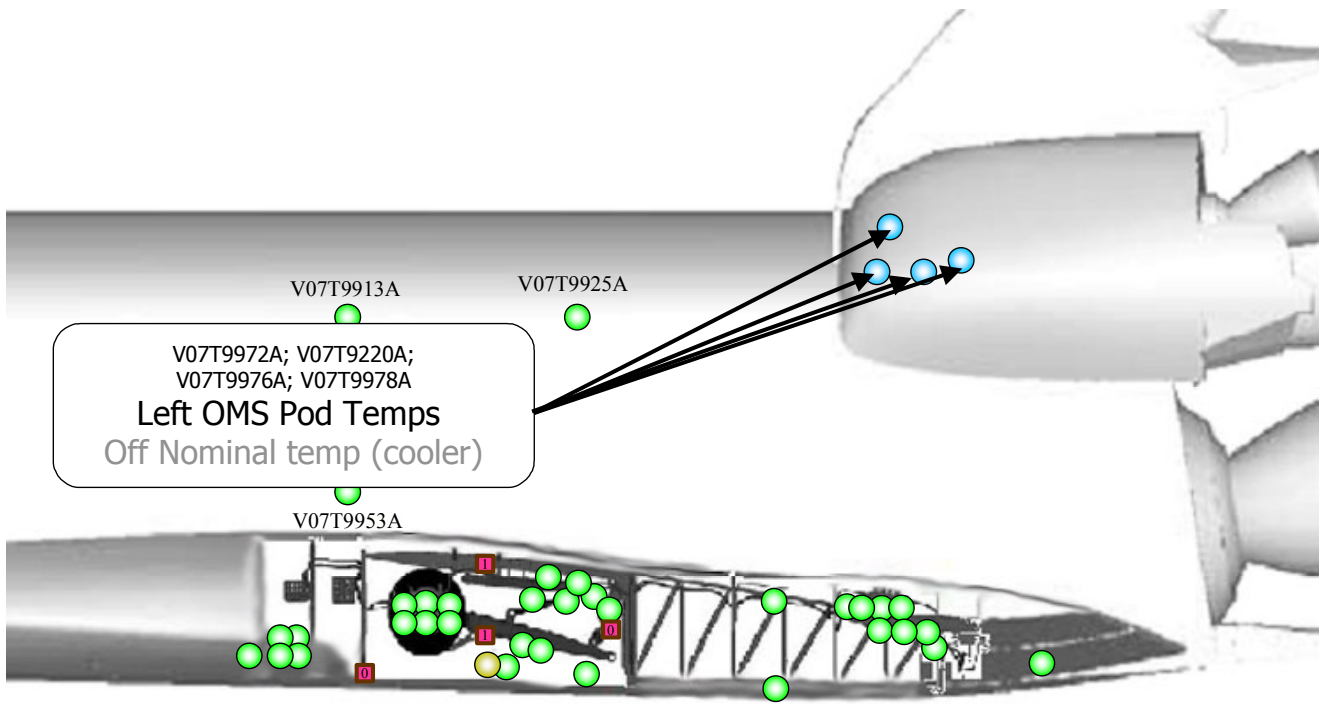
**Figure 5-15. Location of OMS pod thermocouples off-nominal low**

The reduced heating is not completely understood since the weak aerodynamic flow field on the upper surface of the orbiter is difficult to model and is extremely sensitive to disturbances. The best explanation for this reduced heating is that flow into the RCC cavity was venting through to the upper surface of the wing through an existing 0.1-inch vent between the RCC and upper surface carrier panels. This vent exists all along the leading edge from RCC panel 1 through panel 22 and has an approximate area of 66 square inches. This upper surface RCC venting and the flow disturbance created by the panel 8 and upper carrier panel 8 damage caused the vortices from the canopy or area where the wing meets the orbiter fuselage to move from their normal positions, thus reducing the heating on the OMS pod. Figure 5-16 depicts the change in the upper wing surface vortices and the weak upper surface flow.

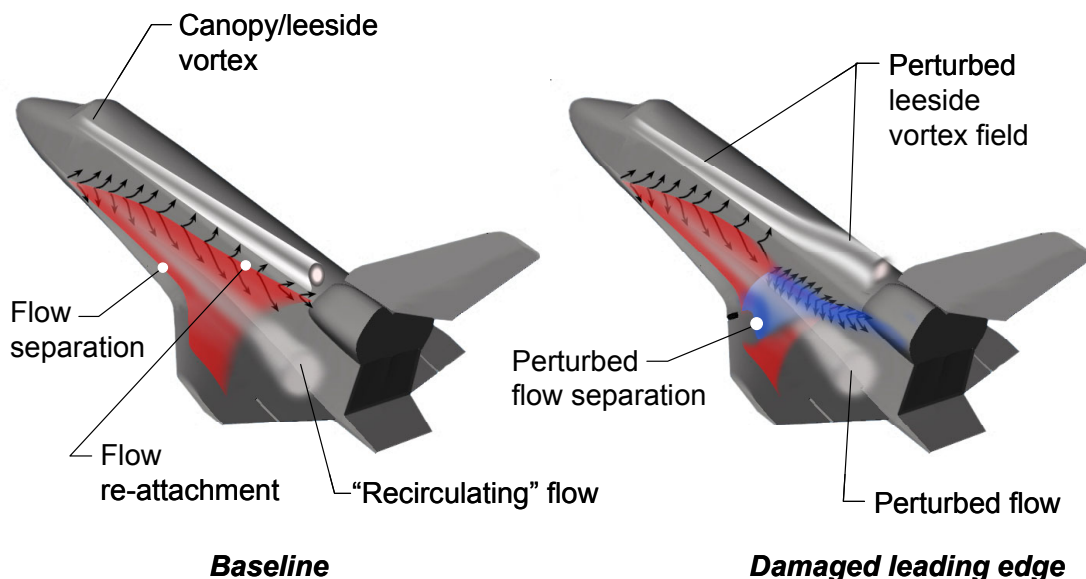
*Wing leading edge damage perturbs leeward flow separation and re-attachment locations as well as leeward embedded shocks (not shown)*

**Figure 5-16. Postulated orbiter leeward flow field associated with wing leading edge damage**

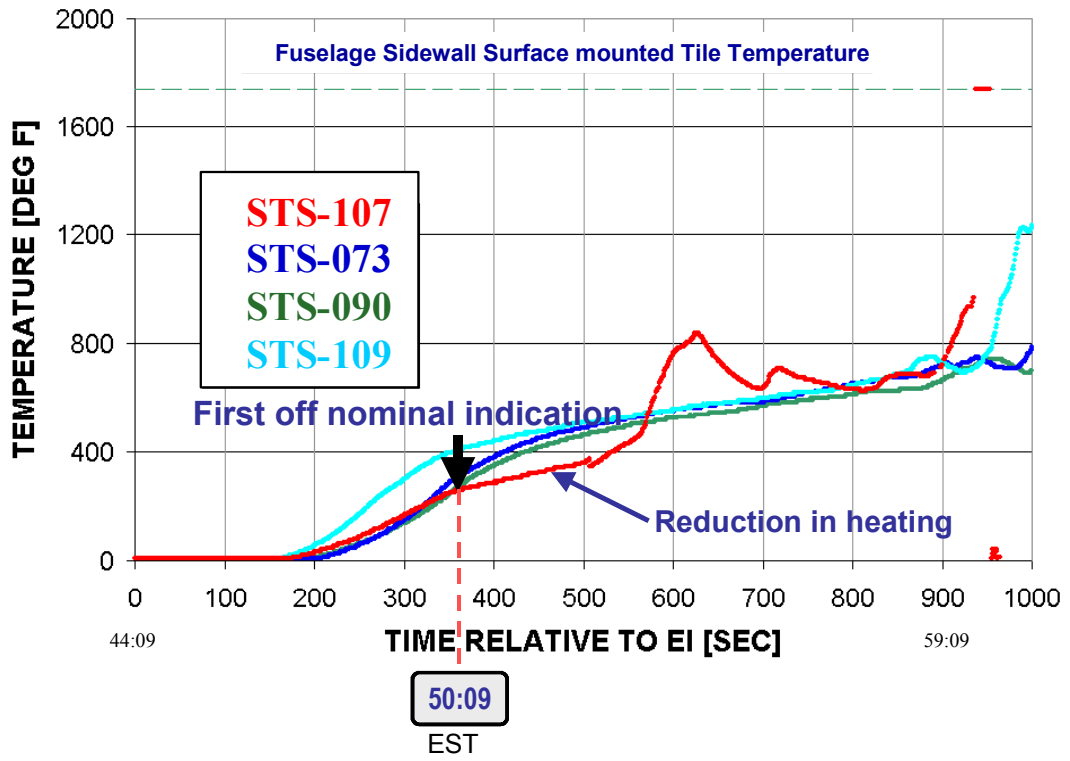
In the same timeframe, at 8:50:09 EST (EI + 360 sec.), a left payload bay fuselage MADS surface temperature measurement (Figure 5-19) showed an off-nominal temperature trend. This trend is a reduced rise rate when compared to other previous Columbia missions, as shown in Figure 5-20. The previously discussed theory of venting and or disturbed flow due to panel 8 damage, causing a shift in the vortices on the upper surface of the wing, is also believed to be the cause of this off-nominal behavior. The flow field and venting on the upper surface rate are constantly increasing since the mass flow rate into the RCC breach is increasing as the orbiter descends lower into the atmosphere.

**Figure 5-20. Off-nominal temperature indication on the left sidewall**

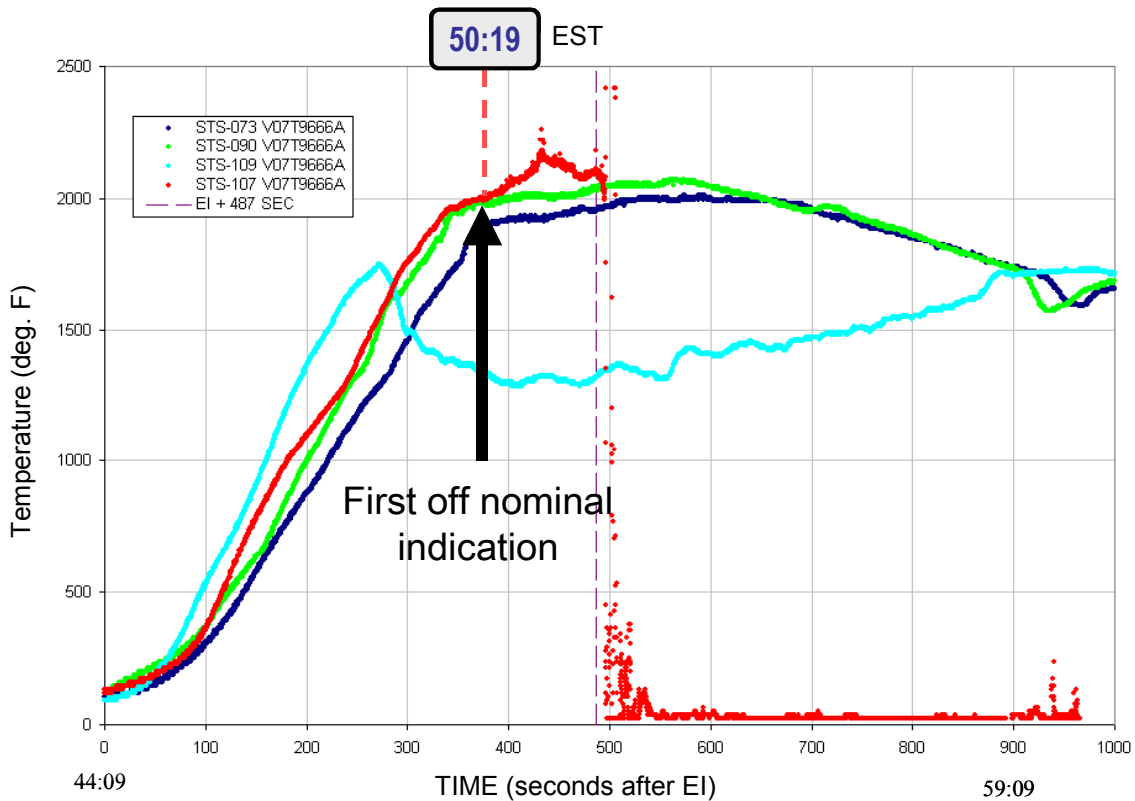
At 8:50:19 EST (EI + 370 sec.), a lower surface thermocouple showed signs of off nominal, increased heating. The best explanation for the increased heating in this area is severely disturbed, turbulent flow caused by the leading edge damage on the bottom of RCC panel 8 and flow from the lower corner of this panel as discussed in Section 5.3. Langley Research Center wind tunnel testing has confirmed that wing leading edge damage (notch or protuberance) near panel 8 will cause increased heating to the lower wing surface. As previously discussed, the eroded lower carrier panel tiles on panel 9 indicate this strong flow from panel 8. This is consistent with flow patterns observed on many recovered lower surface wing acreage tiles along the flow lines aft of the RCC panel 8 area. Figure 5-21 shows this temperature response as compared to other Columbia missions. The location of the sensor can be seen in Figure 5-22.

**Figure 5-21. Temperature rise on tile surfaces aft of RCC panel 9**

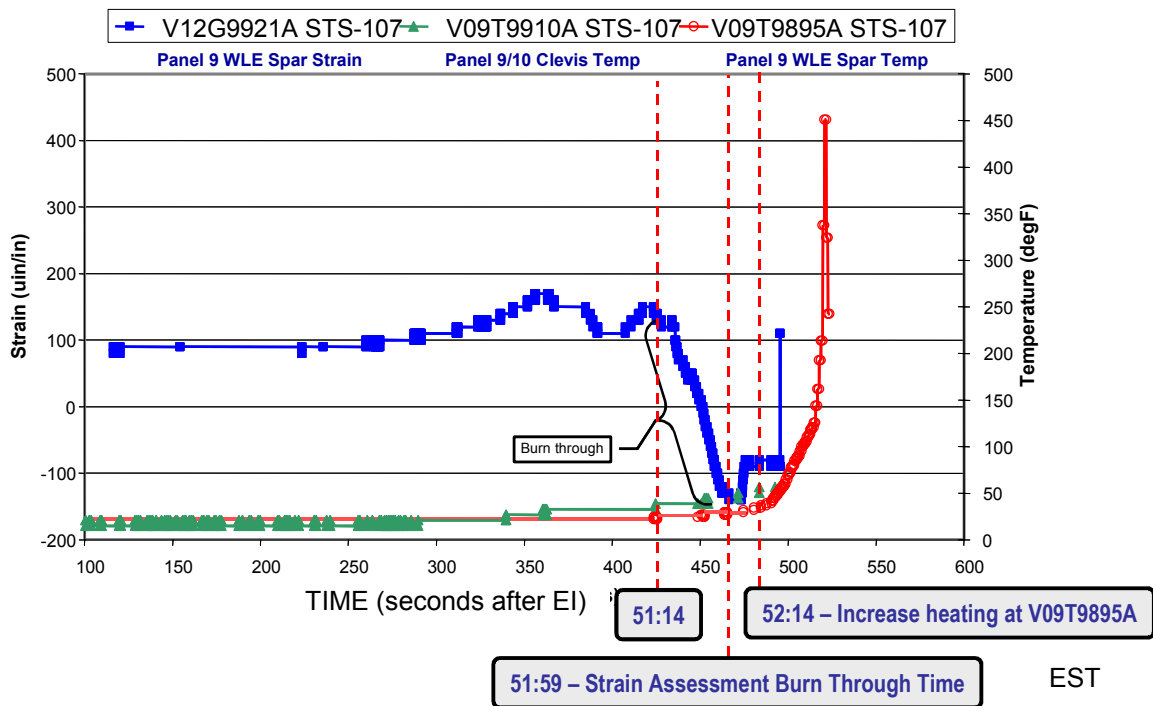
By 8:51:14 EST (EI + 425 sec.), the wing leading edge spar temperature began an early, off-nominal rise, shown in Figure 5-23. At the same time, the clevis temperature in the RCC panel 9/10 region continued to increase. The initial spar temperature rise was relatively slow and was caused by conduction since this measurement is on the backside of the spar in the wing cavity. Eventually, the rise rate increased dramatically as first the Inconel and Cerachrome insulation and later the aluminum honeycomb were destroyed. The exact time of the spar breach is unknown; however, it is estimated to have occurred between 8:51:14 to 8:51:59 EST (EI + 425 to 470 sec.) based on the observed wing leading edge linear decrease in strain during this timeframe. A more detailed discussion of the method used to bracket the time of the wing spar breach is contained in the following section.

**Figure 5-23. RCC panel 9 MADS strain and temperature measurements, STS-107**

The first technique used the strain response, shown earlier in Figure 5-23. On this plot, the initial strain rise that began at about 8:49:09 EST (EI + 300 sec.) is due to thermal elastic strain. It appears that the spar structural softening occurs at approximately 8:50:09 EST (EI + 360 sec.), followed by loss of the structural integrity, or breach, at

approximately 8:51:14 EST (EI + 425 sec.). This appears to be completed by approximately 8:52:00 EST (EI + 471 sec.). A detailed structural model that attempted to reproduce the thermal strain response observed during this timeframe confirmed this timing. This analysis determined that the location of the spar breach must be within about 15 inches of the spar strain measurement. This would locate the spar breach near the intersection of panel 8/9, as shown in Figure 5-29. The flow through the RCC breach maintained some directionality although it was influenced by the shape of the hole, remaining RCC structure, attach hardware, and leading edge insulators. Overall, this strain response is consistent with an RCC breach in the lower part of panel 8 as previously discussed in Section 5.3. Although it is difficult to pinpoint a precise location of the RCC breach, this analysis supports the argument that the breach was closer to the panel 8/9 intersection and Tee seal 8.

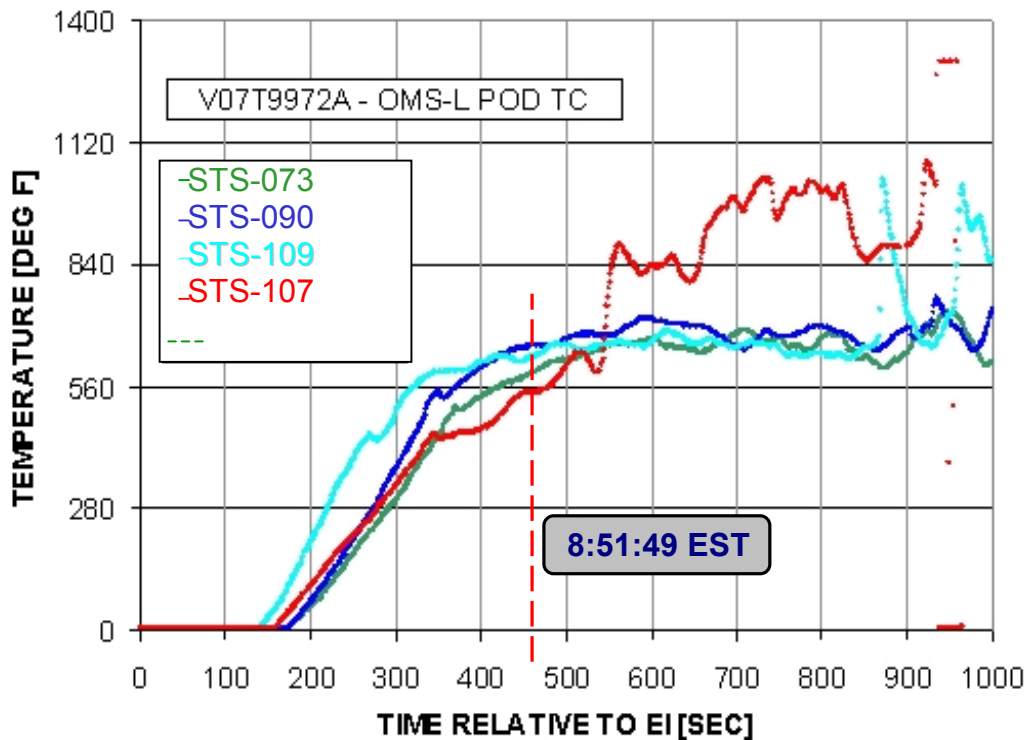
At 8:51:49 EST (EI + 460 sec.), one of the left OMS pod measurements (V07T9972A) began to show an increased temperature rise, indicating that the upper surface flow has changed again. This is shown in Figure 5-24 along with this measurement on other Columbia missions. It is evident that the measurement rises to a higher temperature and at a faster rate than has been observed on previous missions within the next few minutes. Figure 5-25 shows other left OMS pod and fuselage temperature measurements that exhibit an off-nominal rise later in time. The sensor locations on the left side of the orbiter are also shown in Figure 5-25.

**Figure 5-24. Off-nominal low OMS pod thermocouple (V07T9972A)**

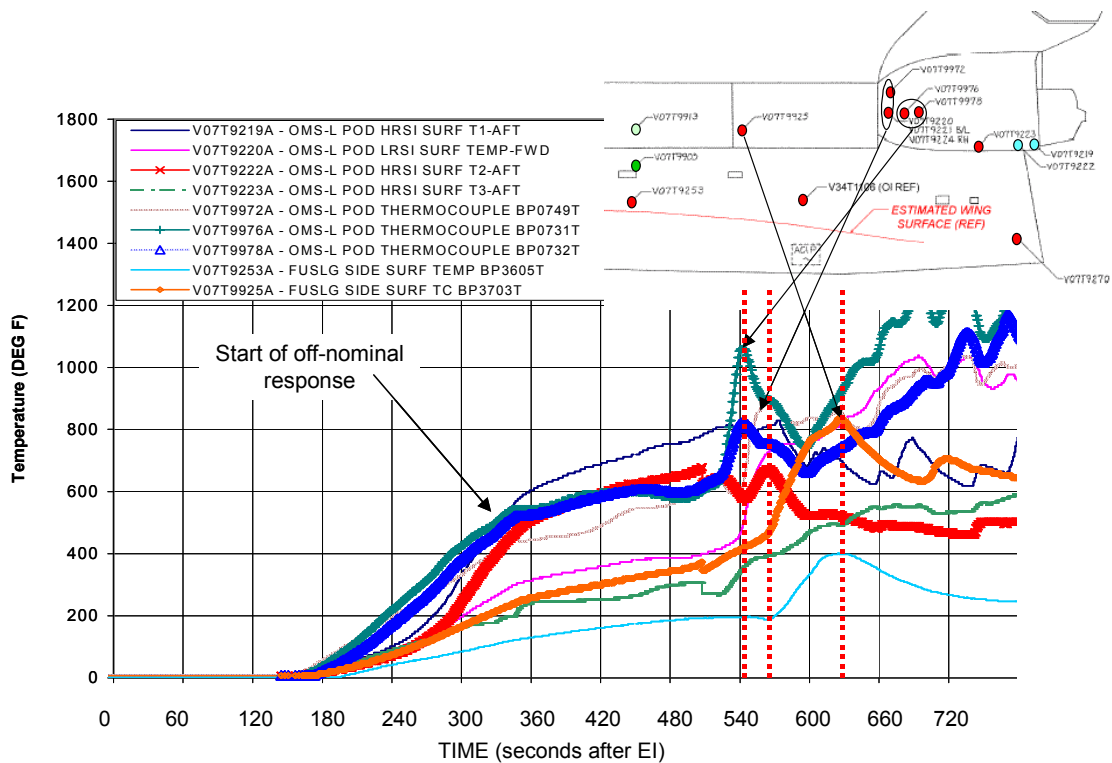
**Figure 5-25. Left side fuselage/OMS pod off-nominal responses indicate increased heating**

These off-nominal temperature rises were caused by a change in the flow field along the upper portion of the left wing as the wing leading edge (WLE) and wing spar damage progressed. The mechanism was a shift in the vortices due to venting on the upper portion of the wing and is similar to the previous discussions on lower than expected OMS pod temperatures. Wind tunnel testing and CFD analysis confirmed that WLE damage on RCC panels 8 and 9 could cause increased heating to the OMS pod due to disturbed upper surface flow or flow impingement caused by re-directed flow from the lower surface. Additionally, the molten Inconel 718 and A-286 spray onto this area are indications that this flow is the cause of these temperature rises. Figure 5-26 (from wind tunnel test results) is a representative example of increased heating on the left fuselage and OMS pod due to RCC panel 9 damage from wind tunnel test results. Figure 5-27 shows a similar picture of the left side as determined by CFD analysis. Note that neither the wind tunnel testing nor the CFD analysis accounts for increased heating that is likely due to molten metal contacting the OMS pod.

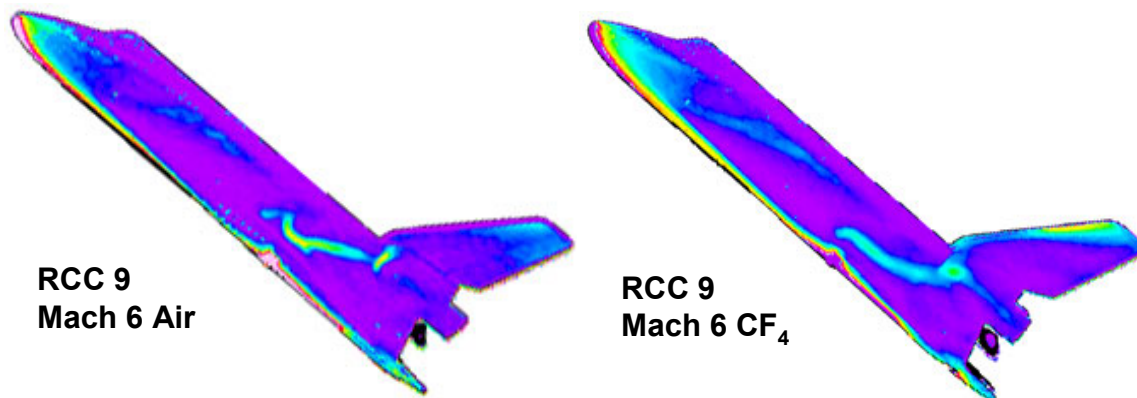
**Figure 5-26. Wing tunnel test results for RCC panel 9 missing and resulting in increased heating to OMS pod**

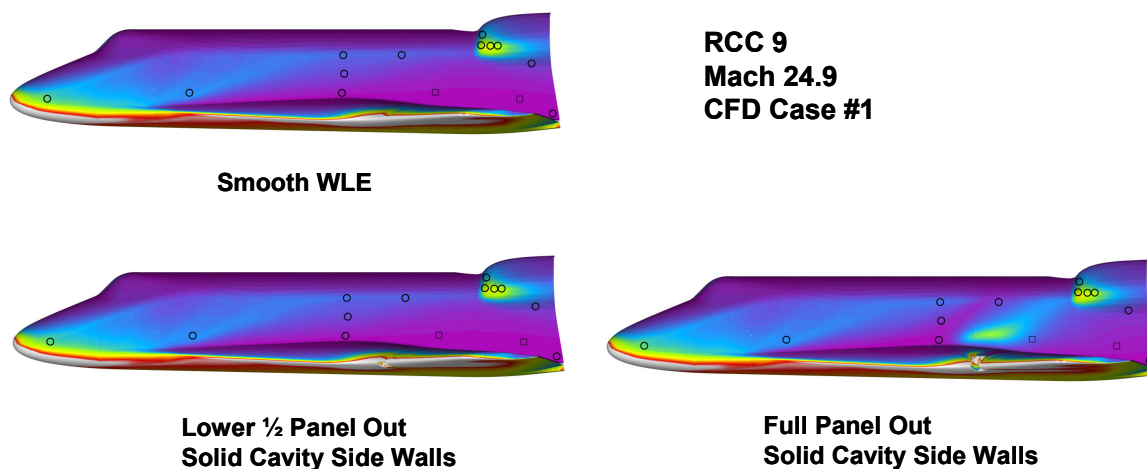
**Figure 5-27. CFD results for no damage, partial damage, and full damage to RCC panel 9 show increased heating on side fuselage and OMS pod**

The increased heating implies that damage/erosion to the RCC panel 8 area had increased or that at least one carrier panel had been lost. The increased heating is also consistent with an increased mass flow rate due to the nature of the entry environment. The dynamic pressure and stagnation heat flux had more than doubled by this timeframe when compared to a few minutes after EI. There are three additional communication dropouts that follow at approximately 8:52:09 EST to 8:52:31 EST (EI + 480 to 502 sec.). Again, these dropouts are consistent with molten aluminum and other metals being released into the environment surrounding Columbia.

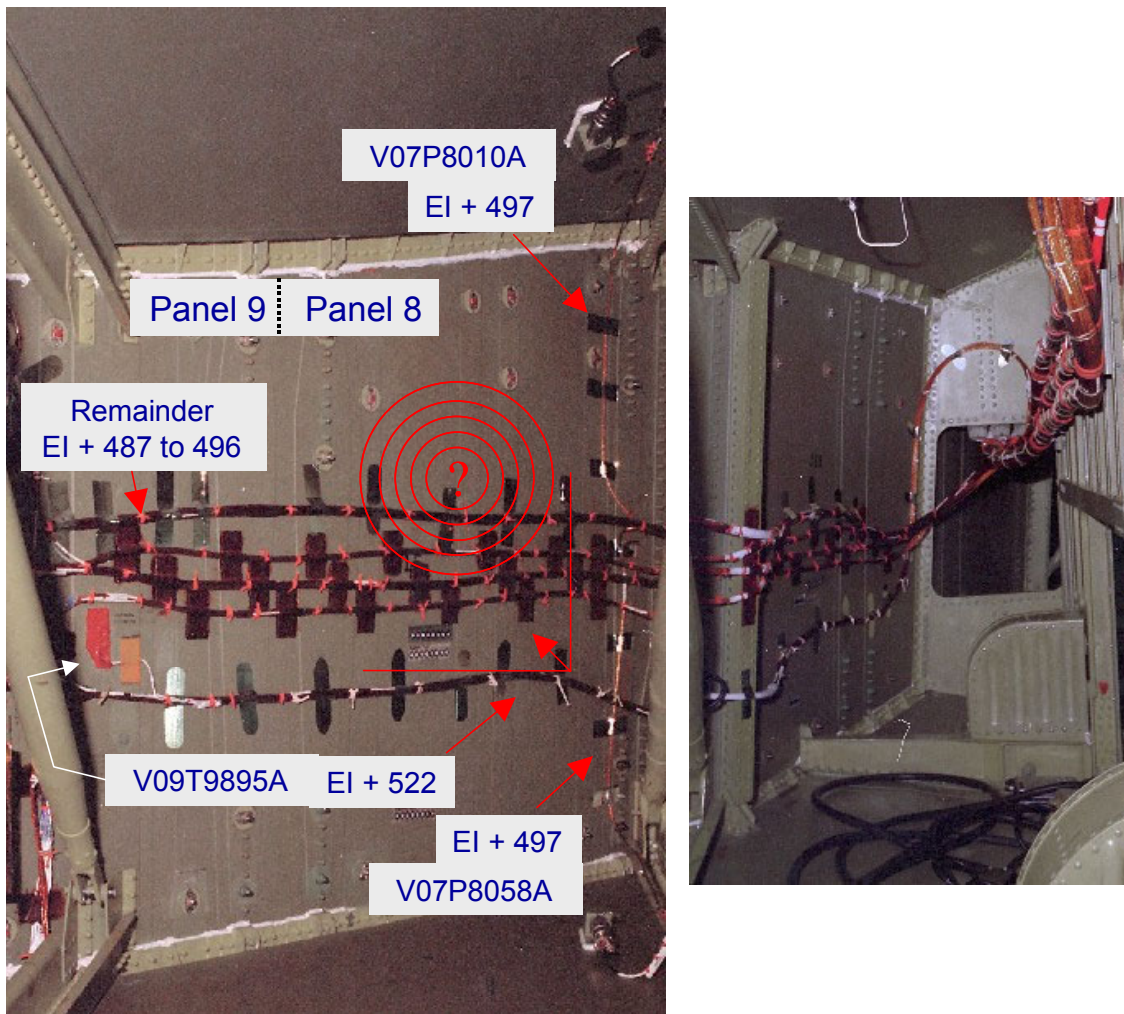
**Figure 5-29. Cable routing on wing leading edge and wheel well wall**

The final technique used was an examination of the wire failures on the wing leading edge spar. These wire runs are shown in Figure 5-29. The first measurement loss was a MADS upper left wing pressure measurement, which failed at approximately 8:52:16 EST (EI + 487 sec.). This measurement is contained in the upper wire bundle in the left photo in Figure 5-29. The combination of these three separate and distinct analyses results in a range of wing spar breach times as early as 8:51:14 EST and as late at 8:52:16 EST (EI + 425 to 487 sec.).

Immediately after the breach, hot gas inside the wing began to heat the remaining wire bundles that contained real-time telemetry and the recorded MADS measurements. Figure 5-29 shows an inside-the-wing view of the approximate breach location based on this wire failure analysis. The view on the left is of the panel 8/9 spar location. This area is not visible in the right photo, which contains the transition spar and a view of the three wire bundles along the outside of the wheel well wall. Figure 5-31 shows the overall spar breach location with respect to the rest of the wheel well. The distance from the spar to the wheel well wall in this area is approximately 56 inches, as shown in Figure 5-32. Figure 5-33 shows a sketch of the venting of the left wing into the payload bay, driving the direction of the internal flow depicted in Figure 5-31. Note the 142 square inch vent into the midbody fuselage located forward of the wheel well.

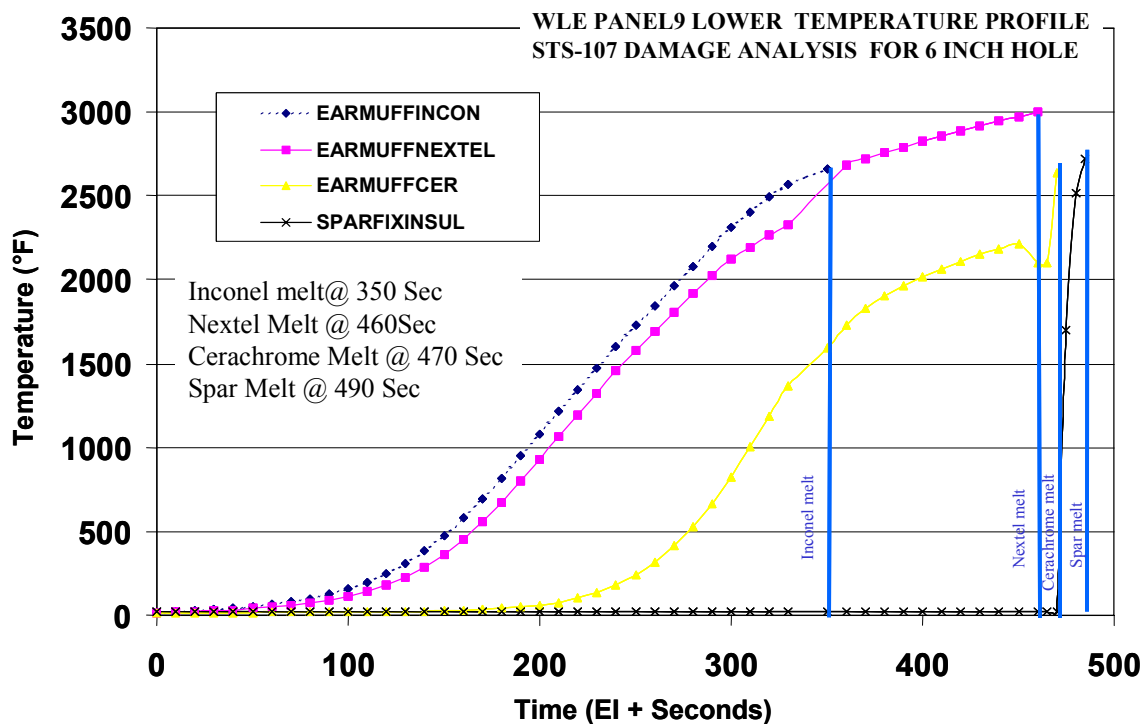
The second technique used a detailed thermal model to determine the time required to burn through the various insulations immediately in front of the wing leading edge spar (Inconel, Nextel, Cerachrome) and then the honeycomb spar. This model assumed the equivalent heating of a six-inch diameter hole in the bottom of RCC panel 8. Using the expected aero heating rate and the various material properties, the spar burn through occurred at 8:52:19 EST (EI + 490 sec.). This time would be accelerated slightly for a larger diameter hole. The results of this thermal model are shown in Figure 5-30.

**Figure 5-30. Thermal model prediction of wing spar burn through**

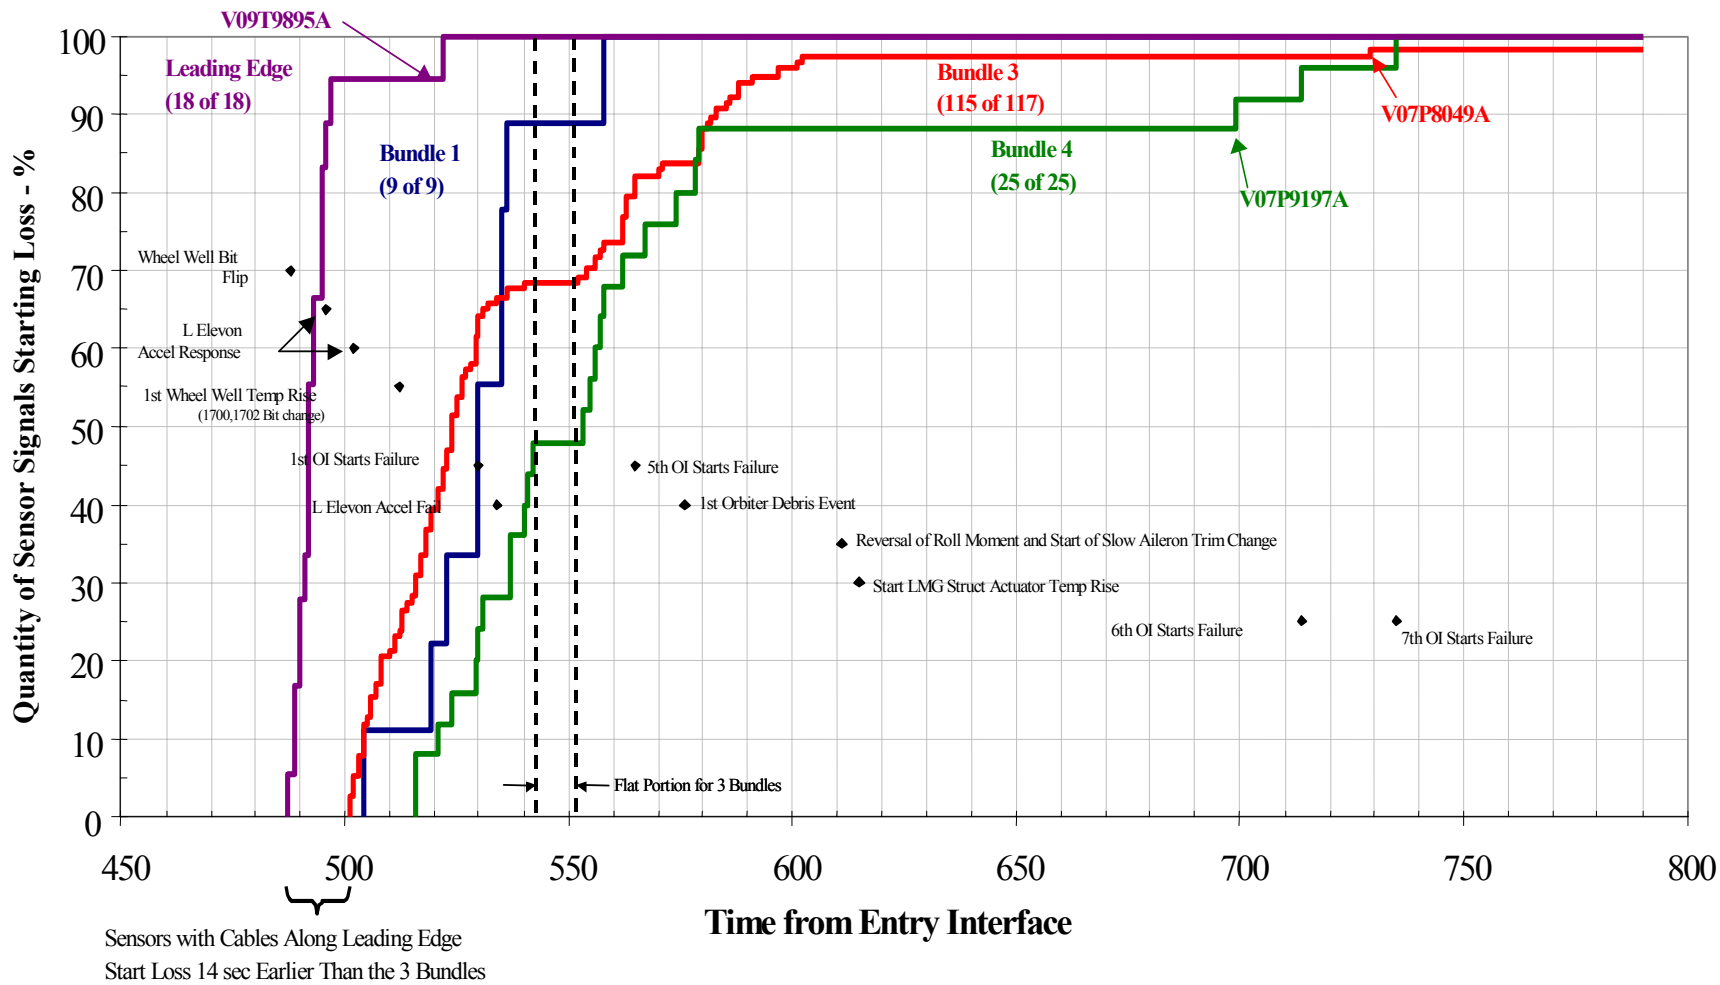
One hundred sixty-three other measurements failed very quickly over the next two minutes. Figure 5-34 is a plot of the percentage of measurements lost as a function of time from EI. The first measurements to fail are all located on the wing leading edge spar as shown by the purple line on the plot. Bundles 1, 3, and 4 along the wheel well (shown in Figure 5-35) began to fail about 14 seconds after the first spar measurements. This is indicative of a plume impinging on the wire bundles on the wheel well wall.

**Figure 5-34. MADS data failure due to wire burning**

Four additional measurements failed after 8:54:16 EST (EI + 605 sec.) with the last starting to fail at 8:56:24 EST (EI + 735 sec.). This last measurement failure took over a minute to fail completely. Figure 5-34 and Figure 5-35 show the measurement loss timing and the wire bundle runs along the wheel well. Although almost all measurements internal to the wing failed, two strain measurements on the 1040 spar (forward of the wheel well) were unaffected and produced data until loss of all MADS data at 9:00:13 EST (EI + 964 sec.). Figure 5-36 shows the location of the sensors on the forward wheel well spar. The fact that these measurements are available until loss of data are important indicators that the RCC breach could not be forward on the panel 6 area since these measurements would have been lost as well (see Figure 5-32). These measurements also record key changes in strain that help indicate some of the changes that the left wing underwent as the remainder of the entry events unfolded.

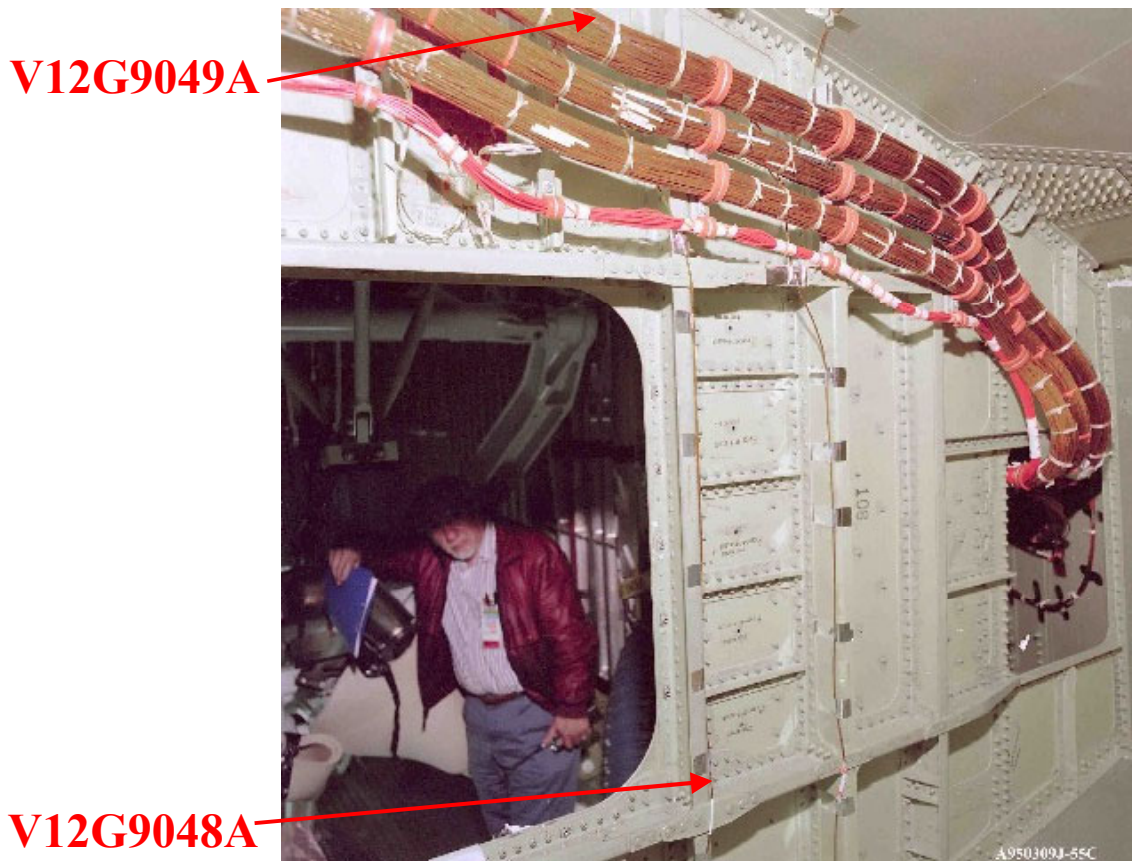
**Figure 5-36. Strain measurements on 1040 spar**

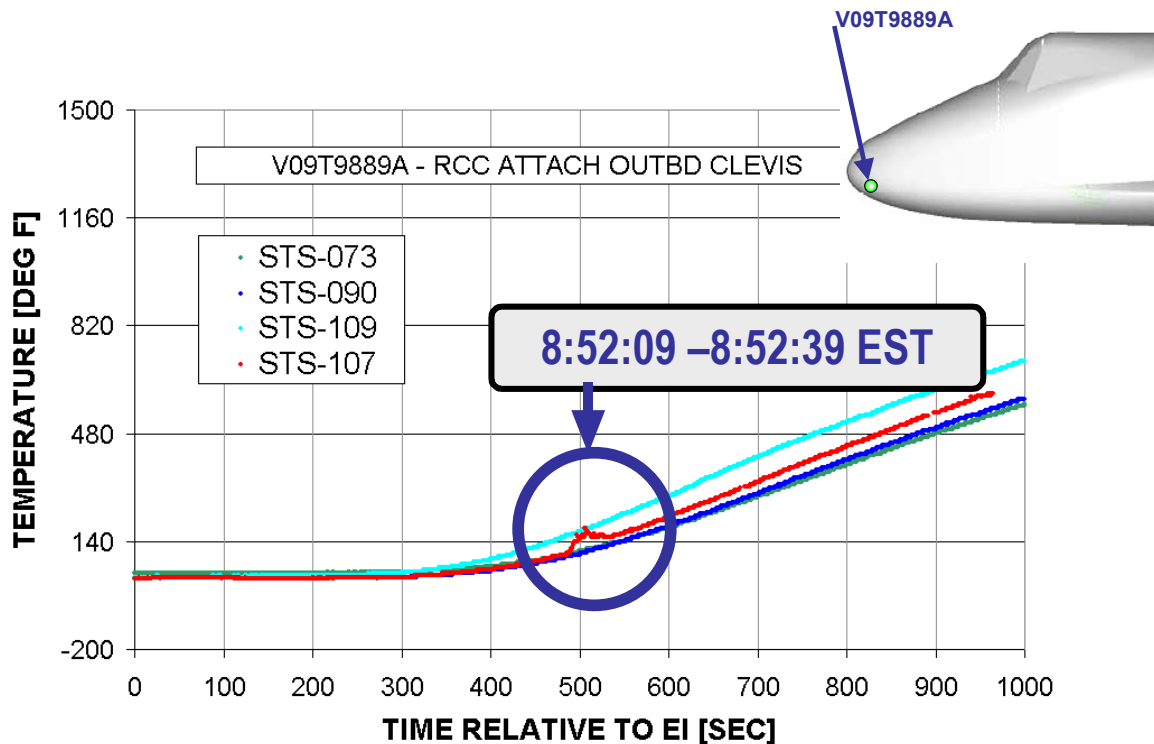
Coincident with the spar breach at approximately 8:52:09 EST (EI + 480 sec.), the nose cap RCC attach clevis temperature had an off-nominal change in rise rate when compared to previous missions. This rise rate was abnormal for approximately 30 seconds and ended at 8:52:39 EST (EI + 510 sec.). The exact cause of this abnormal temperature rise is not known, but the timing is coincident with the breach of the wing leading edge spar. An explanation is that the abnormal rise is an instrumentation anomaly caused by multiple wire failures in this timeframe. This measurement response is shown in Figure 5-37 along with the same measurement for several other Columbia missions. This figure also shows the location of this internal nose cap measurement on the very forward portion of the left fuselage.

Figure 5-37. Off-nominal temperature rise rate in nose cap RCC attach clevis

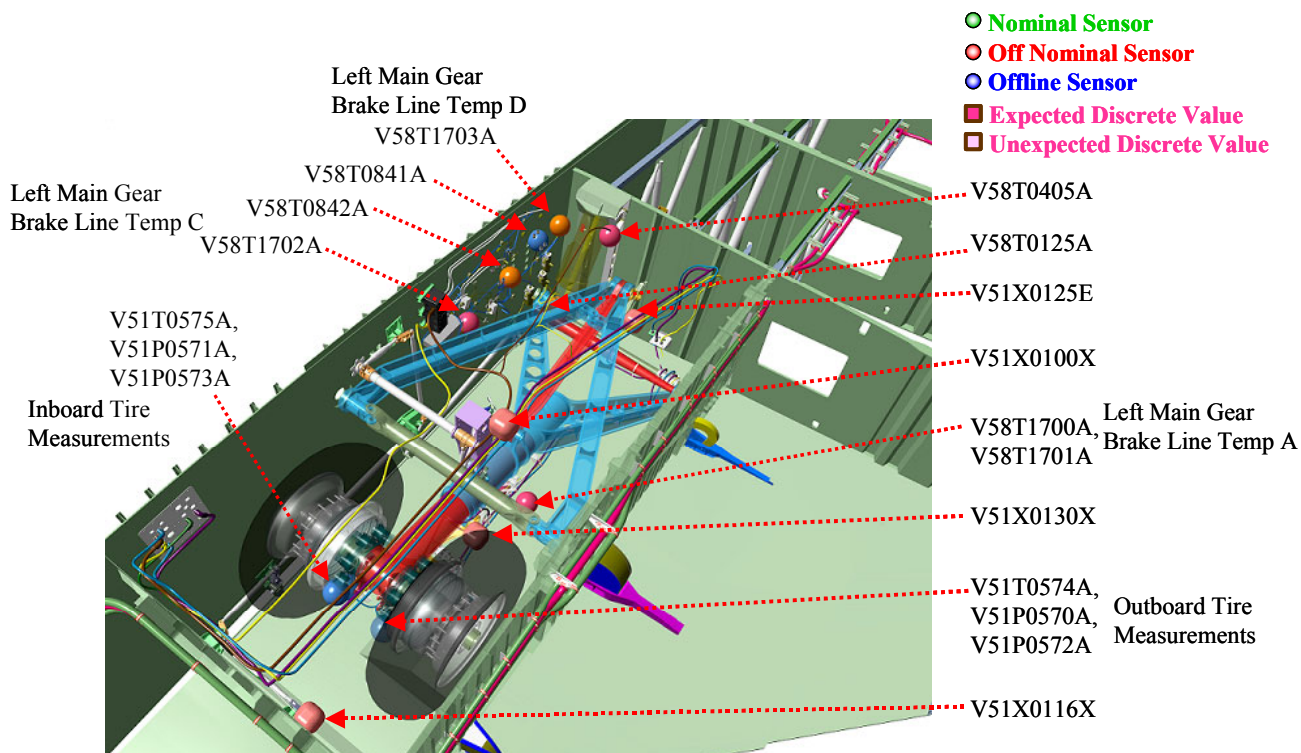
**Figure 5-38. Location of sensors in the LH wing wheel well**

At the same time as the stress was relieved on the lower 1040 spar, two left main gear outboard tire pressures began trending toward an off-scale low reading. This was preceded by a slight upward trend at 8:57:19 EST (EI + 790 sec.) for both pressure measurements. This is an indication of extreme heating of both the left outboard tire and the surrounding instrumentation. The tire has significant thermal mass and substantial heating would be required to produce the slight temperature rise. By 8:58:56 EST (EI + 887 sec.), all left main gear inboard and outboard tire pressure and wheel temperature measurements were lost indicating a rapid progression of damage or wire burning inside of the wheel well. Figure 5-38 shows the location of these pressure sensors.

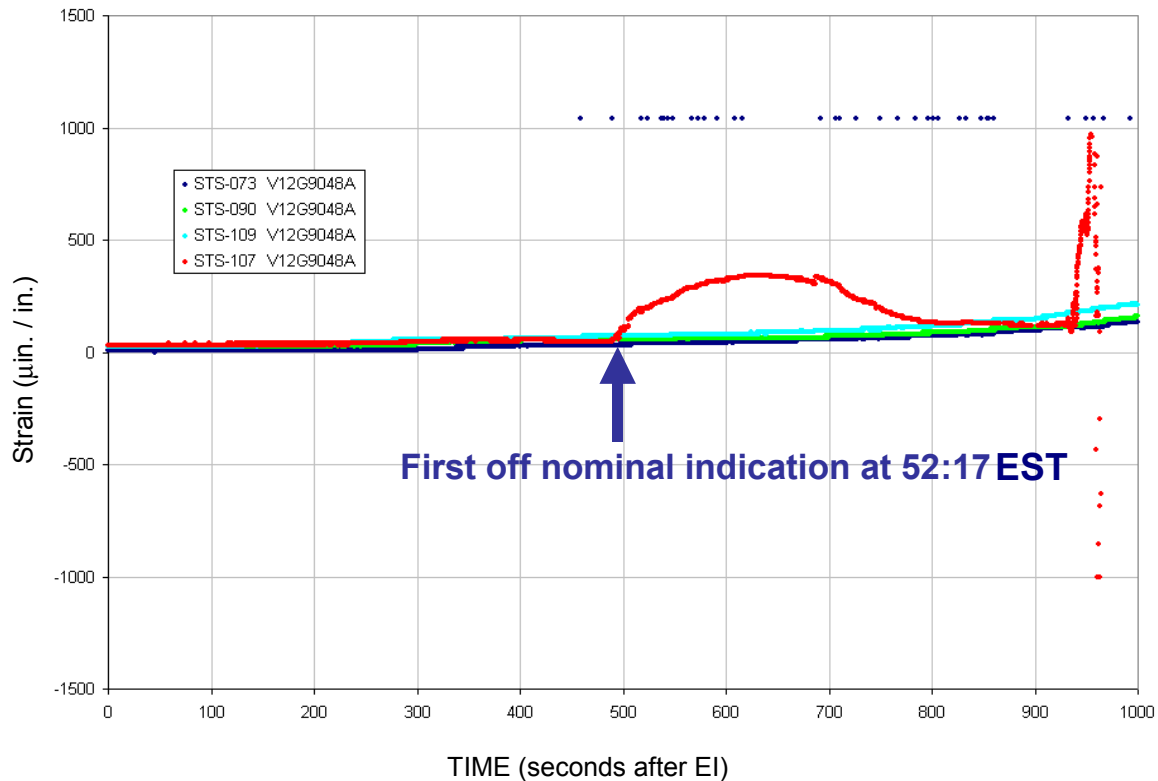
**Figure 5-39. Strain rise in lower 1040 spar cap**

At 8:58:32 EST (EI + 863 sec.), there was a change in stress measured on the left wing 1040 spar (main landing gear forward wall spar), as indicated by strain gauge measurements that began trending up at 8:52:18 EST (EI + 489 sec.). At 8:58:32 EST (EI + 863 sec.) the lower cap strain (near the bottom of the 1040 spar) essentially returned to a normal measurement when compared to previous flights (see previous Figure 5-39). The upper strain measurement continued to increase during this timeframe indicating that the heating was different on the upper and lower portions of the wheel well and 1040 spar. Although the response of the 1040 spar strain is not completely understood, structural analysis indicates that the strain response can be completely explained by thermal stresses caused by severe heating of the wheel well wall and internal wing components.

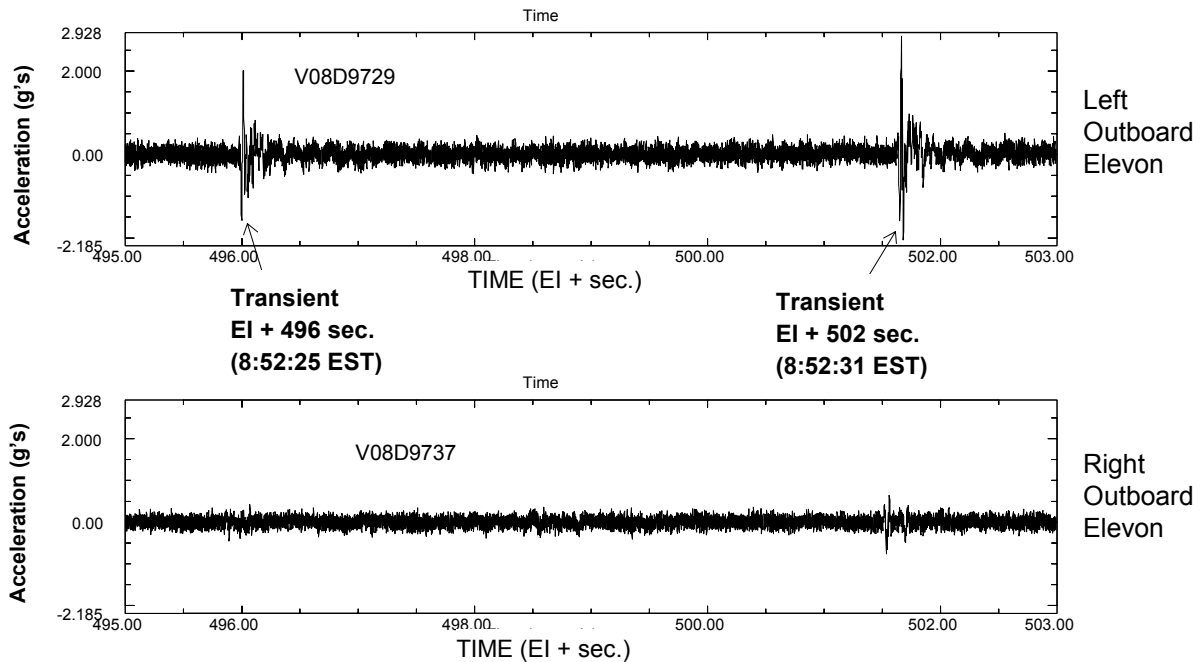
At approximately 8:52:25 EST (EI + 496 sec.), the left outboard elevon wideband accelerometer showed an unusual 2 g peak-to-peak acceleration (see Figure 5-40). This is consistent with the timing of the many wire failures within the left wing and the timeframe when the spar breach occurs. Additionally, there are two unexplained communication dropouts in this same timeframe. Another 3 g peak-to-peak acceleration anomaly was observed at 8:52:31 EST (EI + 502 sec). Additional temperature measurements (left main gear brake line temp A and C) in the wheel well area (see Figure 5-38) began an off-nominal rise at 8:52:41 EST (EI + 512 sec.).

**Figure 5-40. Outboard elevon accelerometer responses at 8:52:25 and 8:52:31 EST (EI + 496 and 502 sec.)**
