## **5.0 DEORBIT/ENTRY**

### 5.3 HARDWARE FORENSICS

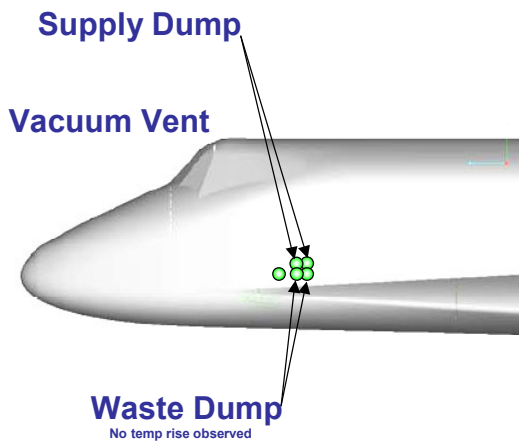
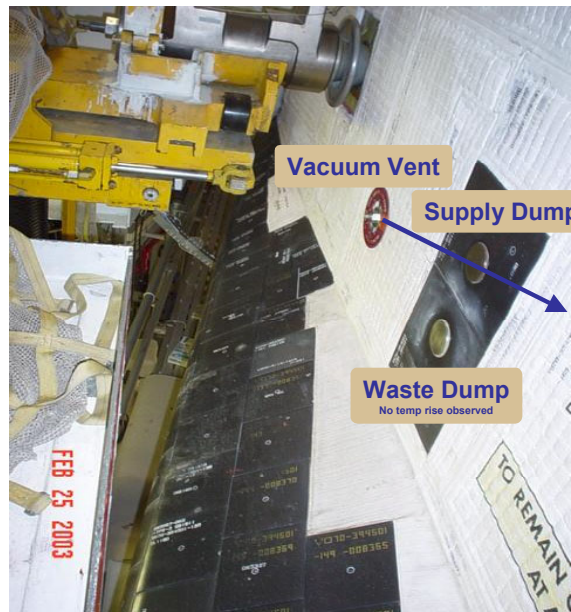
**Figure 5-41. Location of supply dump and vacuum vent nozzles**

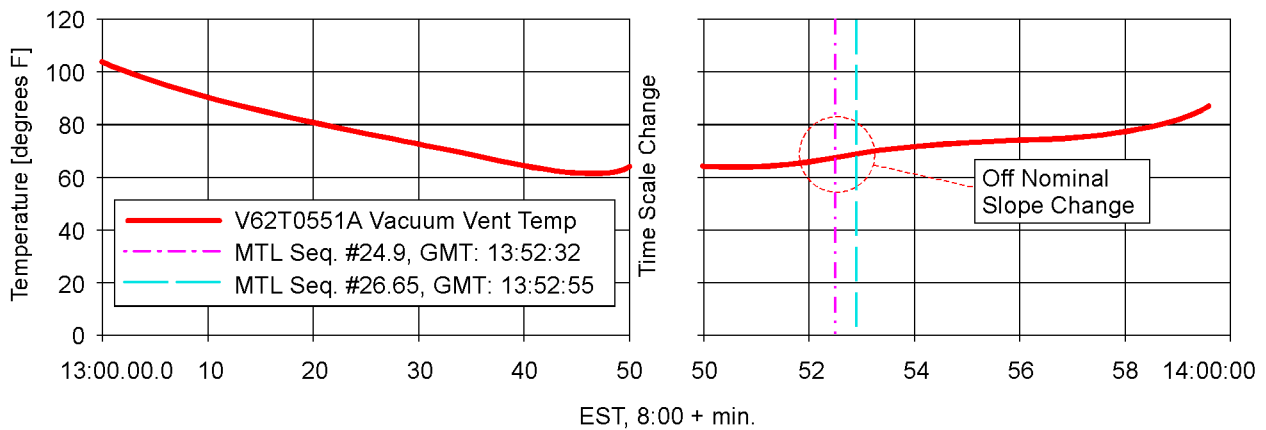
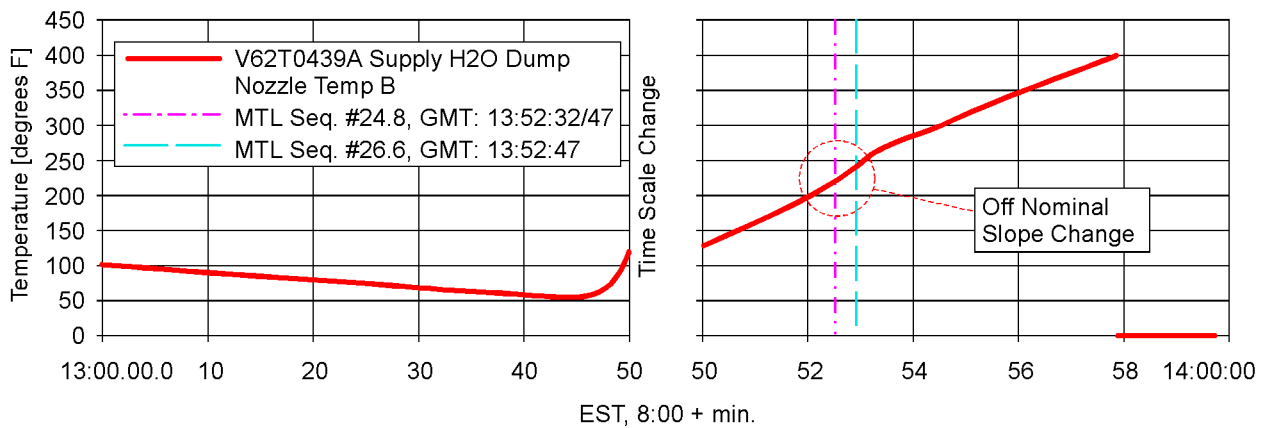
The elevon response event was followed by a change in the rise rate for two supply nozzle temperatures and the vacuum vent nozzle temperatures at 8:52:32 EST (EI + 503 sec.). The off-nominal rise rate occurred for approximately 15 seconds for the supply nozzle temperatures and 23 seconds for the vacuum vent temperatures. The location of these nozzles on the left side of the fuselage is shown in Figure 5-41, and the arrow indicates that they could have been located along a line of disturbed flow. The short, abnormal rise rate is unexplained, has not been observed on any previous Shuttle missions, and may not be associated with the upper wing disturbed flow caused by the leading edge damage. Unlike the RCC nose cap clevis temperature, the instrumentation appears to have been valid for both nozzles. Plots of this off-nominal temperature rise for one of the supply nozzle temperatures and the vacuum vent nozzle are shown in Figure 5-42.

**Figure 5-42. Off-nominal temperature for supply nozzle and vacuum vent nozzle**

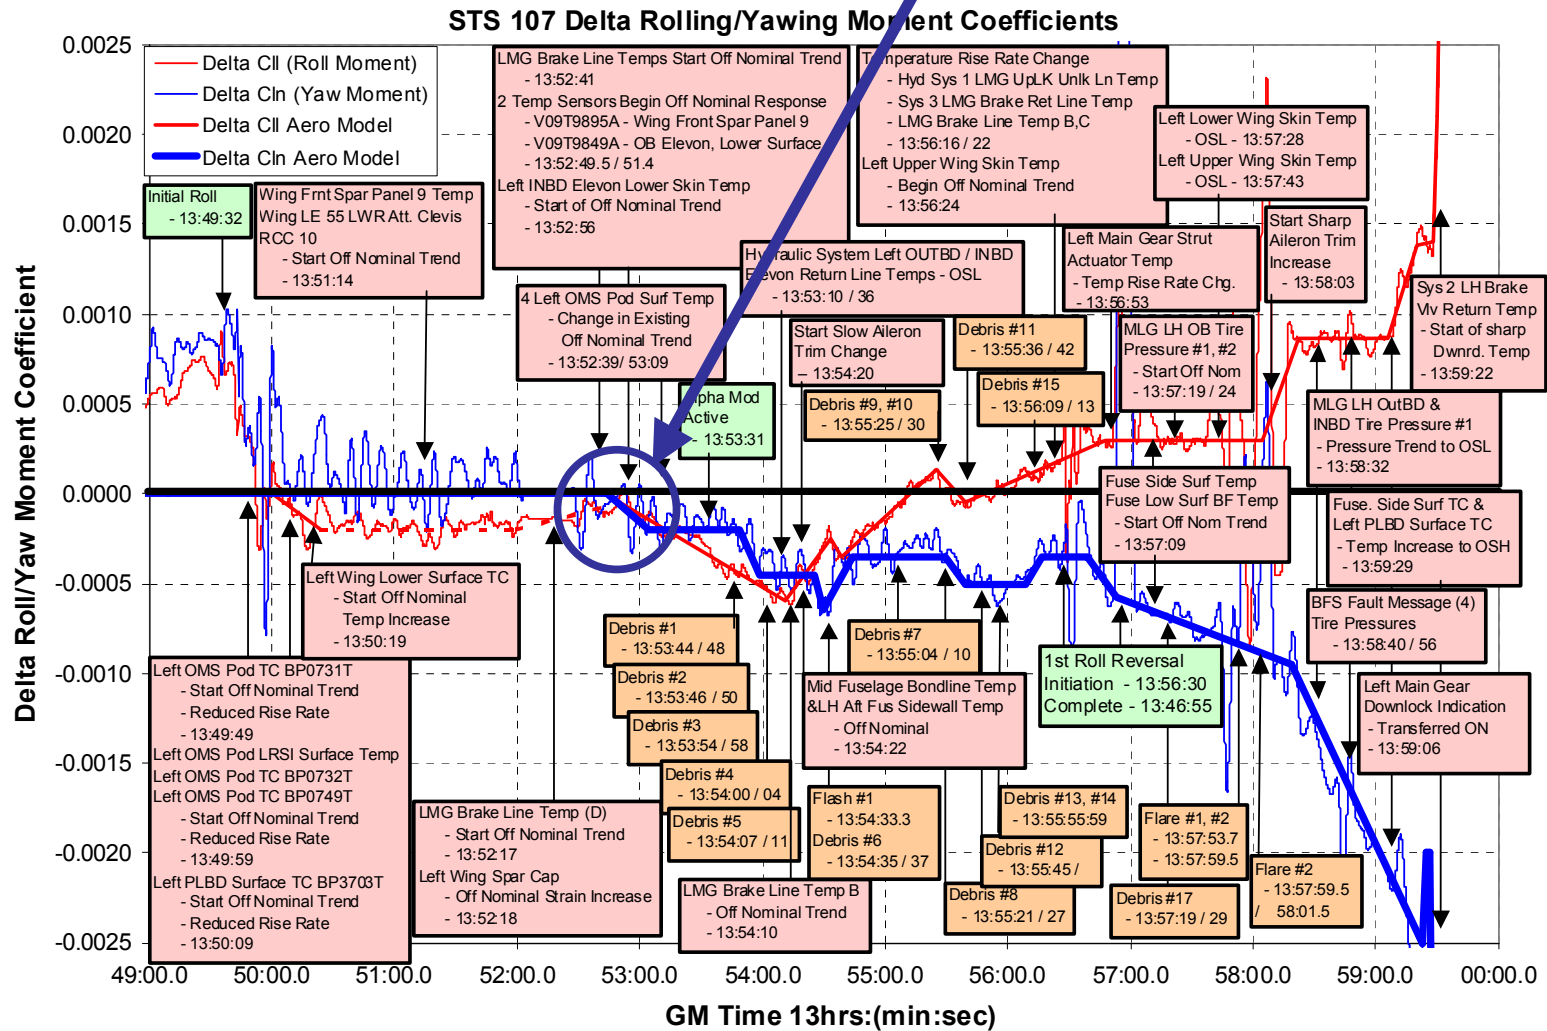
Immediately following these events, at 8:52:44 EST (EI + 515 sec.), the aerodynamic roll and yaw coefficients that have been extracted from the flight data showed a slight negative trend (see Figure 5-43). This is indicative of more drag and decreased lift on the left wing.

**Figure 5-43. First noted off-nominal aero event (Greenwich Mean Time, GMT, is EST + 5 hours)**

Hypersonic wind tunnel tests indicate that both the slight negative roll and yaw deltas can be explained by leading edge damage in the lower half of RCC panel 8. This will be discussed in more detail in Section 5.4.5.

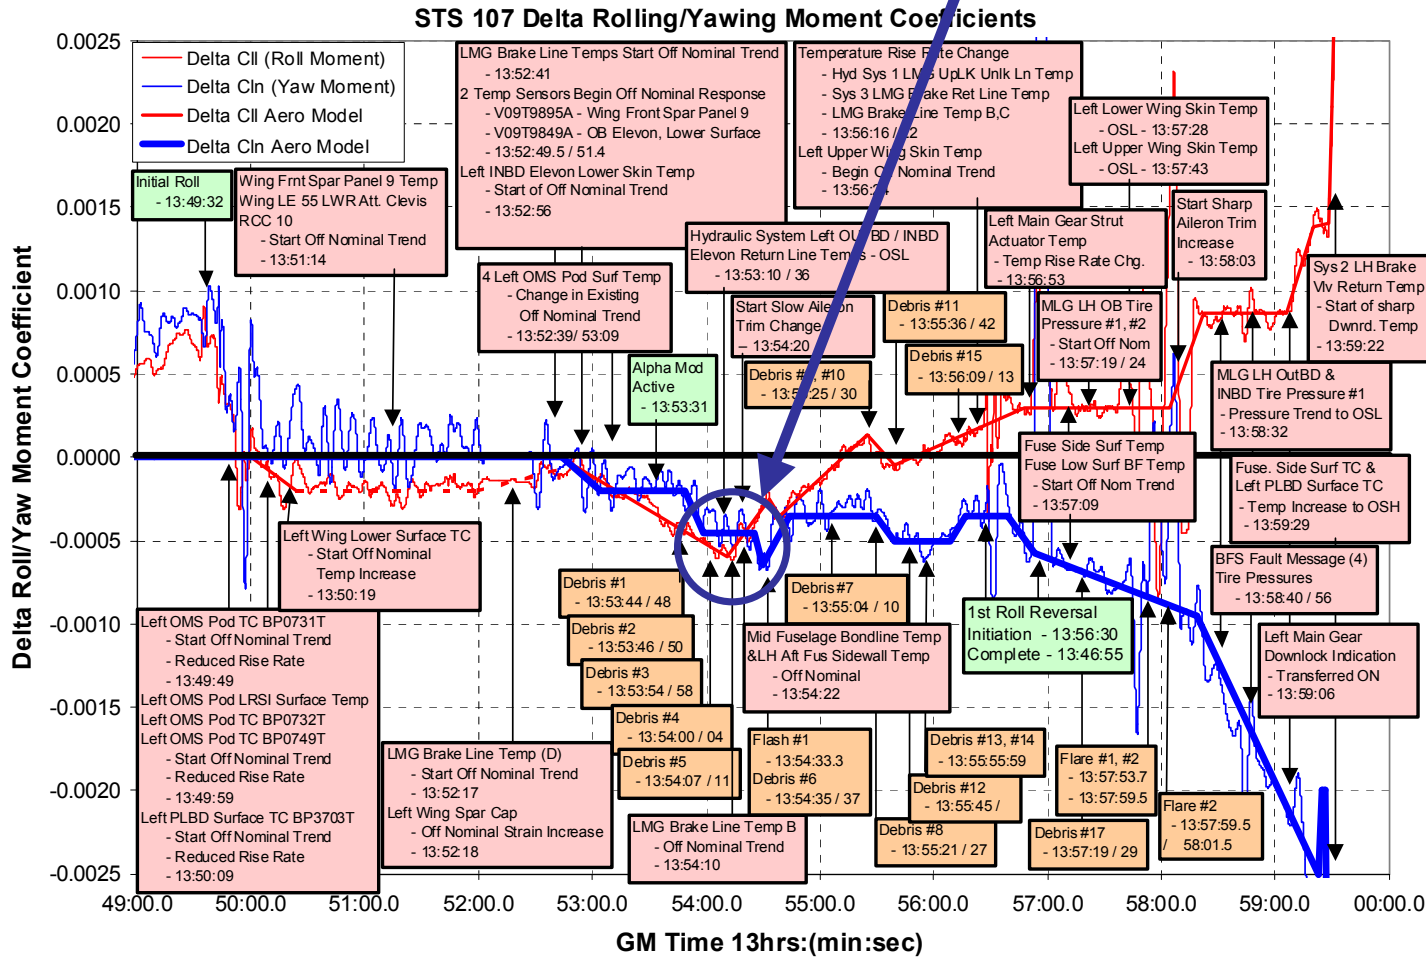
In the 8:54:10 to 8:54:35 EST (EI + 601 to 626 sec.) timeframe, several key events occurred. The first event at 8:54:10 EST (EI + 601 sec.) was an indication that the temperatures in the wheel well had a greater rise rate, indicating the sneak flow or breach into the wheel area had increased. The roll moment trend changed sign at 8:54:11 EST (EI + 602 sec.) almost simultaneously with the change in wheel well temperature rise rate as shown in Figure 5-44, followed by a debris flash event at 8:54:33 EST (EI + 624 sec.). A large debris item, labeled debris event six, was seen leaving the orbiter two seconds later. This debris event and the roll moment trend change are believed to be created by growing damage to Columbia's left lower wing.

Figure 5-44. Sharp change in rolling moment (GMT is EST + 5 hours)

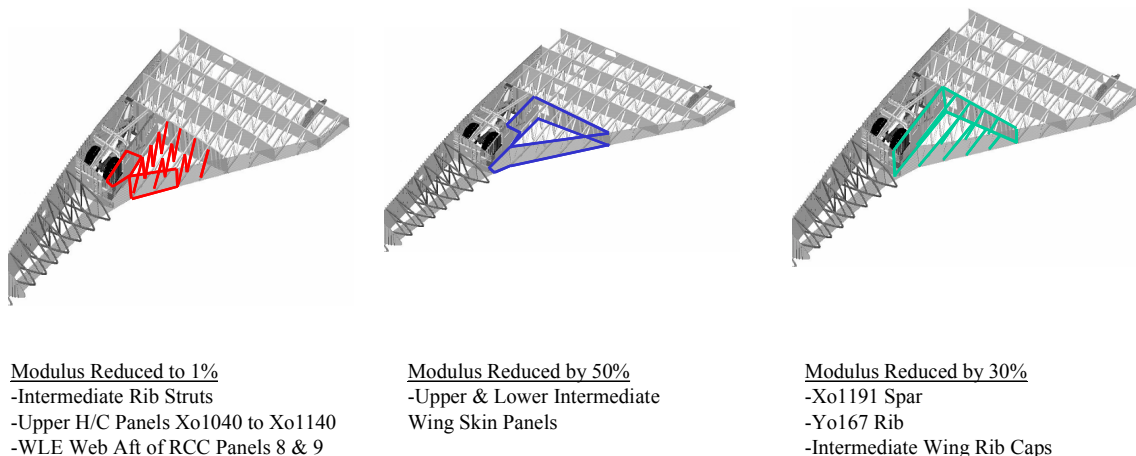
Structural and aerodynamic analysis of wing deformation was performed without any type of recession in the wing lower surface. An assumption of 70 pounds per square foot was used for wing loading. Heat transfer coefficients were updated from previous coupled venting and thermal models for the left wing. A structural model was used along with the heating equivalent of a 10 inch diameter breach in the wing spar beginning at 8:52:16 EST (EI + 487 sec.) assuming 100 percent of the energy from this hole was transferred to the wing interior. Two different cases were analyzed: one with no breach in the upper wing skin and another with a 5 inch diameter breach in the upper skin at 8:54:37 EST (EI + 628 sec.) when a significant visual flash event was observed. Both cases showed that the temperatures of the wing skins, wing spars, and the wheel well wall were high enough by 8:58:19 (EI + 850 sec) that significant damage to the wing structure would occur. Figure 5-45 shows the potential area of damage and that significant deformation of the intermediate wing area and/or a recession in the lower surface is possible.

**Figure 5-45. Modeling results show potential area of damage and that significant deformation of the intermediate wing area and/or a recession in the lower surface are possible**

Based on the structural analysis, it appears feasible that a wing recession occurred and resulted in the large positive slope in the delta rolling moment. The recession was caused by severe prolonged heating internal to the left wing that melted many of the support struts. Once the struts were lost, the wing skin lost structural support, a concave cavity developed, and some lower surface tiles may have been lost. Wind tunnel testing has shown that this type of cavity can cause the change in delta aero moments derived from the aerodynamics reconstruction in this timeframe. The aero moment change is a negative yaw moment due to increased drag and a positive roll moment due to increased lift on the left wing. This testing will be discussed in more detail in the next section.

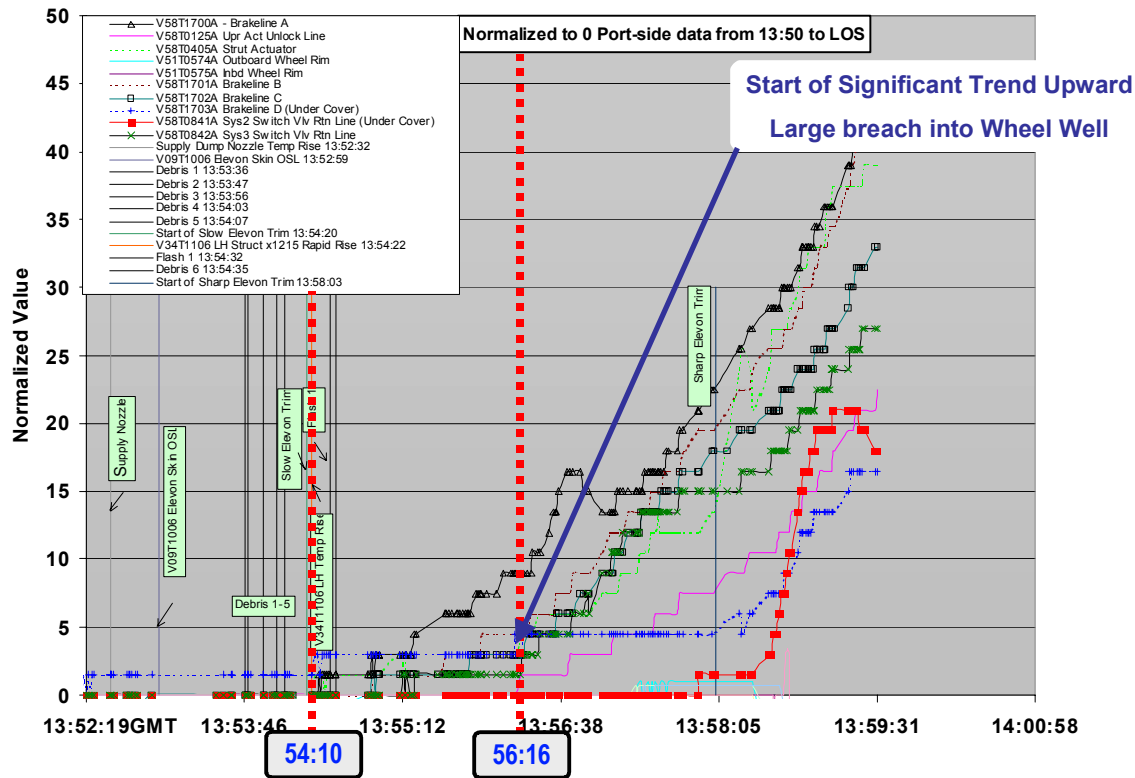
By 8:56:16 EST (EI + 727 sec.), hot gas had penetrated the wheel well wall as indicated by off-nominal rates rise rates in several hydraulic line temperatures (see Figure 5-46). Preliminary analysis indicates that it is feasible to have had some gas intrusion into the wheel well area as early as 8:52:39 EST (EI + 510 sec.) since a honeycomb access panel could melt as quickly as 22 seconds after the wing spar is breached. Additionally, there are various vent paths into the wheel well around the landing gear door hinge covers.

**Figure 5-46. Temperature data in left wheel well trends up (GMT is EST + 5 hours)**

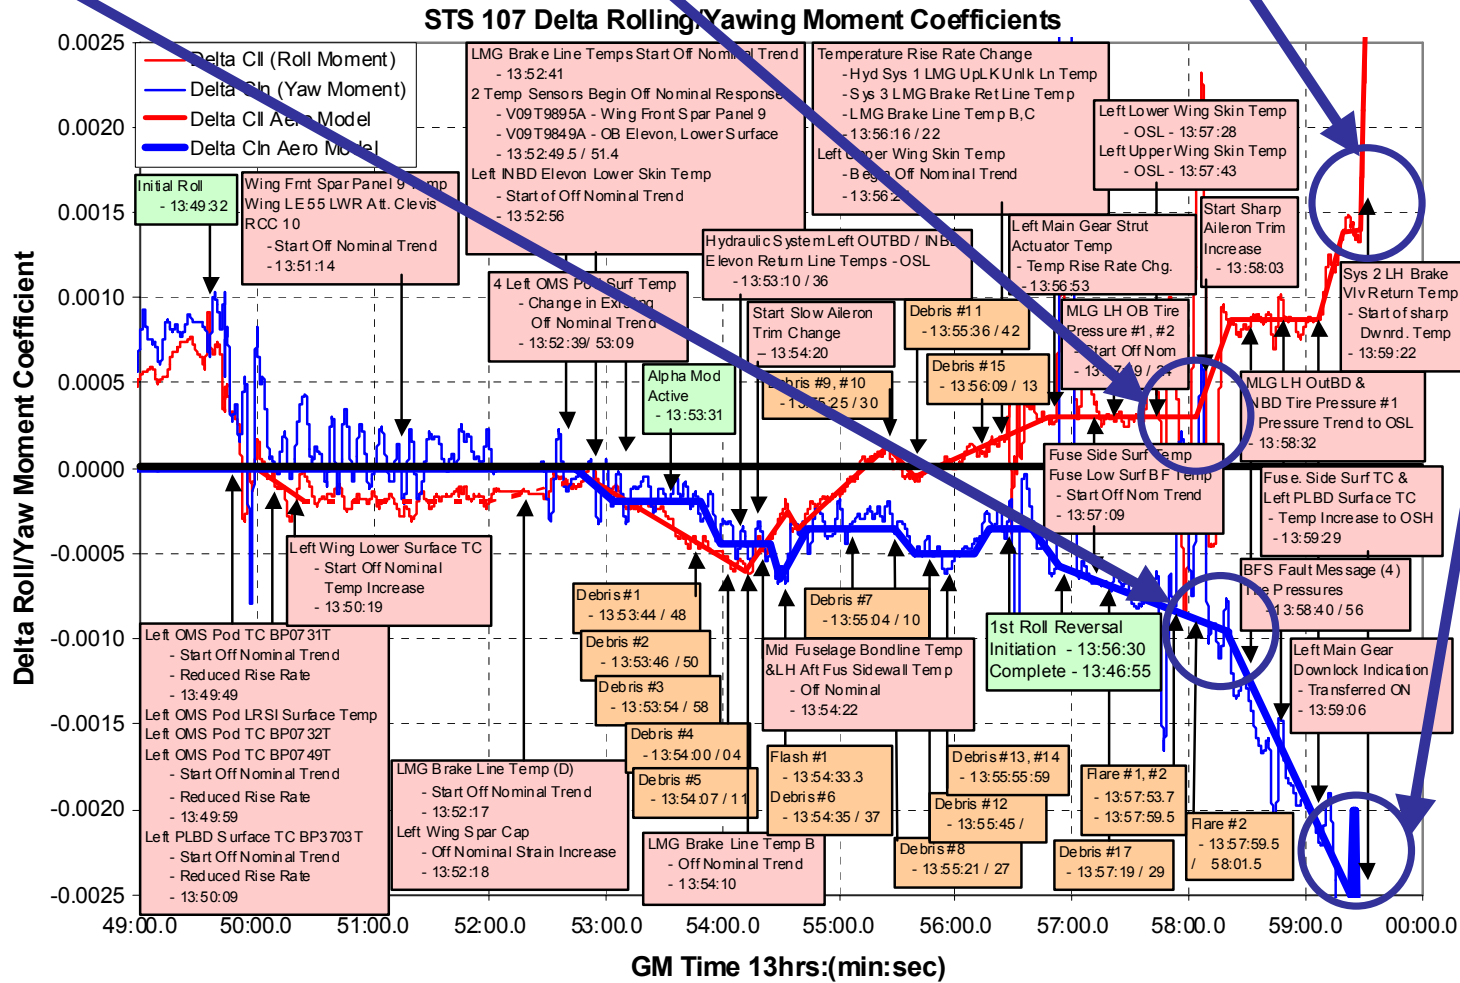
As shown in Figure 5-49, this strain response appears to be consistent with another sharp change in the slope of the derived delta rolling moment coefficient that occurred slightly earlier at 8:58:03 EST (EI + 834 sec.), along with several additional debris events. The vehicle responded to this event with a sharp change in the aileron trim. These events indicate that there was another significant change to the left wing configuration at this time. Wing deformation and an increase in the lower surface recession along with a loss of additional bottom tiles are possible explanations for this behavior.

**Figure 5-49. Increased wing deformation and wing recession leads to significant vehicle aerodynamic changes (GMT is EST + 5 hours)**

As shown in Figure 5-49, there was another abrupt change in the vehicle aerodynamics caused by the continued progression of left wing damage at 8:59:26 EST (EI + 917 sec.). This change was a significant increase in the positive delta roll moment and negative delta yawing moment, indicating increased drag and lift from the left wing. Columbia attempted to compensate for this by firing all four right yaw jets. By this point the MCC had lost all telemetry data at 8:59:23 EST (EI + 914 sec.). Even with all four right yaw jets and a maximum rate of change of the aileron trim, Columbia was unable to control the side-slip angle that was slightly negative (wind on the left side of the fuselage) during much of the entry. The side-slip angle changed sign at 8:59:36 EST (EI + 927 sec.) indicating that vehicle loss of control was imminent (side-slip angle is an aerodynamics terms for the angle between the relative wind velocity and the vehicle direction of motion, or velocity vector).

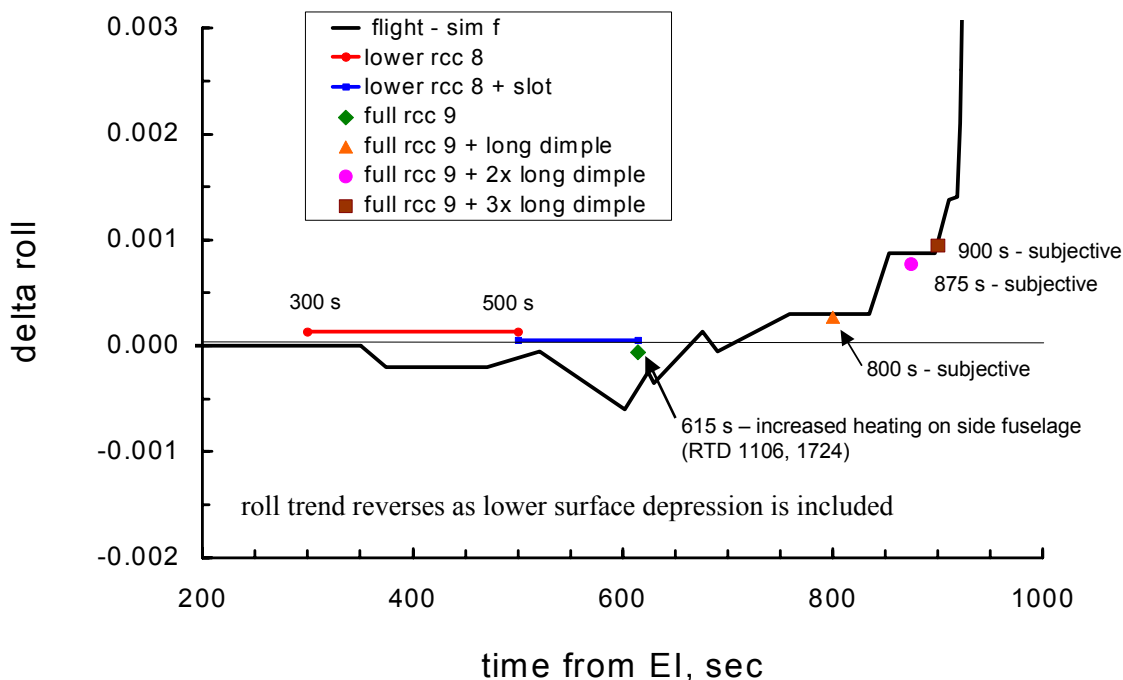
Figure 5-50 through Figure 5-52 show the flight derived delta roll, yaw, and pitch aerodynamic moments, respectively, along with the tested damaged configuration results that are consistent with the flight data. The intent of the remainder of this section is to briefly discuss the CFD analysis and wind tunnel testing used to replicate the derived delta aero moments. Note the time scale on these plots is in seconds from EI.

**Figure 5-50. Wind tunnel testing configurations that match delta roll moment data**

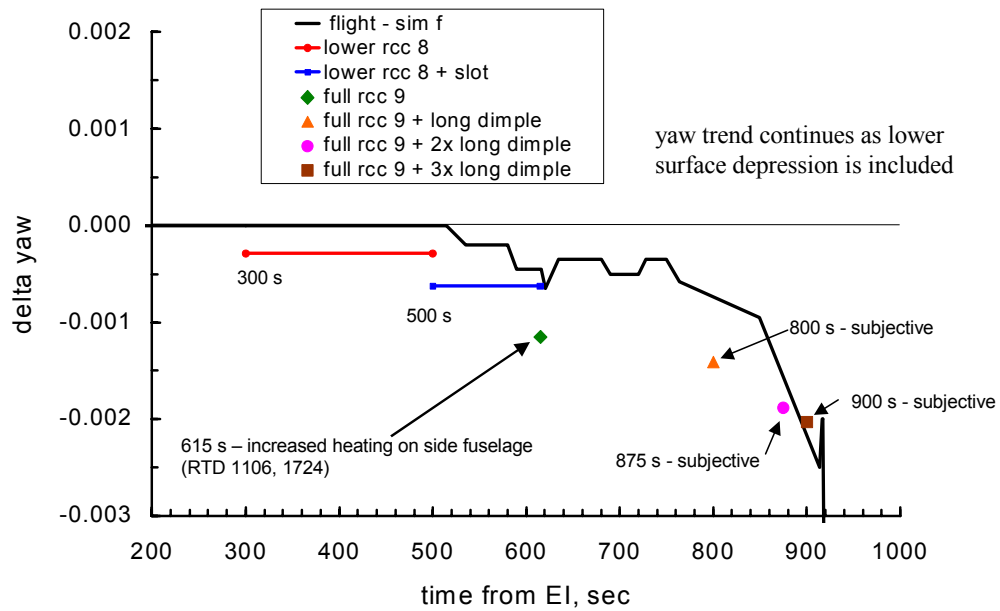
**Figure 5-51. Wind tunnel configurations that match delta yaw moment data**

Initially, the recessed area would have been relatively small; however, it would gradually grow over time to cause the delta roll moment to increase. By 8:57:29 EST (EI + 800 sec.) wind tunnel testing showed that the depression has to be on the order of 20 feet long, two feet wide, and 5.3 inches deep along with panel 9 missing in order to duplicate the delta roll coefficient shown in Figure 5-50. This configuration provides a delta yaw moment that is slightly larger than was observed, but is consistent with a decreasing negative delta yaw moment observed in this timeframe (Figure 5-51).

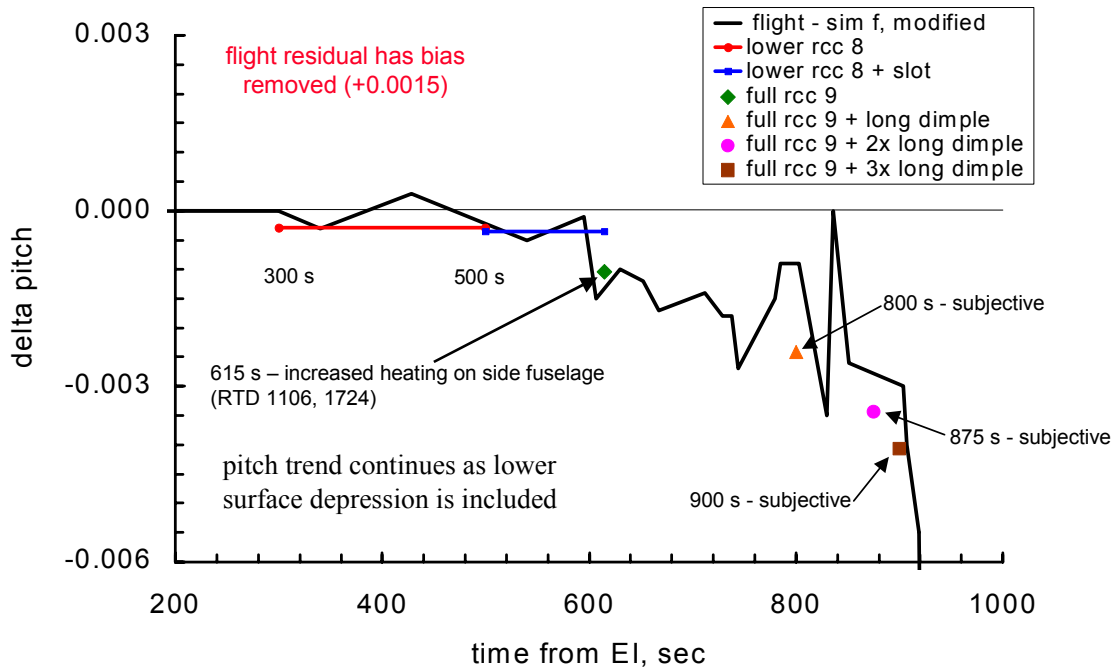
**Figure 5-52. Wind tunnel configurations that match delta pitch moment data**

A little more than a minute later, at 8:58:44 EST (EI + 875 sec.), the width of this recession would need to have increased by another two feet to match the aerodynamic delta roll and yaw moments. At this point, the rate of change of the aerodynamic moments and damage progression is so great that it likely grew by about an additional two feet in width over the next 25 seconds at 8:59:09 EST (EI + 900 sec.). Additionally, the delta pitch moment was now observed to deviate from previous mission reconstructions in this timeframe. Figure 5-52 shows that the recession concept is

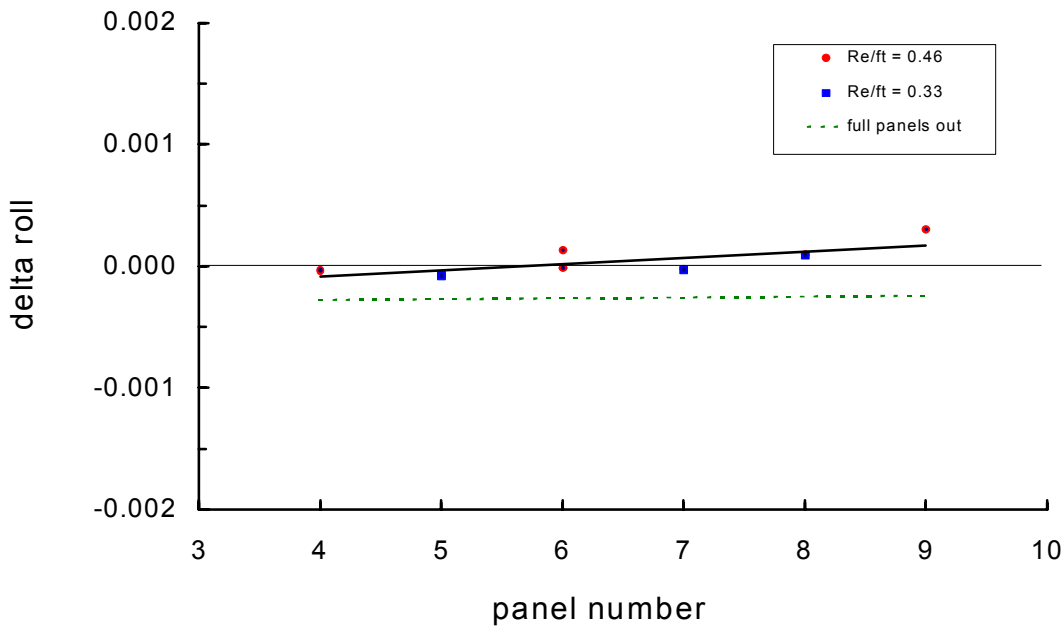
As discussed previously, the reconstructed aerodynamic moments showed little to no change due to damage through 8:52:29 EST (EI + 500 sec.). Based on the forensics data discussed in Section 5.3, the most likely region of initial damage was in the lower part of RCC panel 8. Wind tunnel testing in the Langley Research Center (LaRC) CF4 tunnel indicated that a missing bottom part of RCC panel 8 (from the apex to the lower carrier panel) matches the initial aerodynamic increments, which show a minimal effect on the overall vehicle aerodynamics. In fact, even a full missing panel 8 produces only a small change to the roll and yaw aero moments. Figure 5-53 and Figure 5-54 show the results of this LaRC evaluation.

**Figure 5-53. Delta roll for lower half and full panel RCC panel missing**

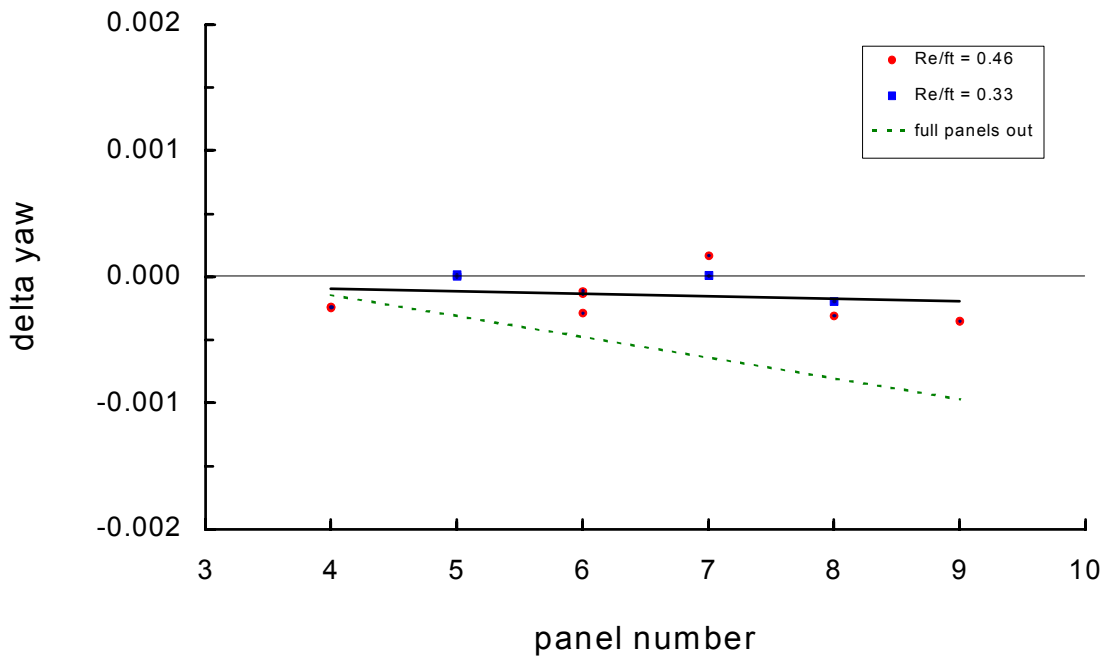
**Figure 5-54. Delta yaw for lower half and full panel RCC panel missing**

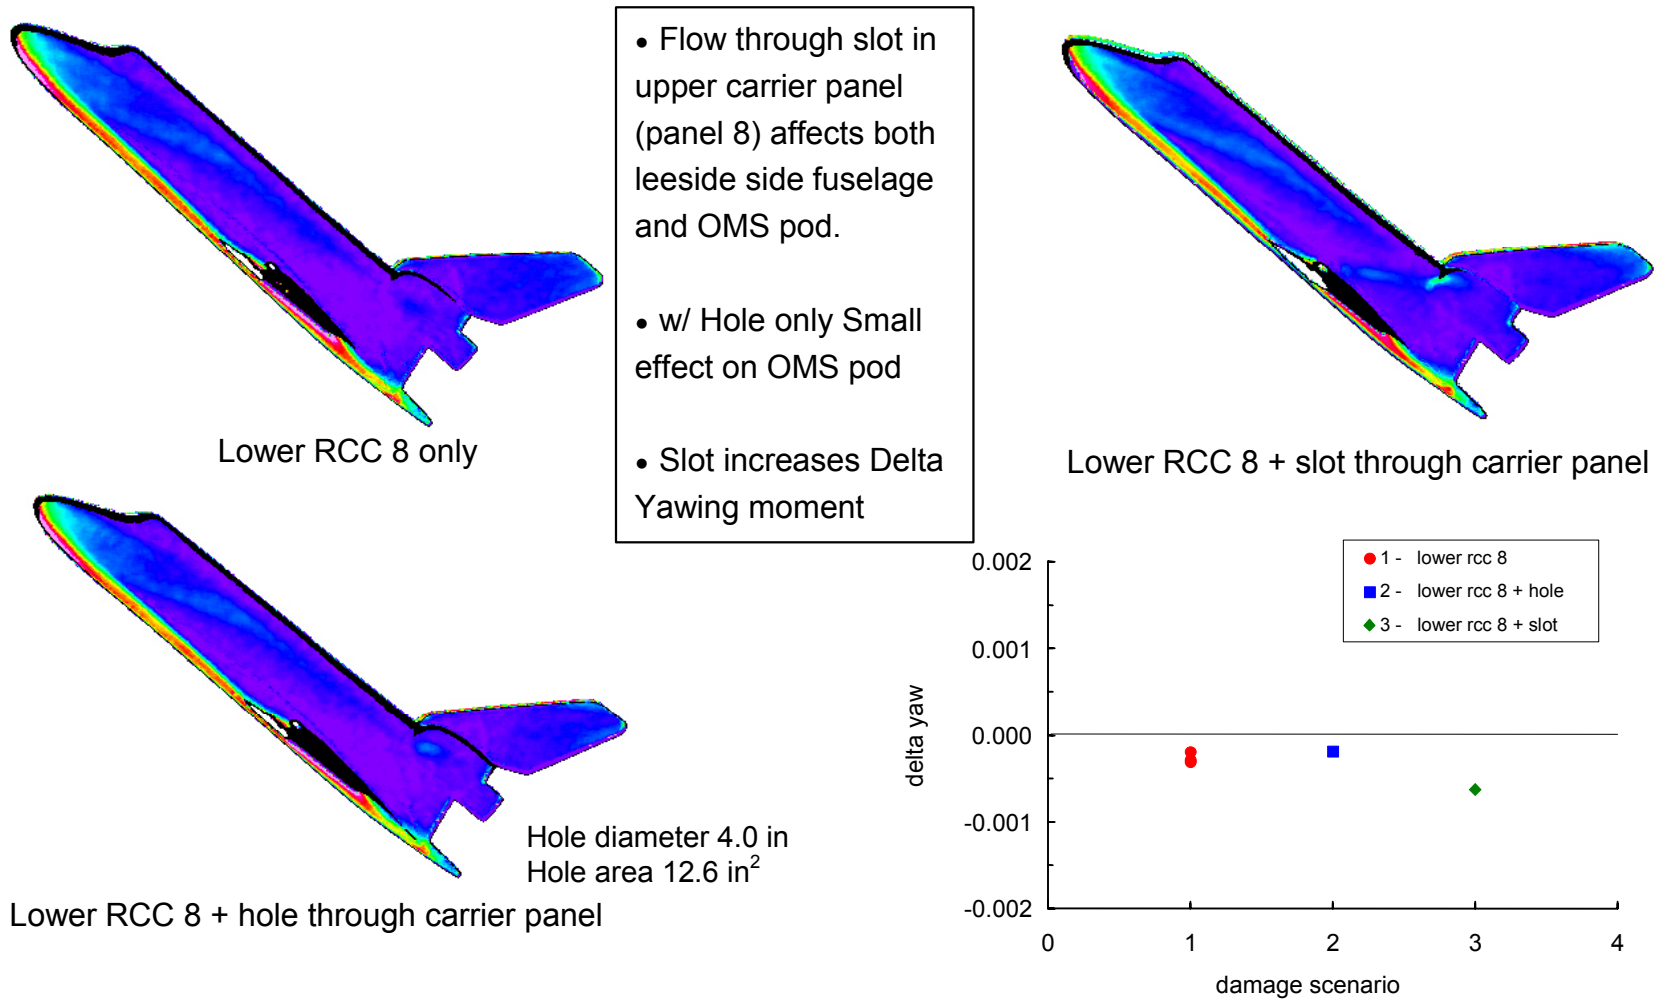
The left wing spar was breached in the 8:51:14 EST (EI + 425 sec.) to 8:52:15 EST (EI + 487 sec.) timeframe. Initially, the spar breach had little to no effect on the derived aero moments. Over time the leading edge damage progressed and a slot or upward deflection of the flow through the upper carrier panel 8 developed. The combination of flow through the wing leading edge and flow through a slot onto the upper carrier panel is consistent with the first observed aerodynamic response, which occurs at 8:52:29 EST (EI + 500 sec.). This can be observed in Figure 5-50 and Figure 5-51 as a slow negative trend in delta roll and yaw. Figure 5-55 shows the wind tunnel test results for three different cases: missing lower RCC panel 8, missing panel 8 combined with a 4 inch diameter hole in the upper carrier panel 8, and missing RCC panel 8 with a slot through the upper carrier panel. The slot was shown to produce the increased delta yaw observed during flight as well as the upper surface flow disturbances on the OMS pod and left side fuselage, which were also observed during flight by abnormal temperature rise rates.

**Figure 5-55. Wind tunnel testing results for missing lower carrier panel 8 and a slot and hole through wing**

It is possible that a hole through the upper wing developed in the 8:54:11 EST (EI + 600 sec.) to 8:54:31 EST (EI + 630 sec.) timeframe. This is consistent with a lull in the measurement failure rate in the wire bundle along the wheel well that was discussed earlier in Section 5.4.3. Wind tunnel testing and CFD analysis have shown that sizable holes through the wing have little to no effect on the aerodynamics and heating on the left side of the fuselage and OMS pod. A representative sample of this work is shown in Figure 5-55 as damage scenario number 2.

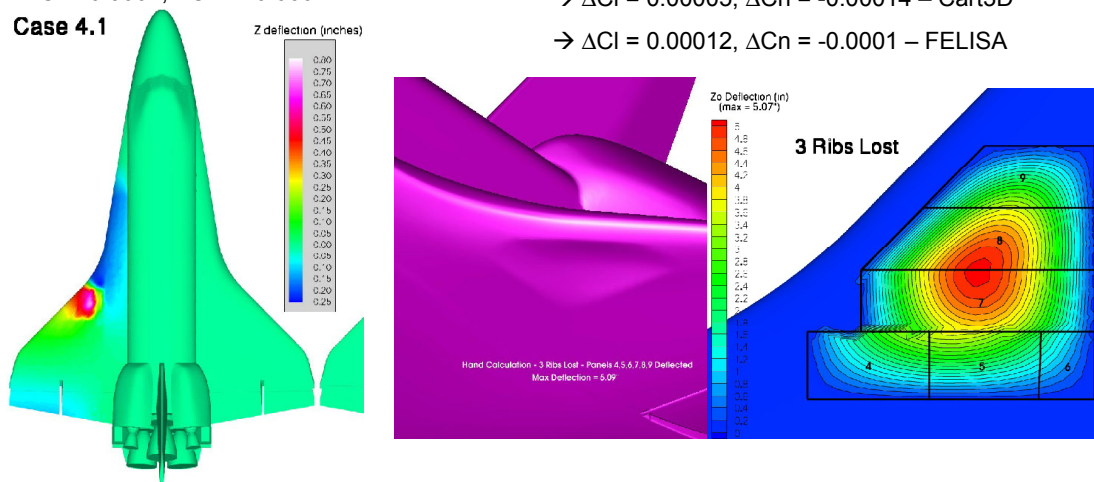
The next significant aerodynamic event occurred at 8:54:11 EST (EI + 602 sec.) when a dramatic reversal of the aero rolling moment trend occurs. By this time hot gas and an internal plume environment had severely degraded the structural integrity of some of the intermediate wing support structure leading to wing deformation. Three different configurations were tested to validate the theory of wing deformation. The first involved global wing deflection of up to 0.79 inches due to damage and is depicted in Figure 5-56. CFD analysis of this configuration showed extremely small aero moment response for yaw and roll that does not match the flight derived data. More substantial local wing skin deformation with a maximum deflection of 5.1 inches due to three ribs missing along with other internal wing damage was examined using CFD tools. Again, these results produced only small aerodynamic moment changes, which did not match the flight-derived data.

- Case 4 Aerodynamic Increments – Global wing deflection due to damage  
Max RMS Delta  $\Delta$ Wing Deflection  
(Nominal – Damaged structure) is 0.79”  
→  $\Delta$ Cl = 0.0001,  $\Delta$ Cn = -0.0001
- Hand Calculation Increments – Local wing deformation due to damage  
Max  $\Delta$ Wing Deflection,  $Z_0 = 5.1”$   
→  $\Delta$ Cl = 0.000,  $\Delta$ Cn = -0.0001 – Newtonian  
→  $\Delta$ Cl = 0.00005,  $\Delta$ Cn = -0.00014 – Cart3D  
→  $\Delta$ Cl = 0.00012,  $\Delta$ Cn = -0.0001 – FELISA

**Figure 5-56. CFD analysis of wing deformation**

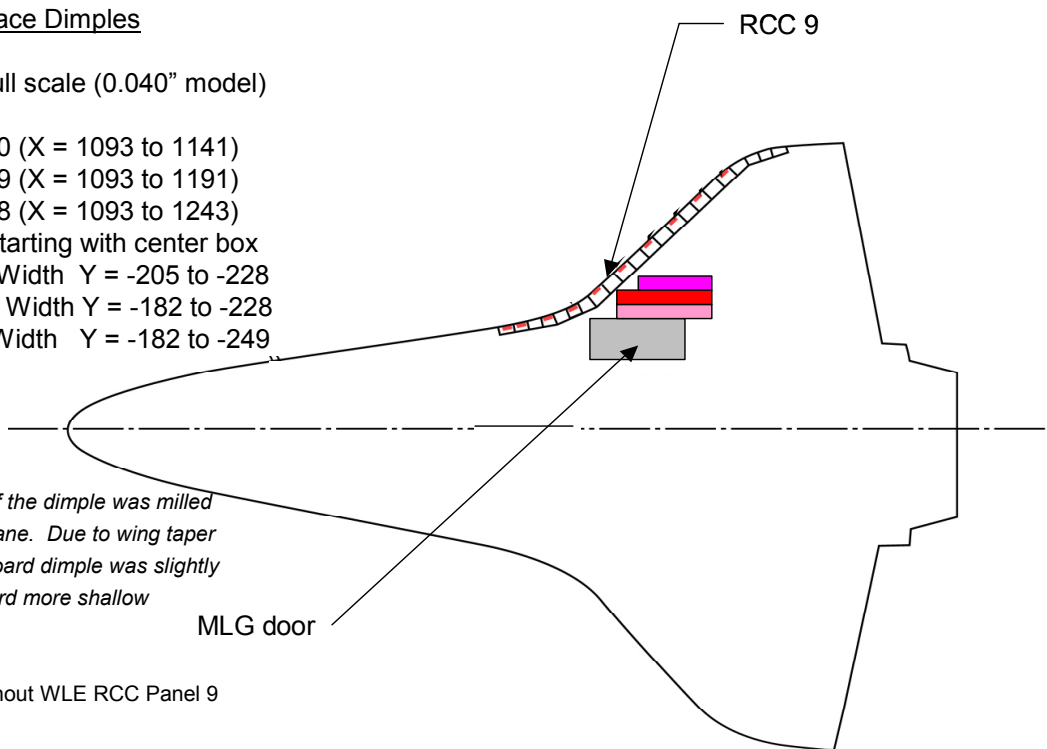
structural damage that was most probable in this timeframe. LaRC wind tunnel testing and CFD analysis were performed for several different configurations of lower surface recessions shown in Figure 5-57. The data shows that it is feasible for a recession to cause the change in the rolling moment sign when combined with some portion of RCC panel 9 missing at 8:54:11 EST (EI + 602 sec.).

**Figure 5-57. LaRC wind tunnel testing of lower surface depressions**
