Investigation on different materials after pulsed high field conditioning and low-energy H⁺ irradiation

During operation, the radio-frequency quadrupole (RFQ) of the LINAC4 at CERN is exposed to high electric fields, which can lead to vacuum breakdown. It is also subject to beam loss, which can cause surface modification, including blistering, which can result in reduced electric field holding and an increased breakdown rate. First, experiments to study the high-voltage conditioning process and electrical breakdown statistics have been conducted using pulsed high-voltage DC systems in order to identify materials with high electric field handling capability and robustness to low-energy irradiation. In this paper, we discuss the results obtained for the different materials tested. To complement these, an investigation of their metallurgical properties using advanced microscopic techniques was done to observe and characterize the different materials and to compare results before and after irradiation and breakdown testing.

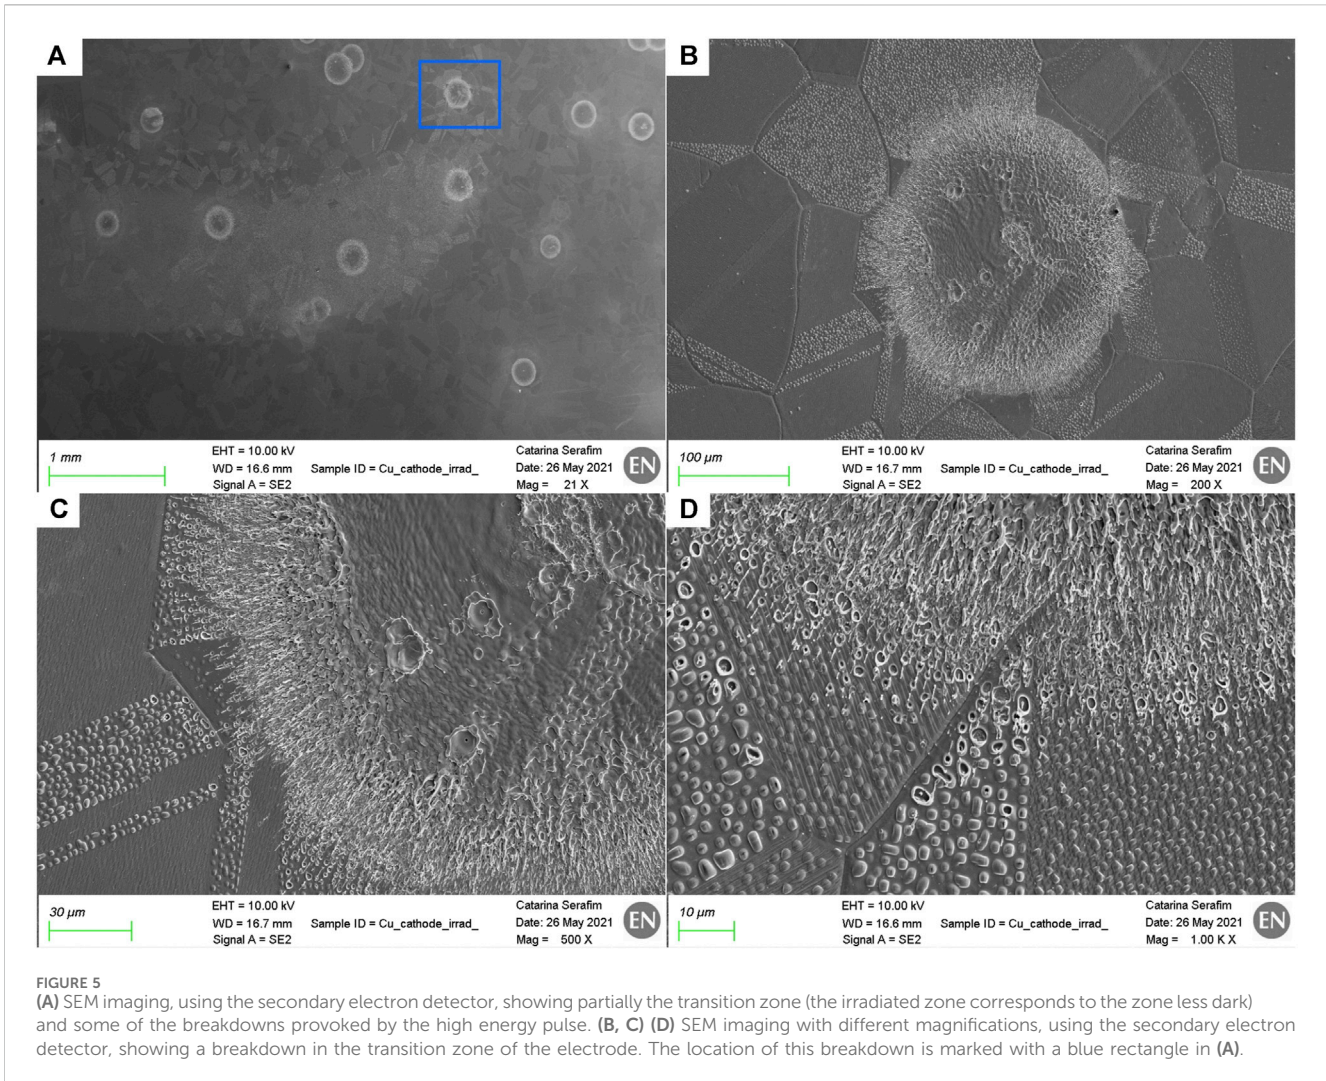
FIGURE 5 (A) SEM imaging, using the secondary electron detector, showing partially the transition zone (the irradiated zone corresponds to the zone less dark) and some of the breakdowns provoked by the high energy pulse. (B, C) (D) SEM imaging with different magnifications, using the secondary electron detector, showing a breakdown in the transition zone of the electrode. The location of this breakdown is marked with a blue rectangle in (A).

Figure 5A–D show the results of Cu-OFE after the electrode had been irradiated with the H⁻ beam and then subjected to high electric field pulsing in the LES. We can observe from Figure 5A that the breakdowns are well-distributed on the surface and do not seem to be correlated with the irradiated zone (zone less dark due to the blistering effect). Figures 5B–D show a breakdown in the transition zone, designated as the area where we start to see a decrease in the density of blistering. In this zone, it is visible that only some grains are affected by blisters. The fact that the phenomenon of blistering is more evident in just some of the grains may be correlated with the grain orientation of the material. Figures 5B, C also suggest that the

The breakdowns have a circular shape between approximately 100 μm and 200 μm , with splashes of melted material on their surroundings. The heat generated from the plasma formed during a breakdown has been shown to be significant enough to melt some of the blisters close to it, as shown in [Figure 5D](#).

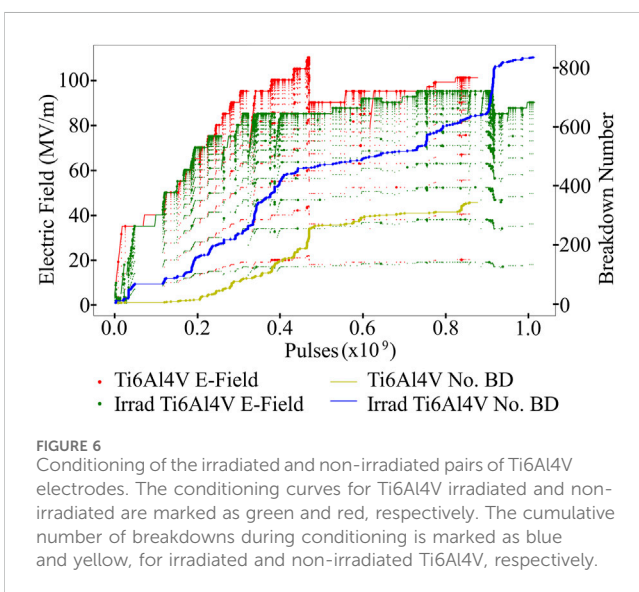
FIGURE 6 Conditioning of the irradiated and non-irradiated pairs of Ti6Al4V electrodes. The conditioning curves for Ti6Al4V irradiated and non-irradiated are marked as green and red, respectively. The cumulative number of breakdowns during conditioning is marked as blue and yellow, for irradiated and non-irradiated Ti6Al4V, respectively.

Concerning the LES experiment after irradiation, the Ti6Al4V electrodes have reached a stable field of 90 MV/m. Furthermore, the Ti6Al4V electrodes have shown a slight decrease in the breakdown performance due to irradiation—the pair of Ti6Al4V non-irradiated electrodes that was tested in the LES reached the average value of 100 MV/m. The conditioning of each pair can be seen in [Figure 6](#).
