# ***Return to Flight Task Group***

**Executive Summary**

**June 28, 2005**

## Final Report of the Return to Flight Task Group

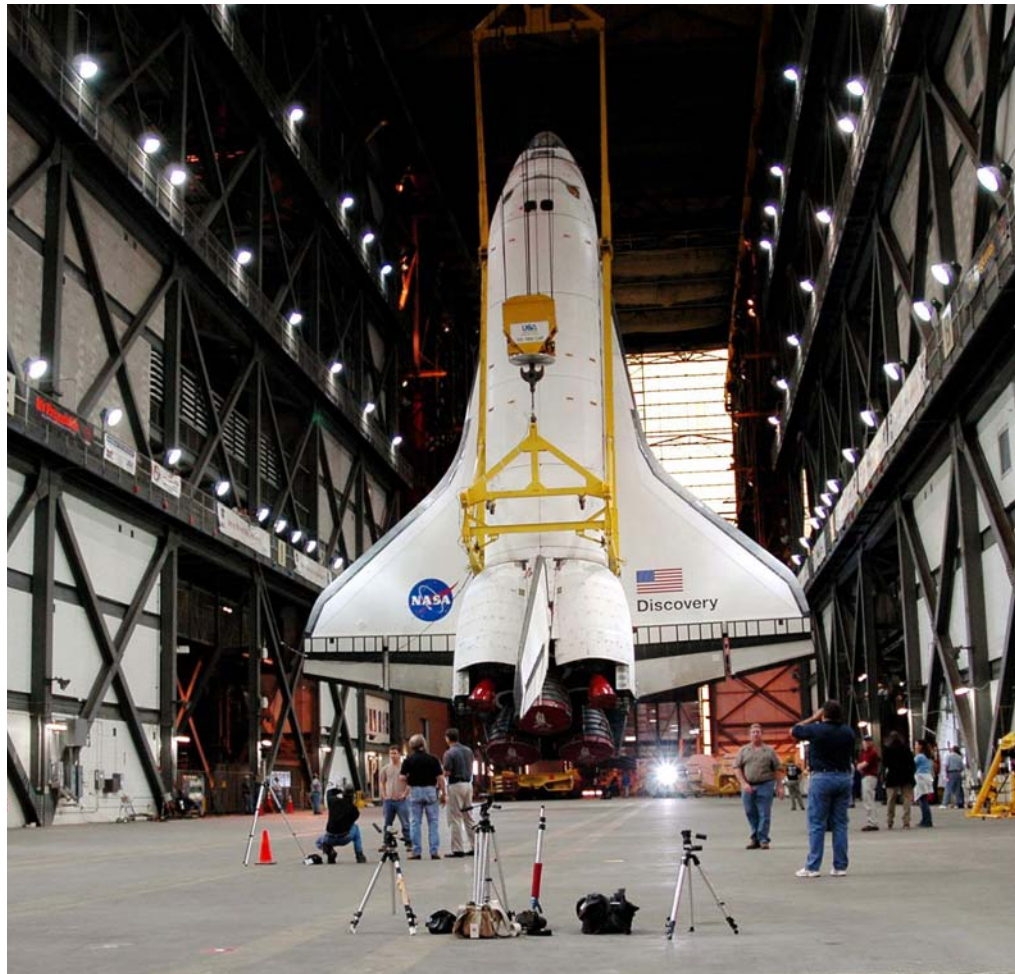
Before a crowd of photographers, *Discovery* is hoisted into a vertical position in the transfer aisle of the Vehicle Assembly Building at the Kennedy Space Center. After this the Orbiter was lifted into a High Bay to be mated with a waiting set of Solid Rocket Boosters and an External Tank.
