Variety in Grade Negotiation

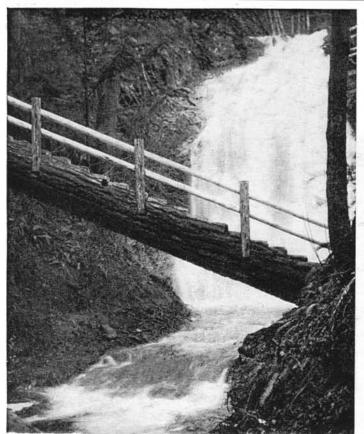
Deception Pass State Park, Washington

To the left are illustrated means for negotiating grades too steep for an easy rise and tread. A trail ladder requires careful maintenance, and is a hazard in use. The inclined log serving as foot trail bridge, although something of a "stunt," surely is permissible in parks where huge trees are present. Its picturesqueness, as well as its practicability, recommend it.

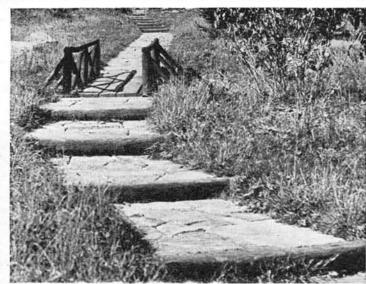
Allegheny State Park, New York

Above are log risers and treads paved with random flagging; below are simple trail steps of stone well naturalized by means of skillful planting of the trailside.
