*Administration Building, Longmire, Mt. Rainier National Park*

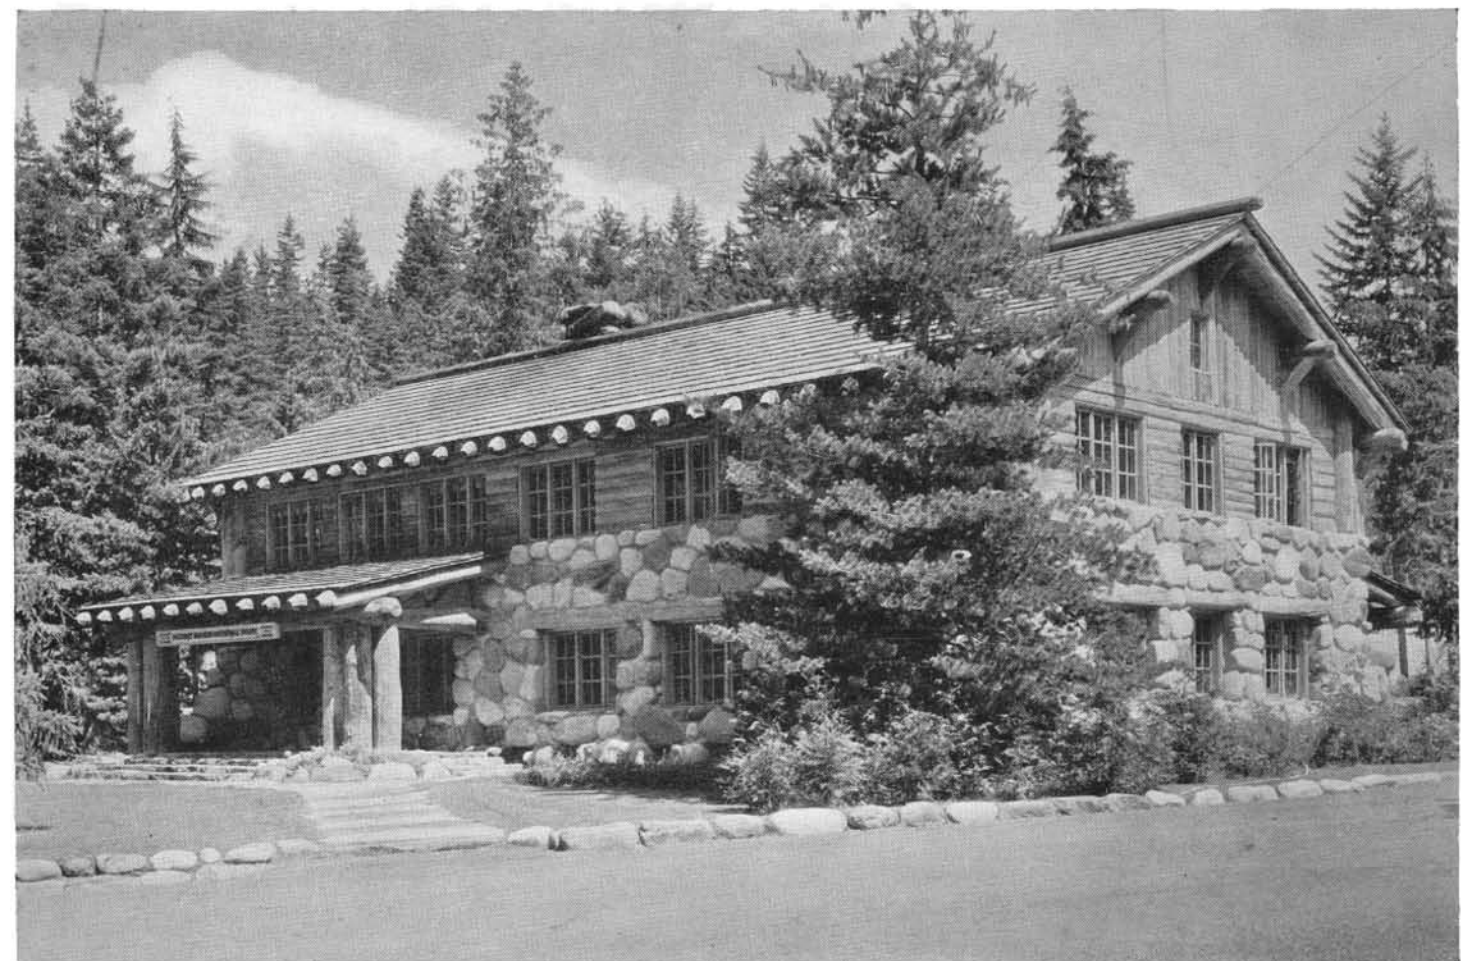
The plans on the opposite page exhibit the several functions that may accrue to an administration building in a major park. The employment of boulder masonry as here illustrated is usually dictated and only justified by the absence of more workable rock material within reasonable distance. However well handled, it seems impossible to at-

tain a satisfying appearance of stability. The rafters are appropriately vigorous in scale, and the blunted terminations of them are most agreeable. There is abundant provision of windows to insure a well-lighted interior without sacrifice of wall surfaces to the point where the exterior suffers in appearance.
