Shelter, Darling State Forest Park, Vermont

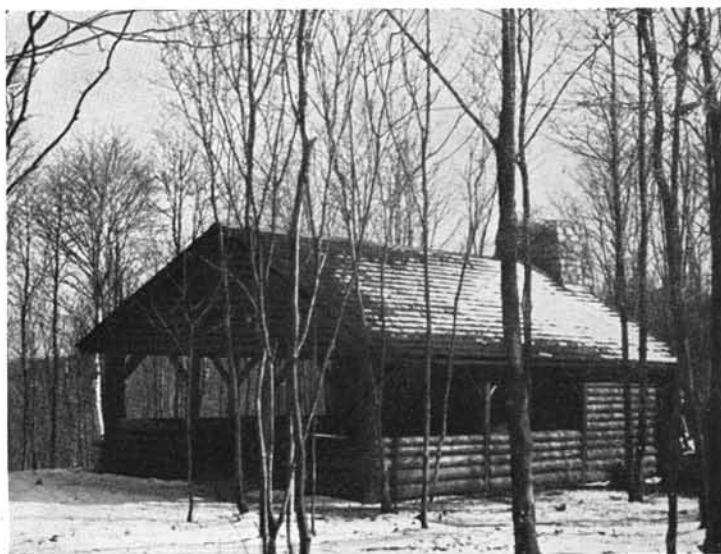
Opposite are shown the plan and detail drawings of this shelter. The general arrangement with fireplace at one end, and this end enclosed for one-third the length of the structure, is somewhat regional in its popularity. It is typical of New York and the New England States.

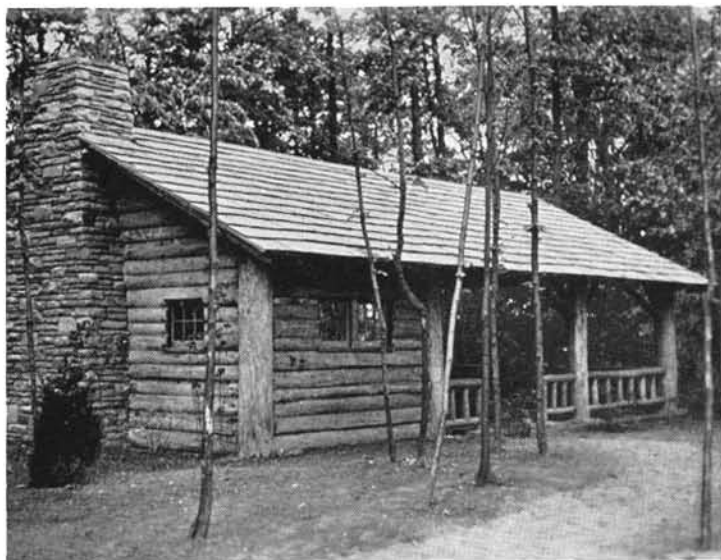
Kisil Point Shelter, Letchworth State Park, New York

Kinship of this example with the one above is quite apparent. Points of difference are minor. This shelter and the one below employ rough slabs applied horizontally to give semblance of the true log structure. The chimney with continuous batter from grade to cap seems also to be a regional characteristic.

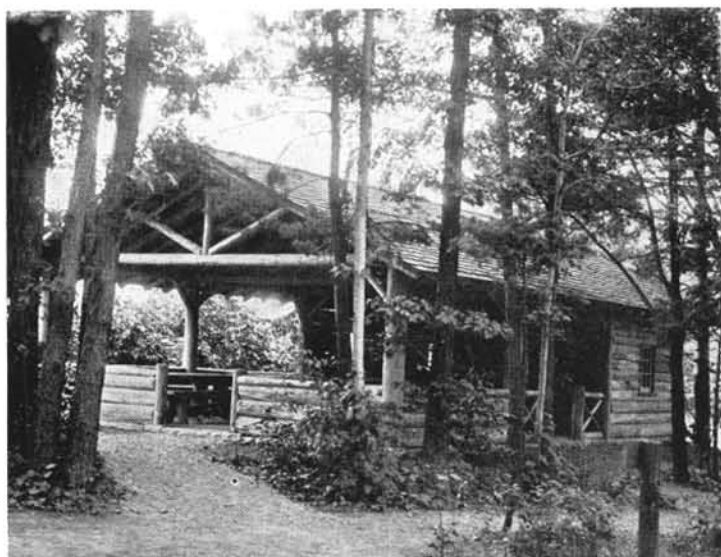
*Tea Table Rock Shelter, Letchworth State Park,
New York*

This third rendering of the group displays an open truss in the gable end, a feature usually no more successful than here. There is a look of frailty about most trusses fabricated of timbers in the round that is all but unavoidable. This one seems distressingly light.
