*Shelter, Lake Guernsey State Park, Wyoming*

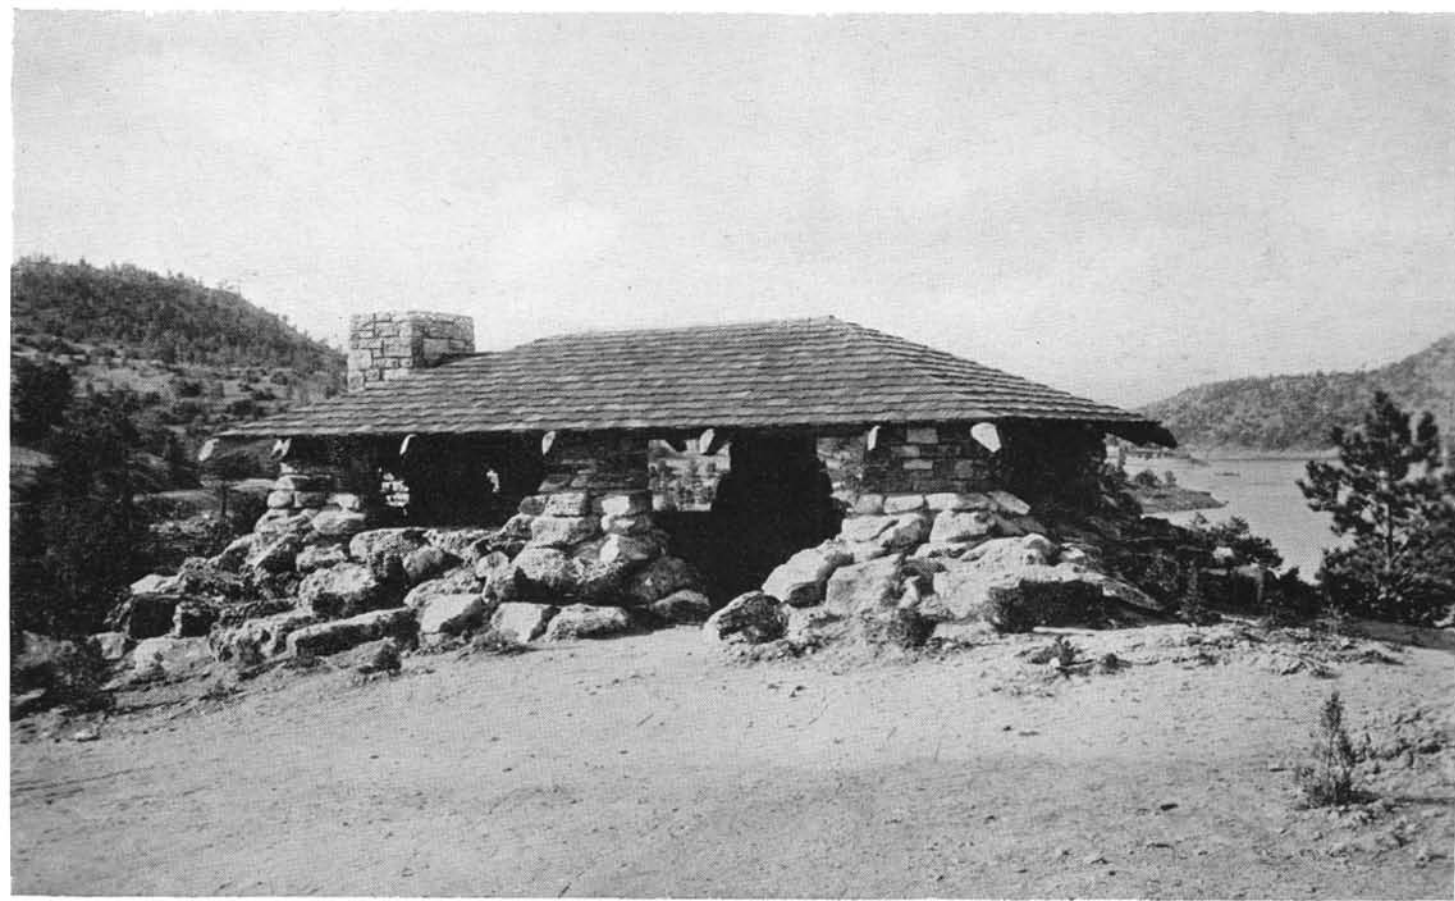
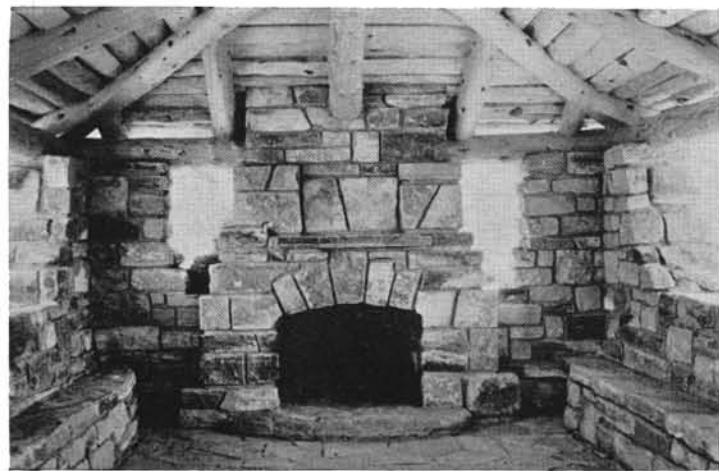
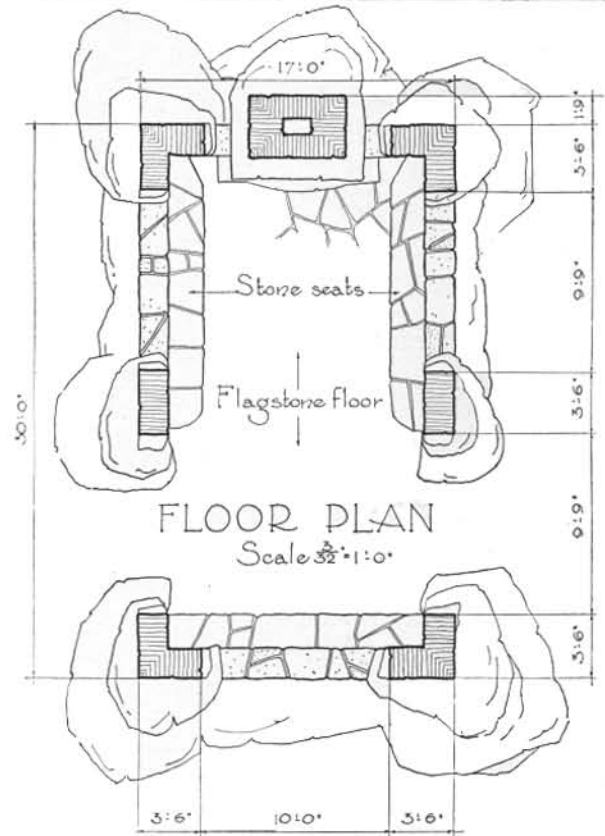
From rude outcropping at its base to finished termination of the chimney is visual presentation of successive stages of masonry evolution. Plant growth should ultimately complete the blending to site so skillfully started by the rock work. The contrast between exterior and interior masonry surface is startling.
