*Community Building, Longmire,  
Mt. Rainier National Park*

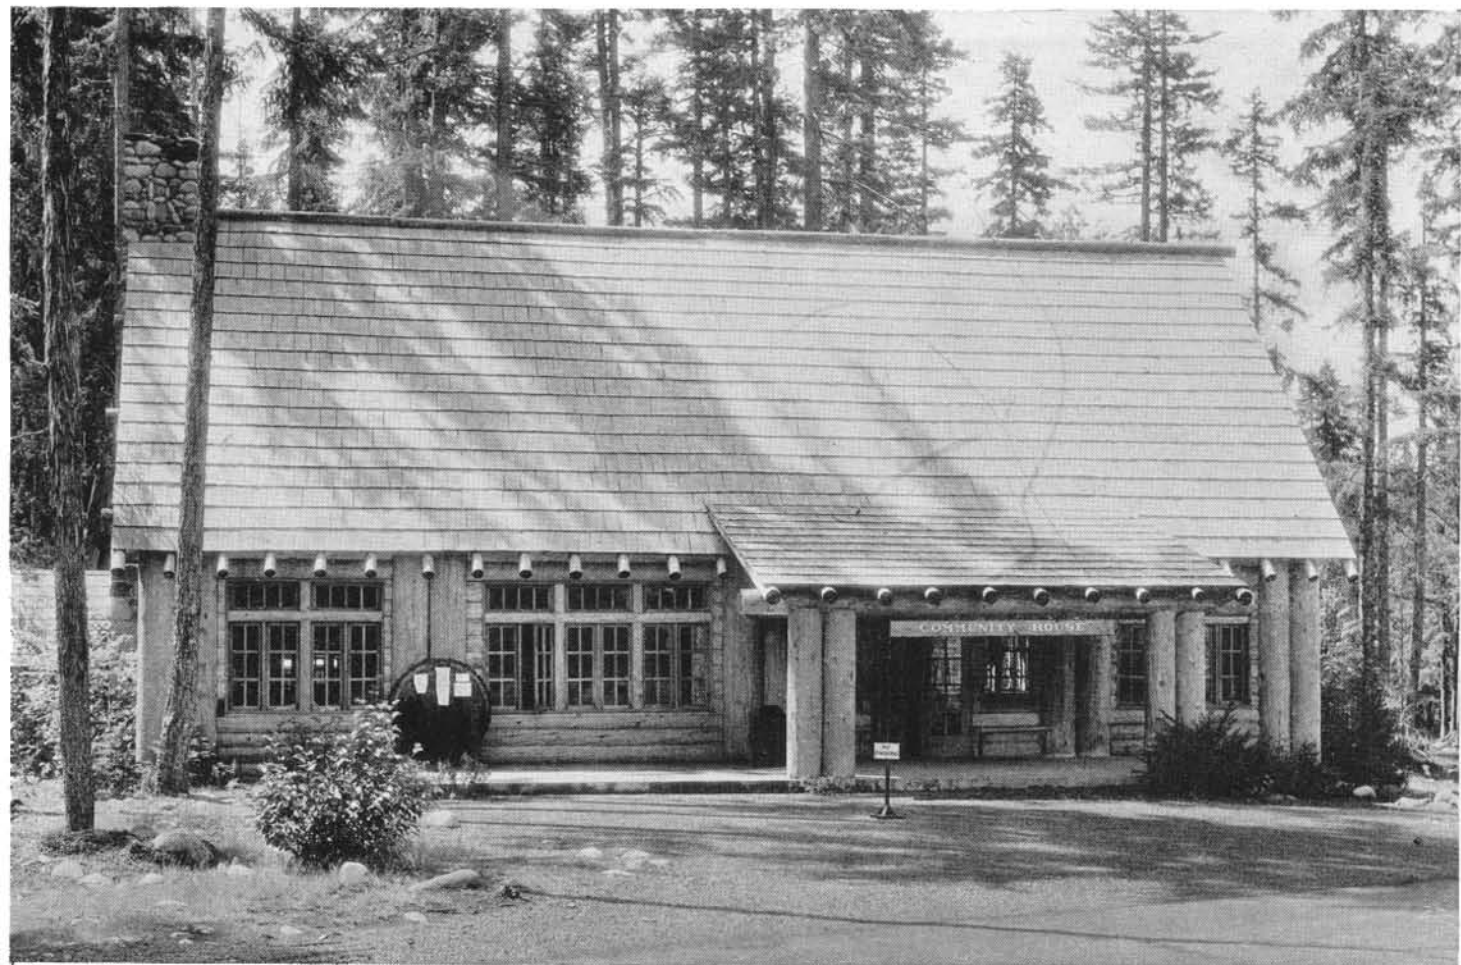
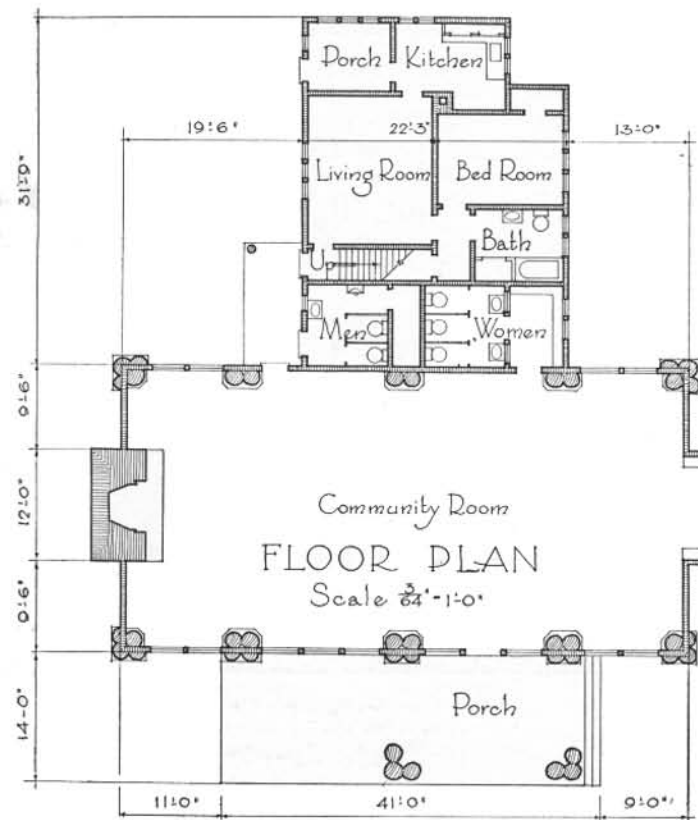
A park structure of importance that after pointing the way for many later buildings, has been far outrun in achievement of subtleties of design and execution making for true park structural character. The thinness of the roof shingles and the masonry of the chimneys are unfortunate. Comparison of the almost mechanical stiffness of the rafter ends with the handcrafted quality of the "whittled" rafter ends of other subjects more recently built, will indicate one such advance in structural technique.
