## HEROISM AND HORROR

### 9.1 PREPAREDNESS AS OF SEPTEMBER 11

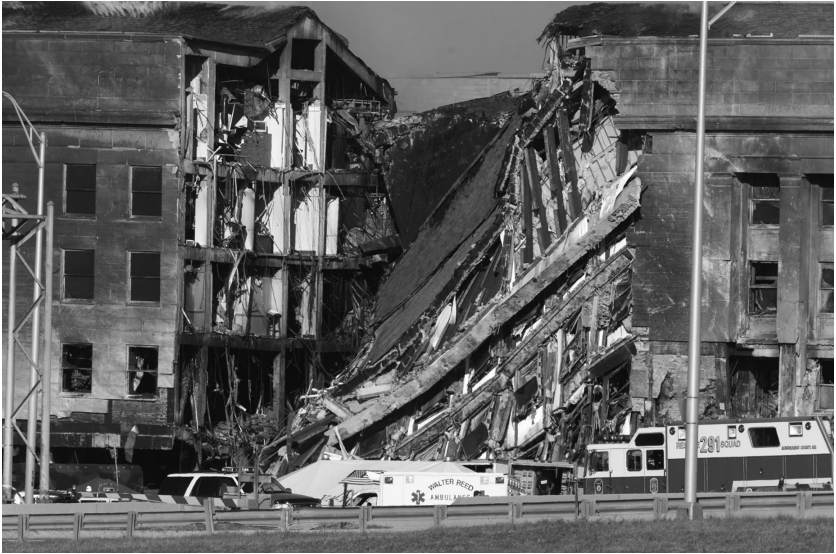
*The Pentagon, after being struck by American Airlines Flight 77*

At 9:37, the west wall of the Pentagon was hit by hijacked American Airlines Flight 77, a Boeing 757. The crash caused immediate and catastrophic damage. All 64 people aboard the airliner were killed, as were 125 people inside the Pentagon (70 civilians and 55 military service members). One hundred six people were seriously injured and transported to area hospitals.<sup>192</sup>
